TWO RIVERS PUBLIC SCHOOLS

FACILITIES ASSESSMENT REPORT

08.19.21

Two Rivers School District Facilities Assessment July 2021

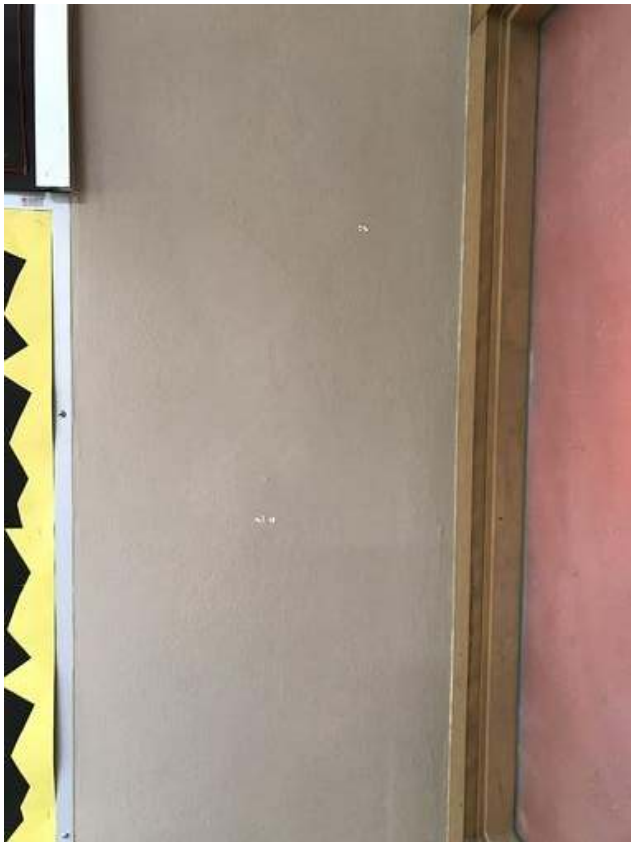
G55: General

Description: Bent and damaged wall, area needs painting

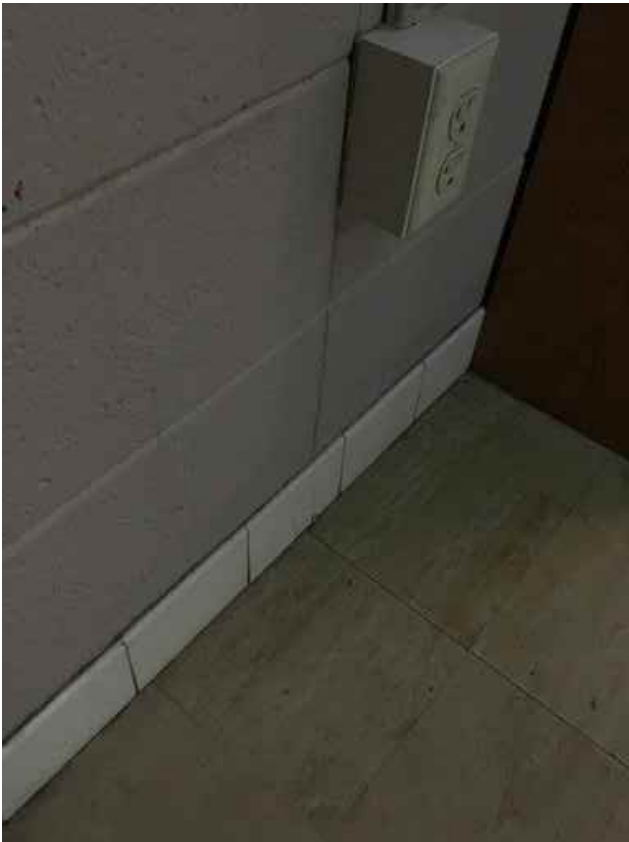
G86: General

Description: Cracks and holes in flooring

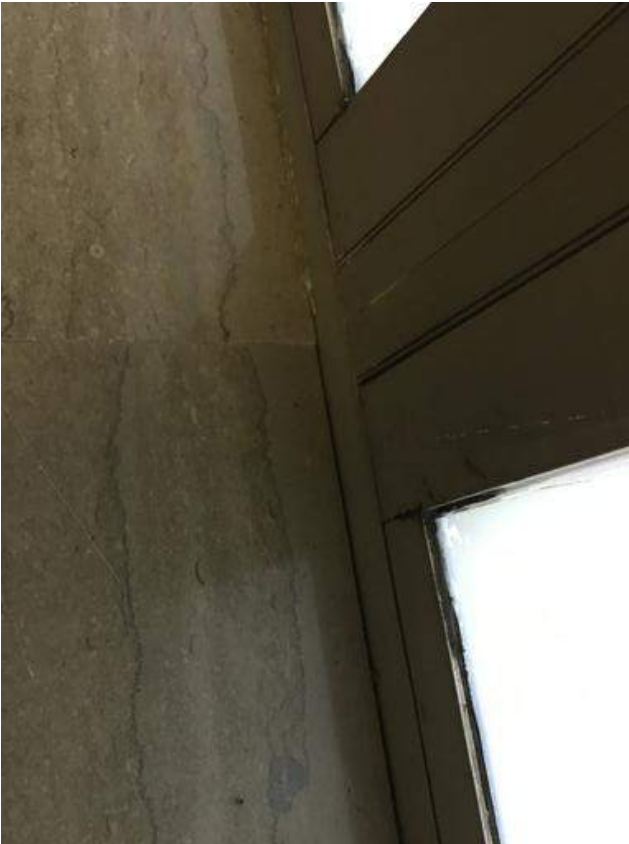
G97: General

Description: Tile base is chipped and cracked

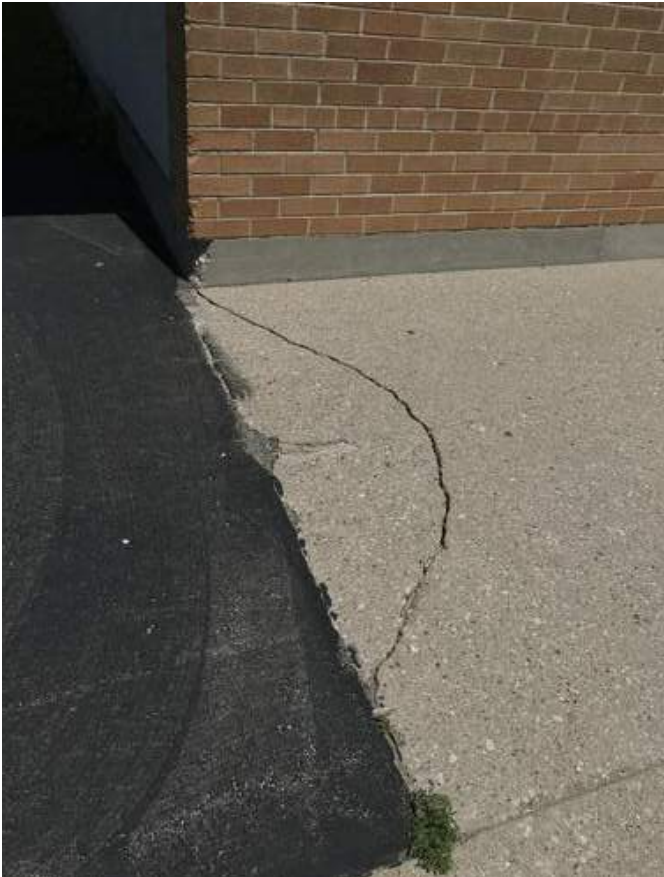
S5: Site Work

Description: Cracked concrete

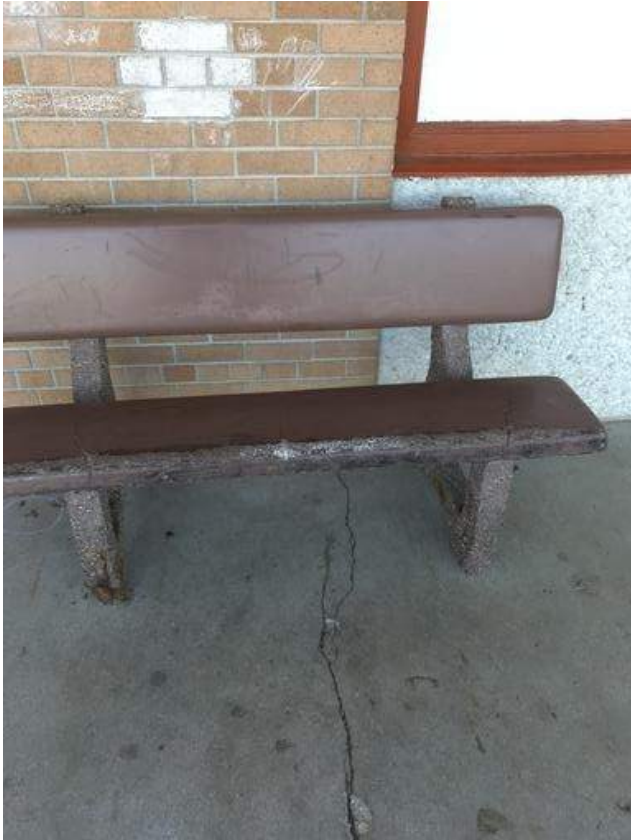
X13: Exterior

Description: Cracked concrete

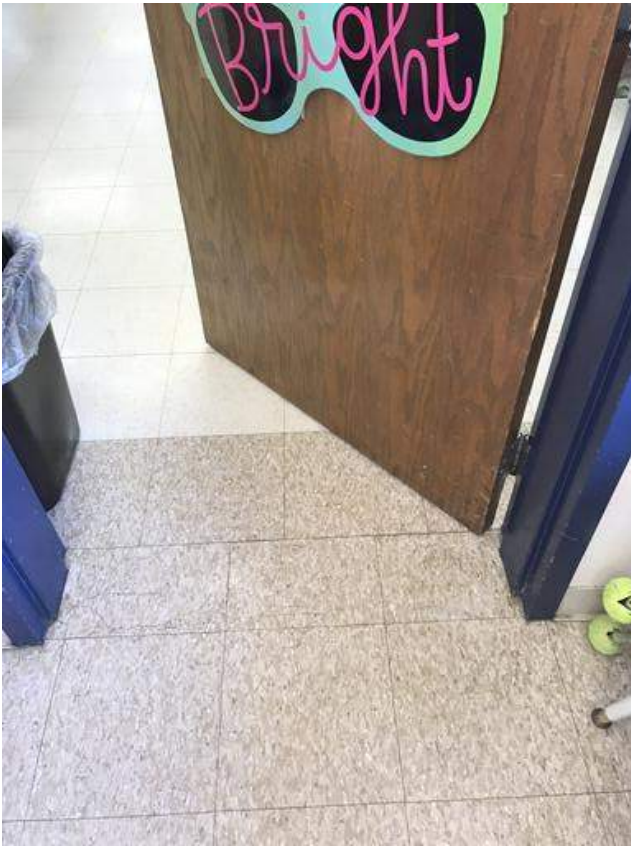
G4: General

Description: Floor Cracks

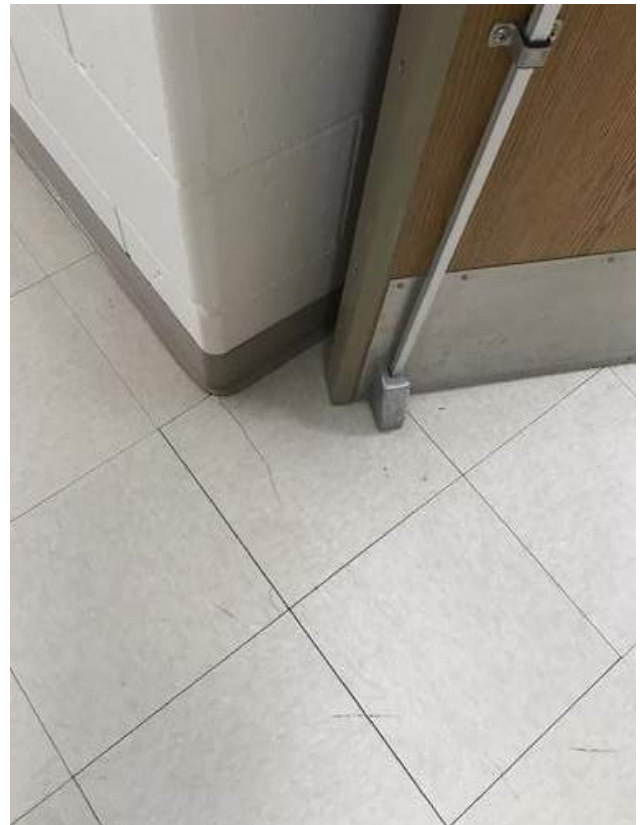
G46: General

Description: Cracks in floor

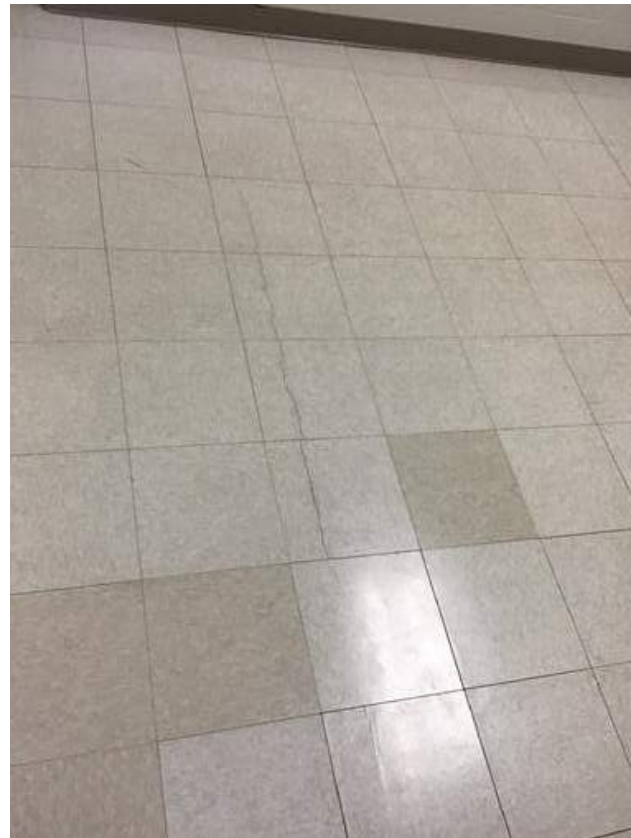
G69: General

Description: Floor has cracks

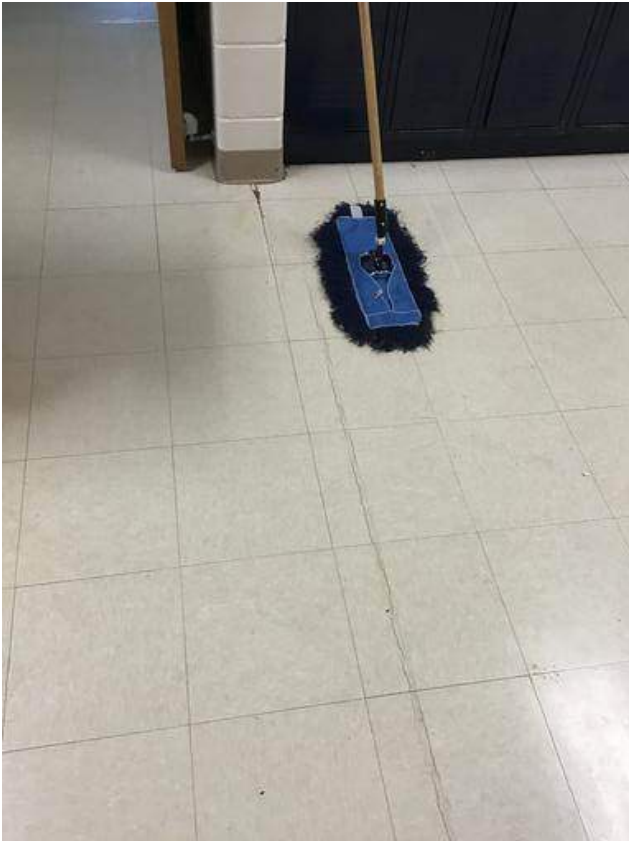
G70: General

Description: Floor has cracks

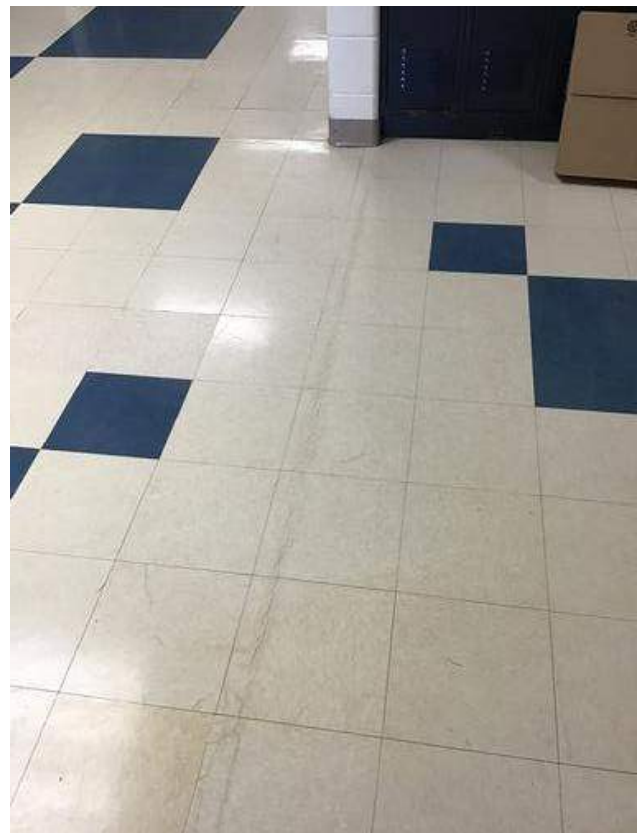
G71: General

Description: Floor has cracks

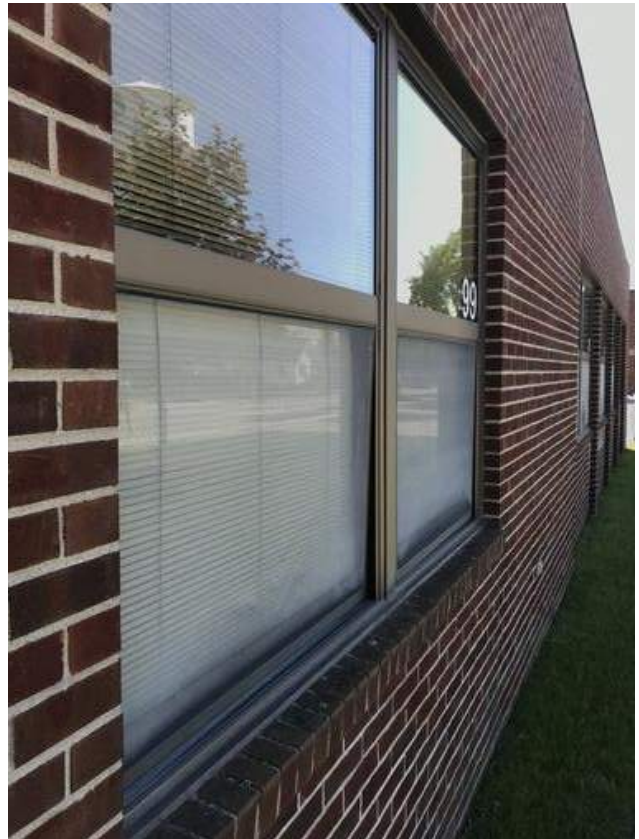
X7: Exterior

Description: Cracked mortar and damaged brick

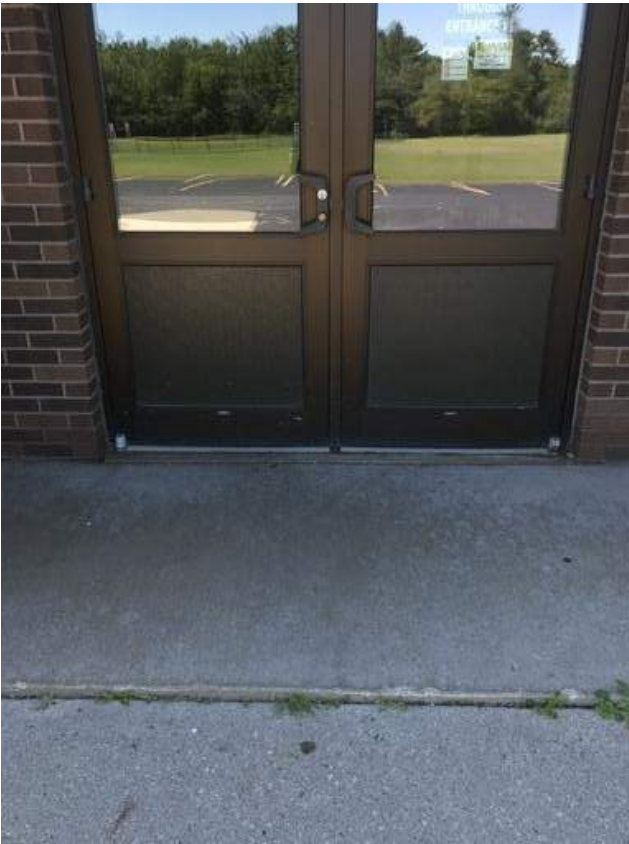
G19: General

Description: Cracks in concrete floor and floor finish is chipped

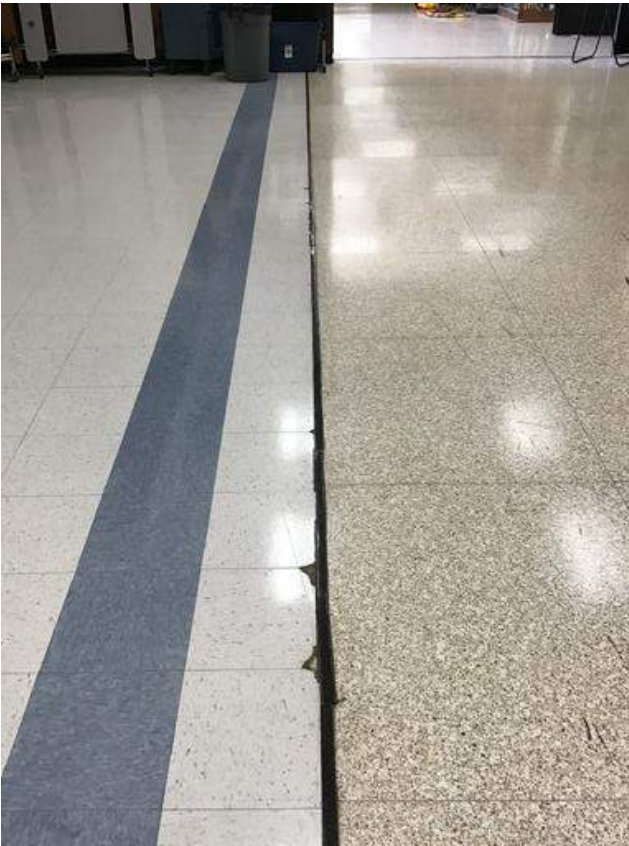
G29: General

Description: Cracks in flooring

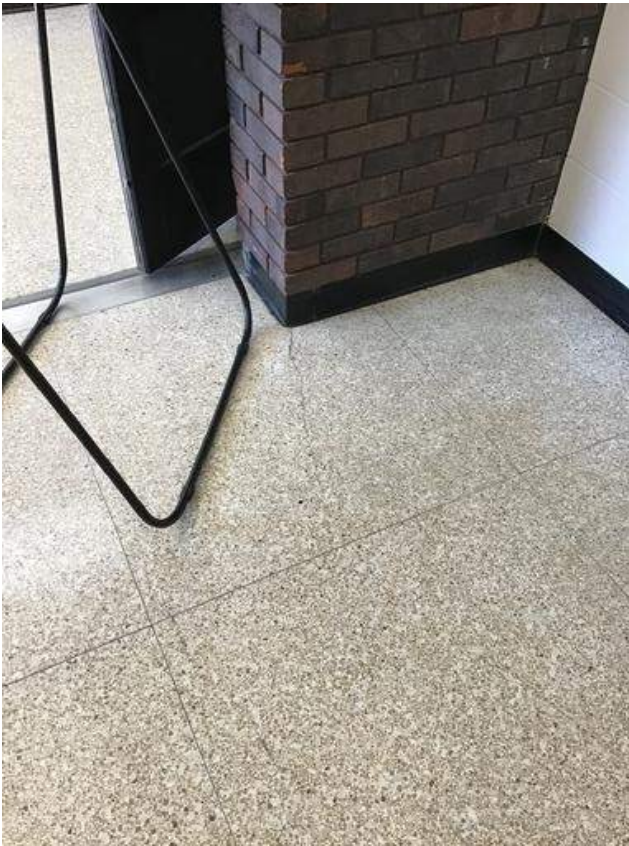
G30: General

Description: Crack in flooring

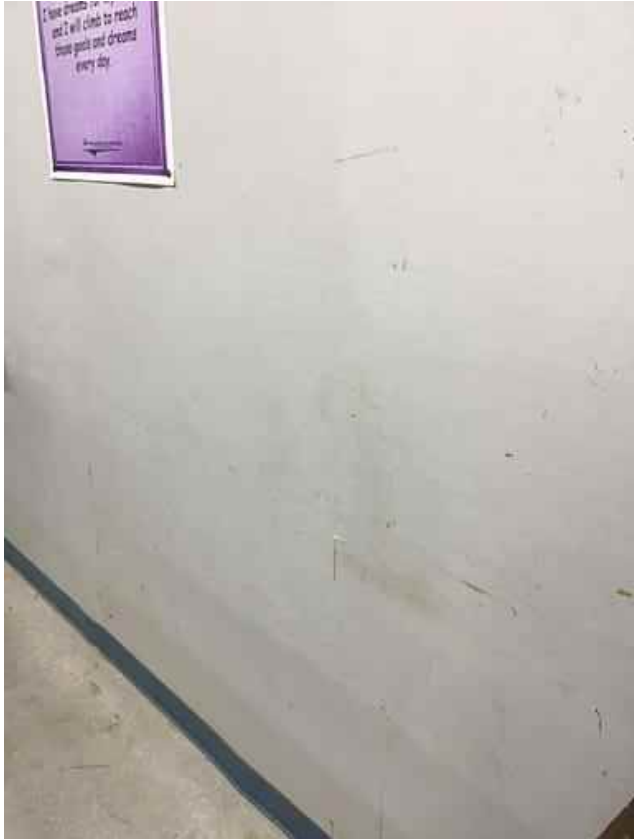
G39: General

Description: Cracks in CMU wall

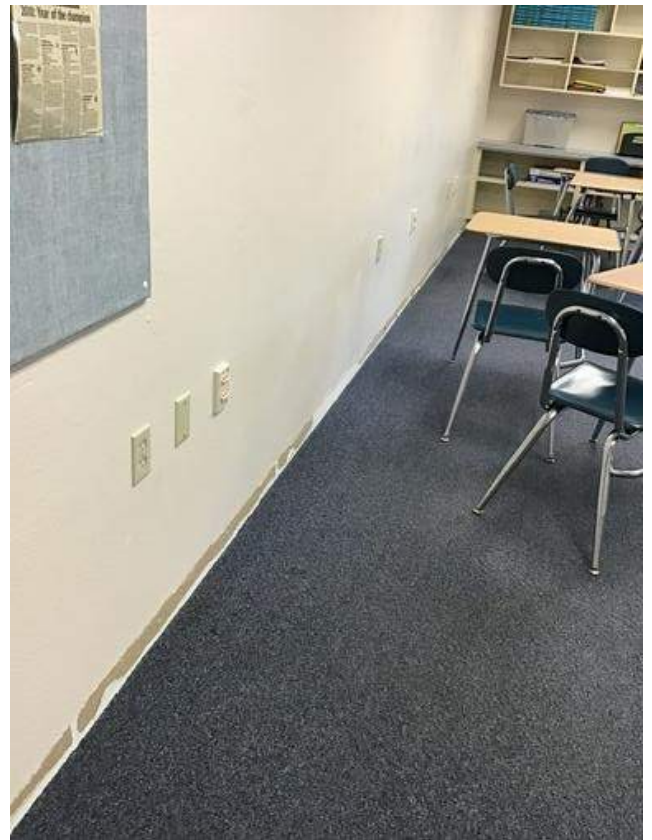
G50: General

Description: Stained carpet

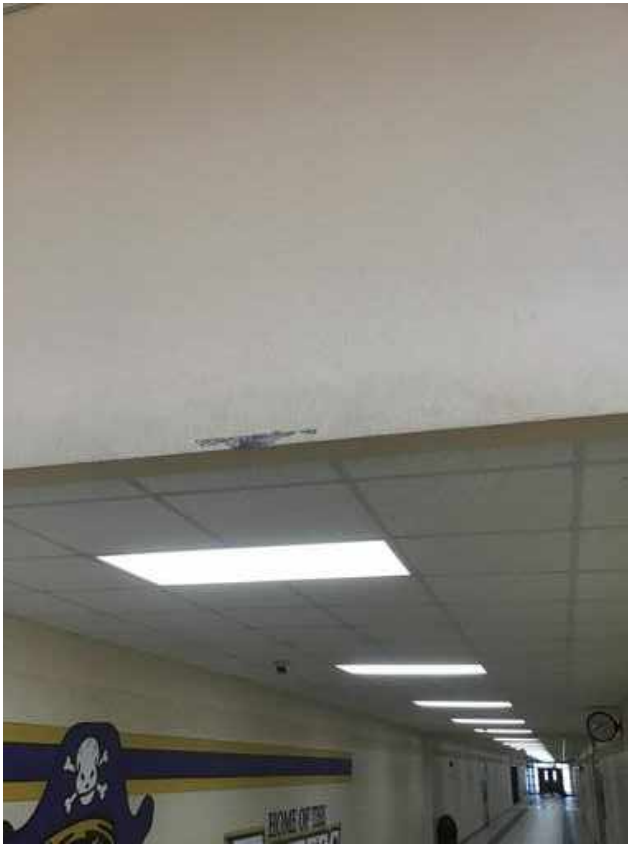
G14: General

Description: Damaged ACT

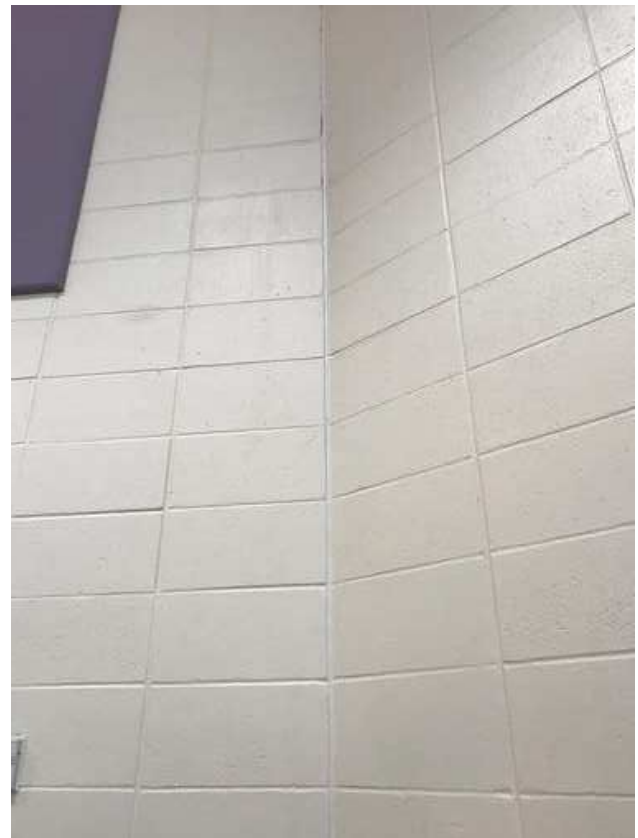
G50: General

Description: Wall cracks

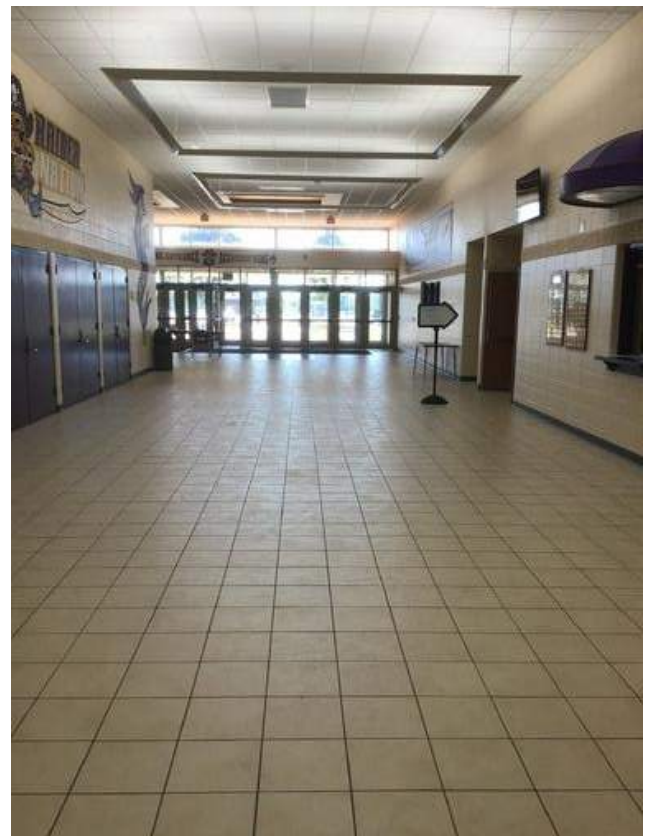
G52: General

Description: Cracked floor tile

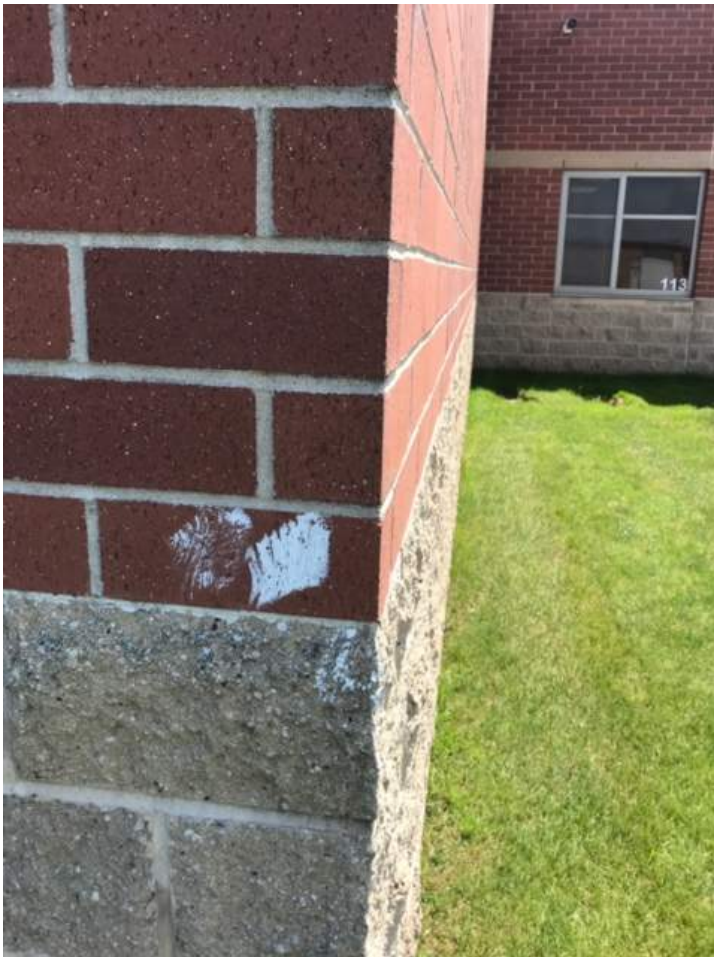
X7: Exterior

Description: Stain on CMU

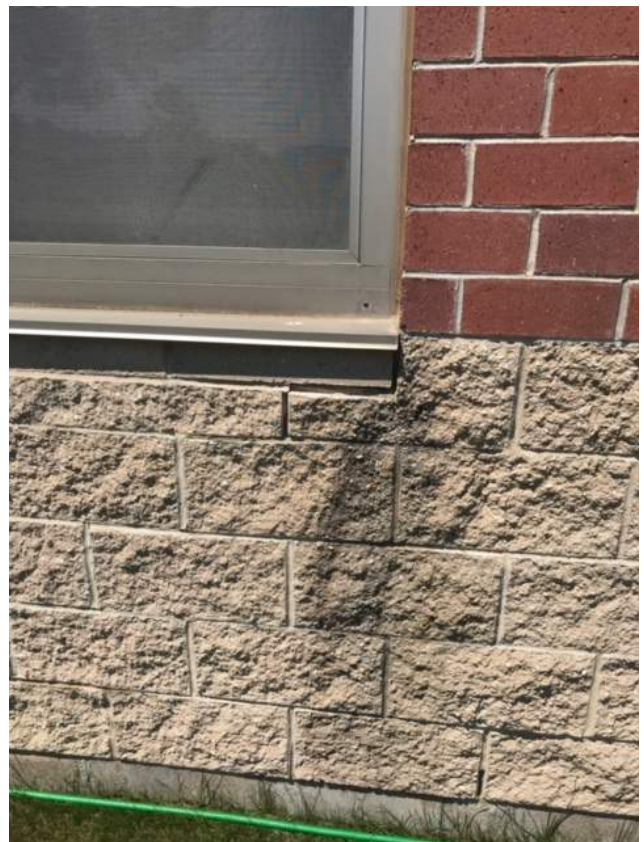
X8: Exterior

Description: Mortar needed at joint of CMU

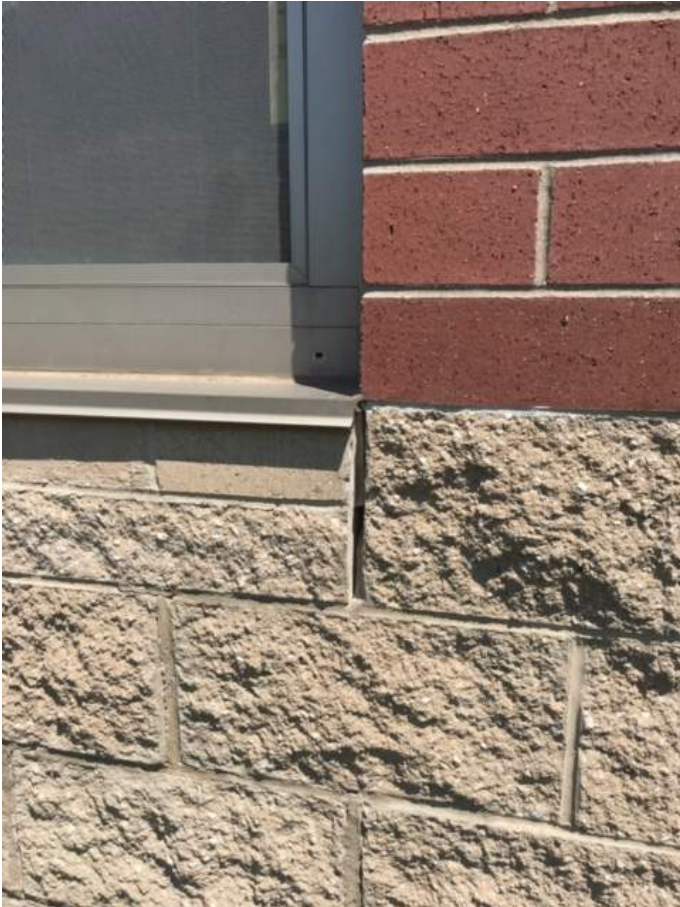
X9: Exterior

Description: Mortar cracked and missing at CMU
