TWO RIVERS PUBLIC SCHOOLS

FACILITIES ASSESSMENT REPORT

08.19.21

Two Rivers School District Facilities Assessment July 2021

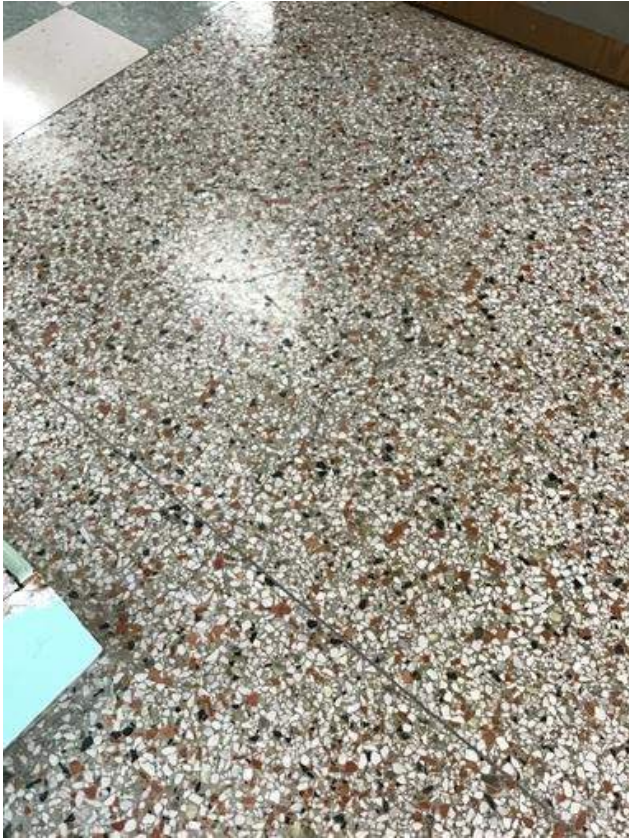
Sheet
A2.0

Description: Floor has cracks

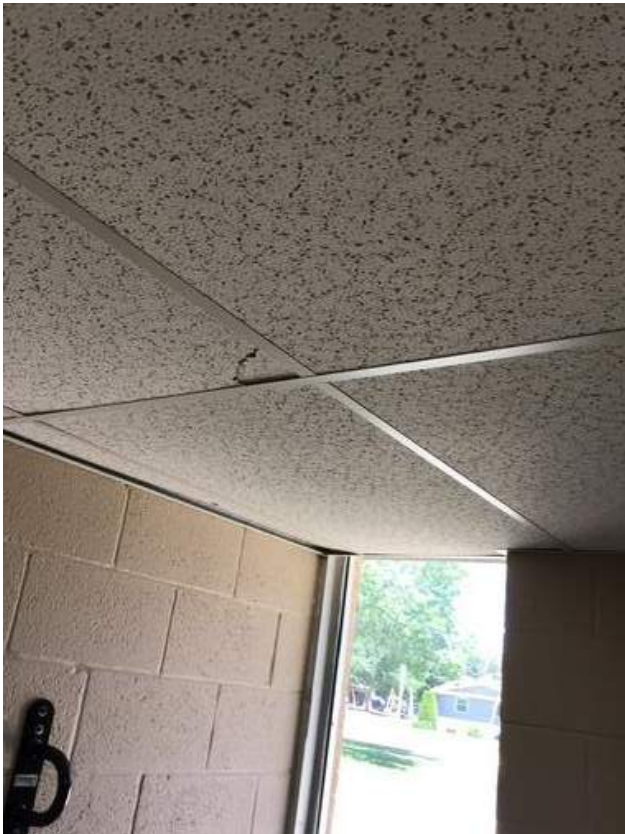
G2: General

Description: Damaged ACT

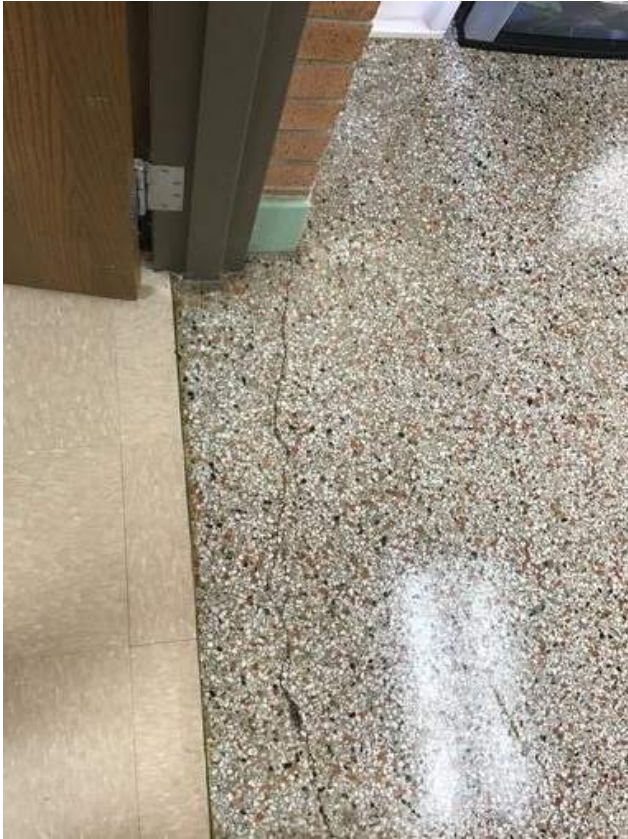
G3: General

Description: Cracked floor

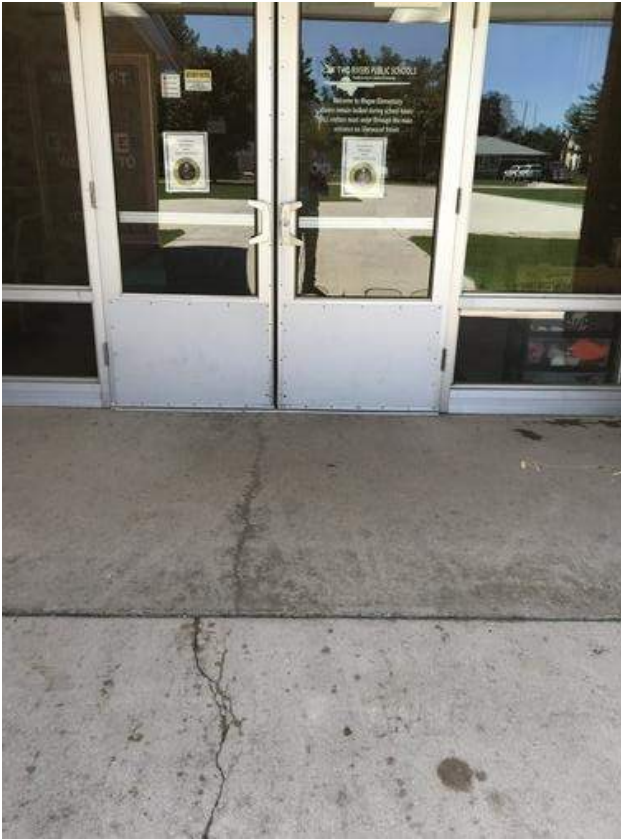
G4: General

Description: Cracked concrete

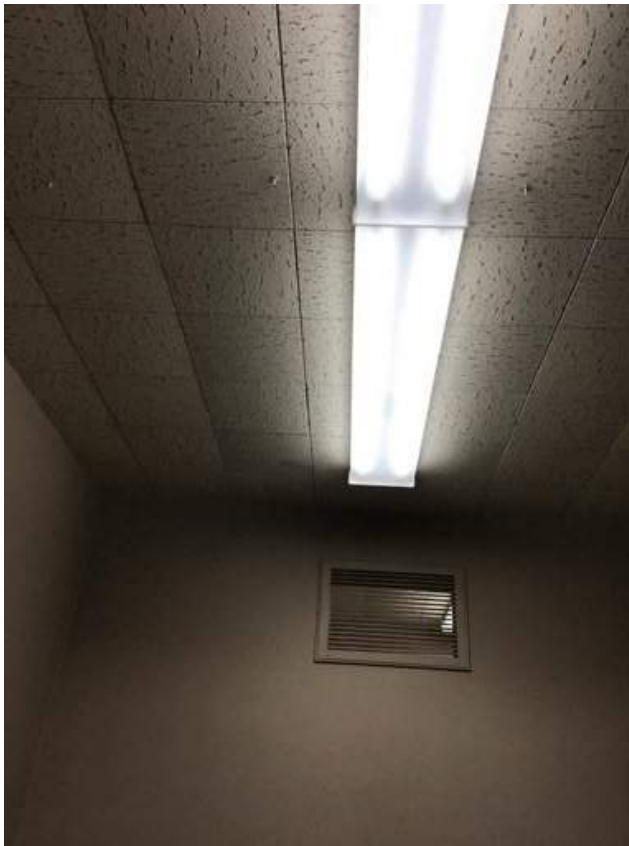
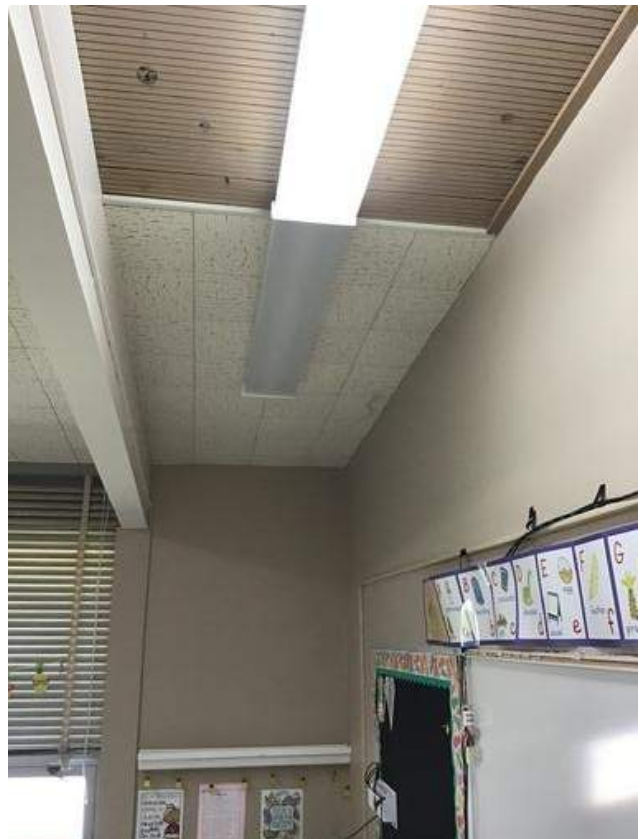
G6: General

Description: Stained ceiling

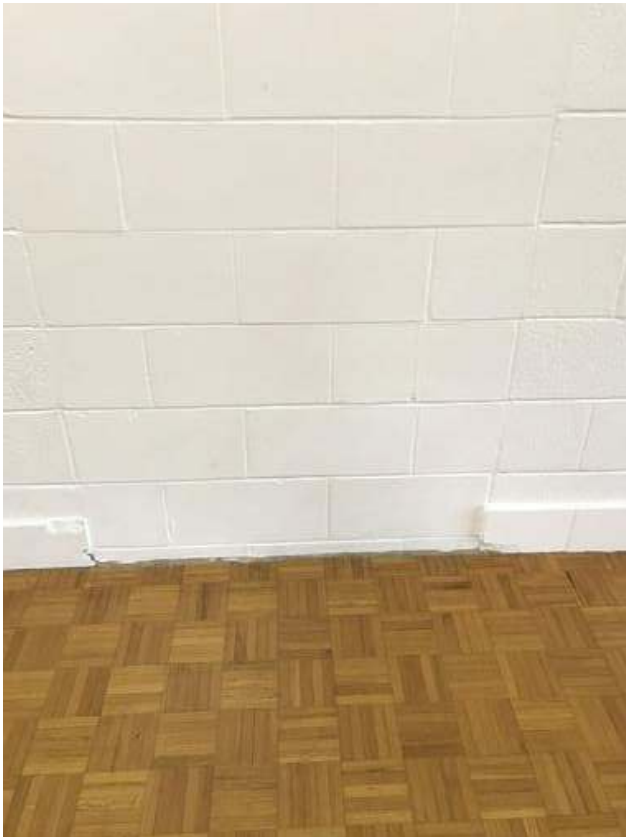
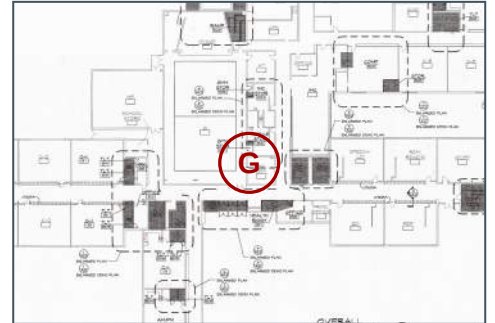
G8: General

Description: Missing wall base

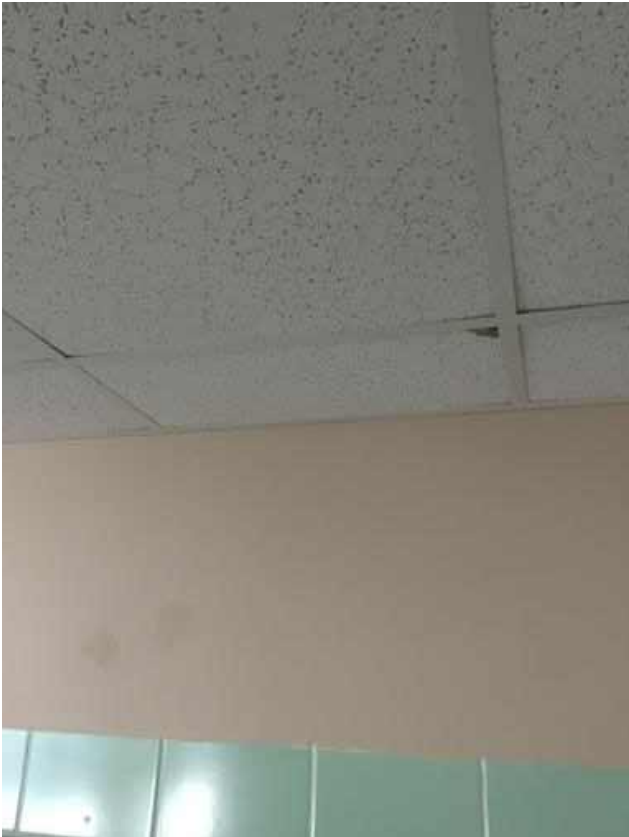
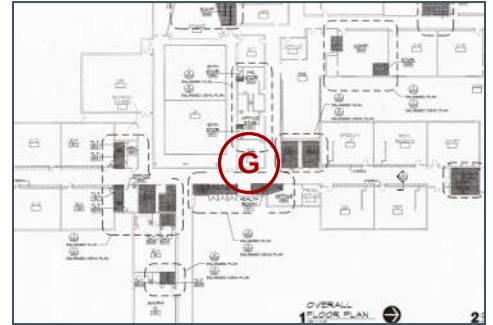
G10: General

Description: Damaged ACT

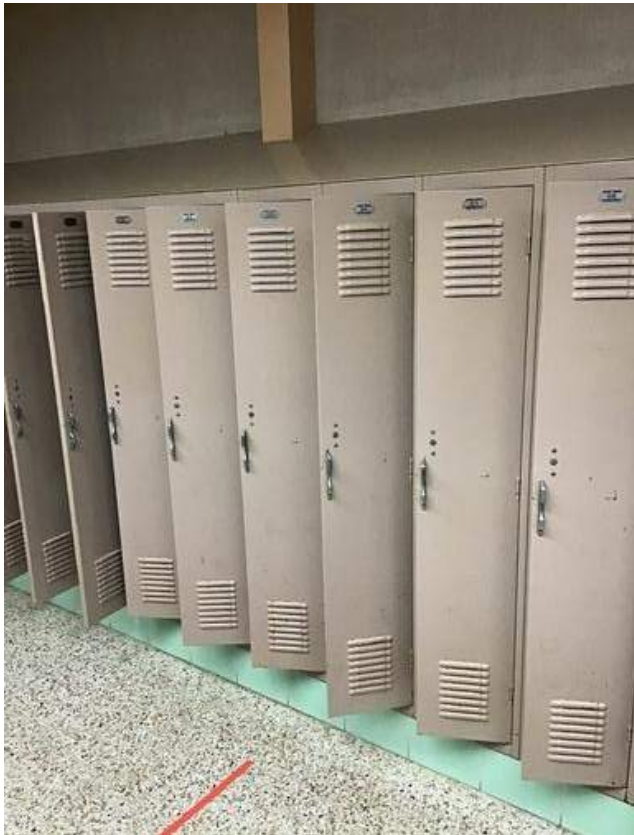
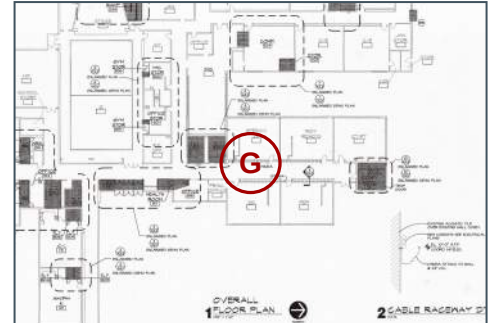
G11: General

Description: Rusted lockers

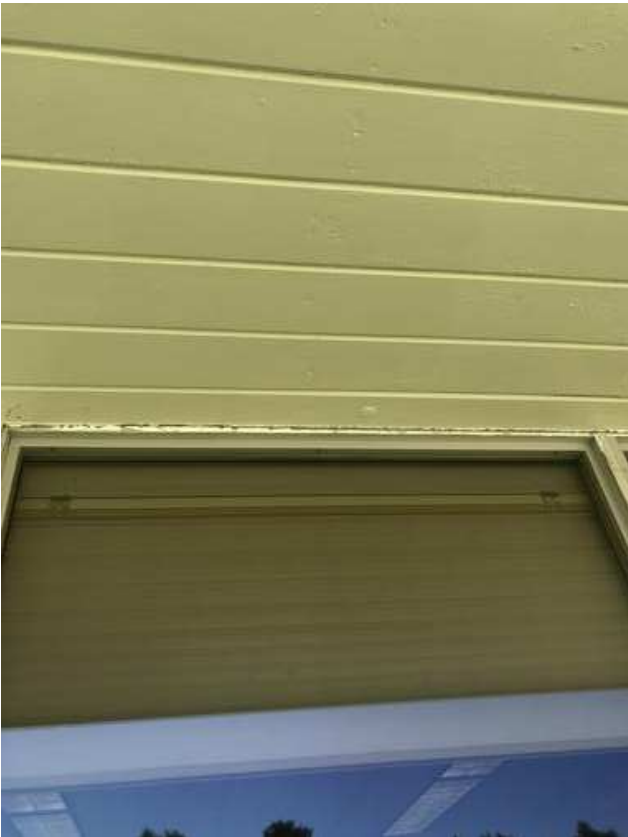
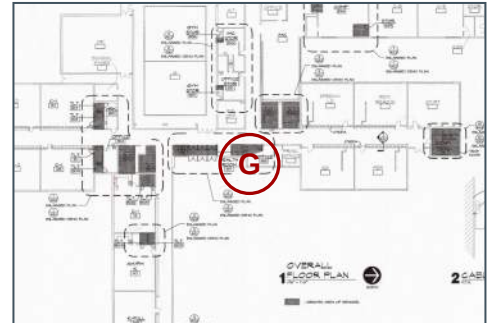
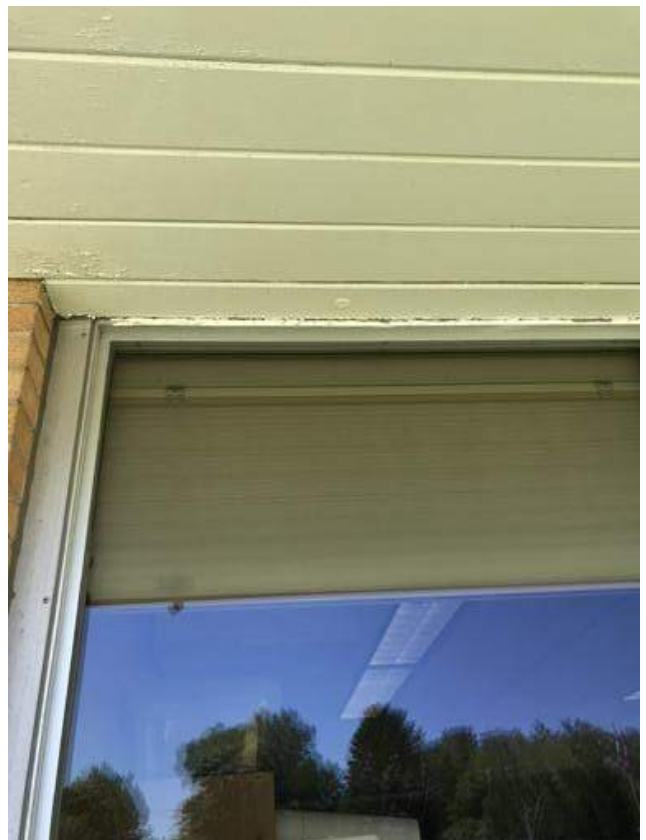
G12: General

Description: Windows need to be caulked

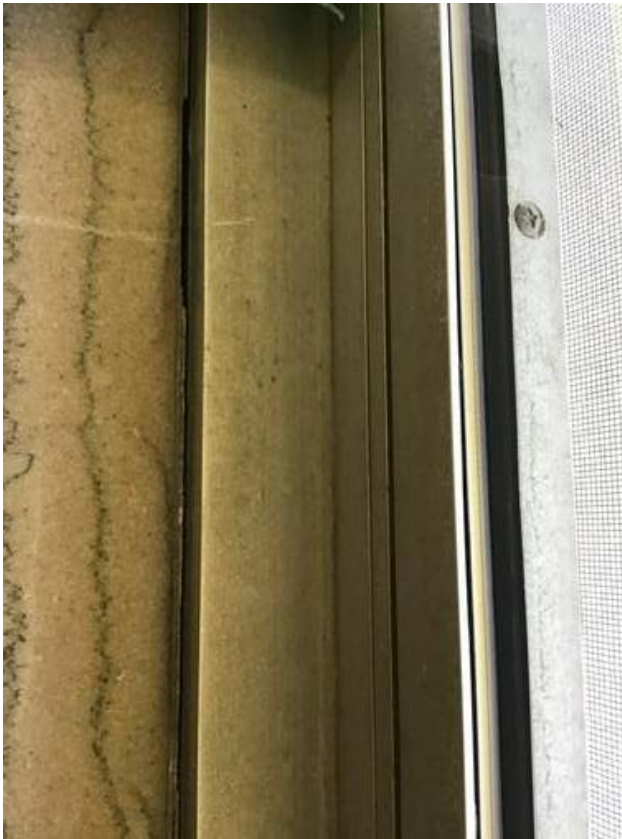
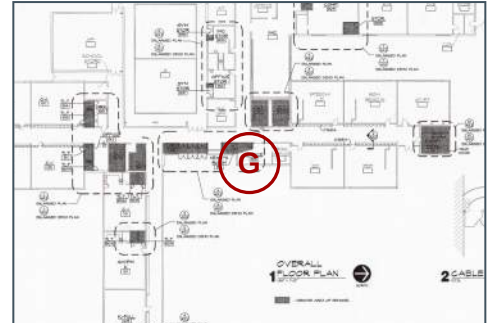
G13: General

Description: Window needs to be caulked

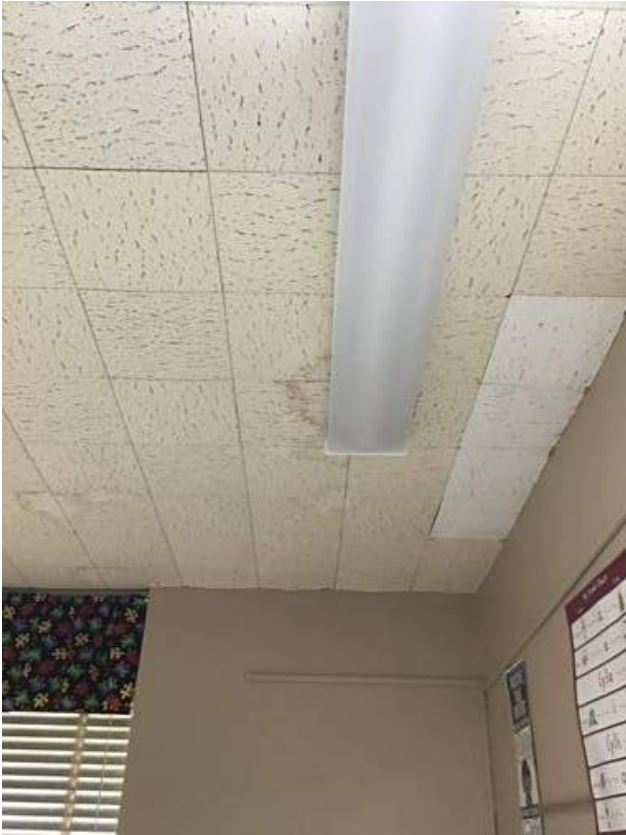
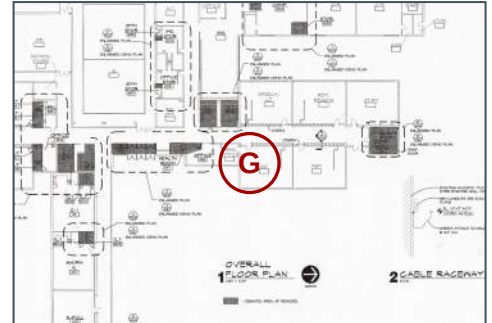
G15: General

Description: Stained ACT

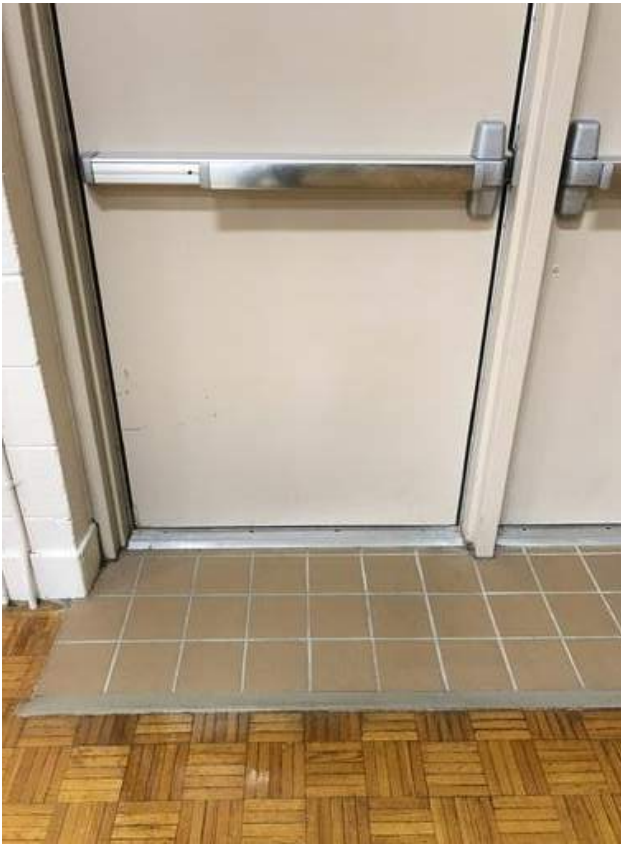
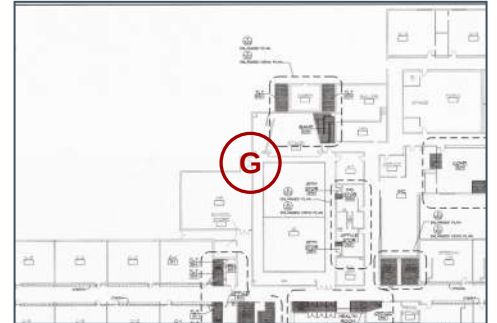
G34: General

Description: Stained floor

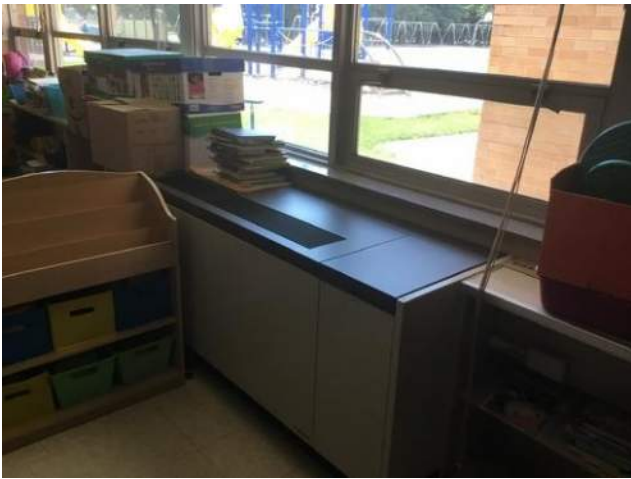
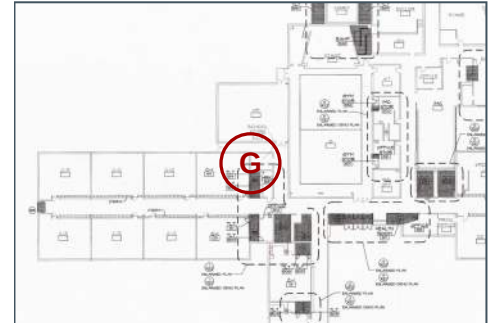
G37: General

Description: Broken and cracked wall tile

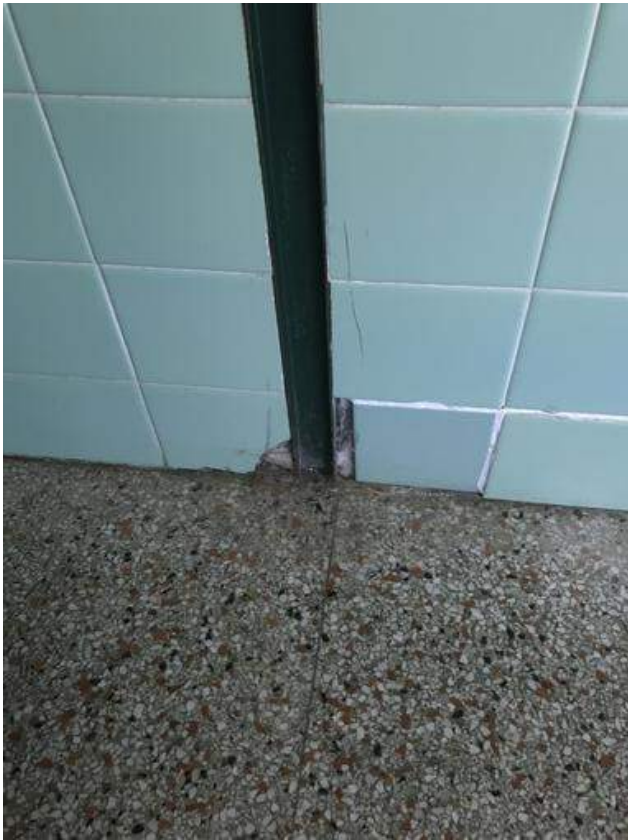
G38: General

Description: Floor cracks

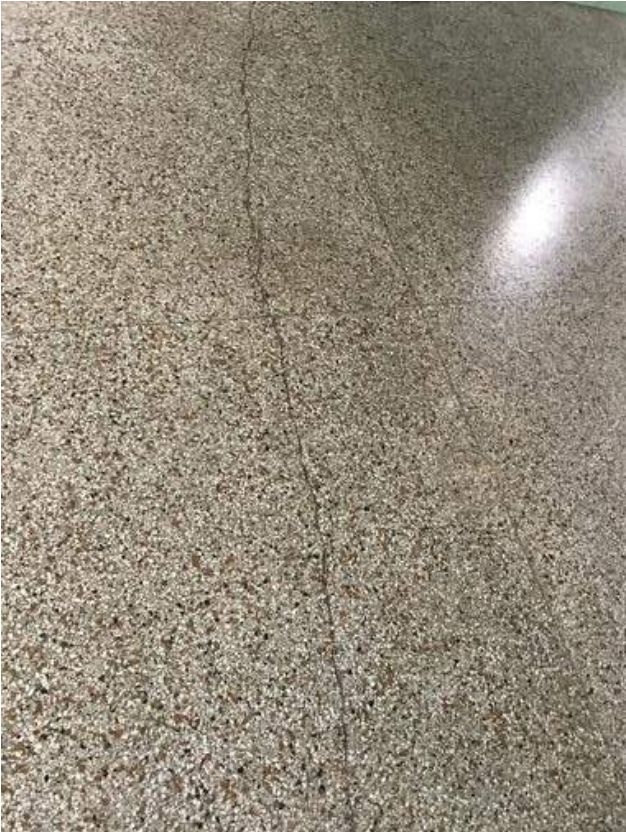
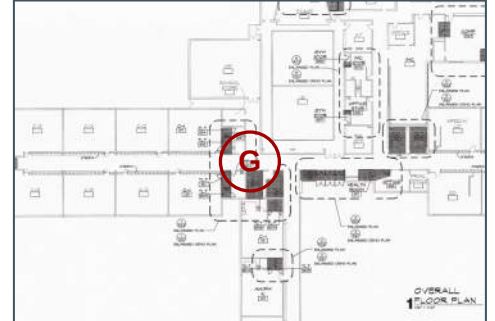
G39: General

Description: Caulking at urinals and stained floor

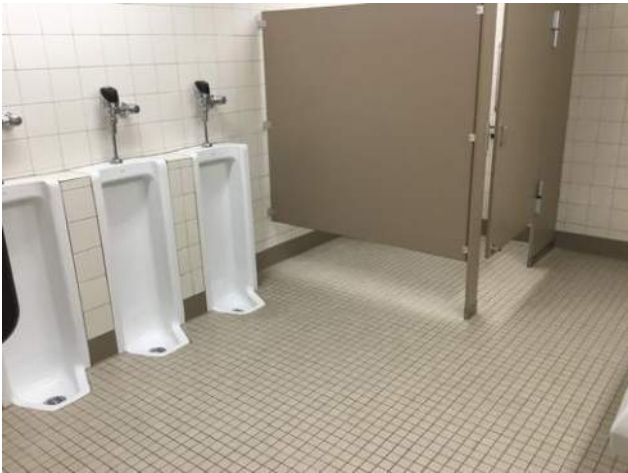
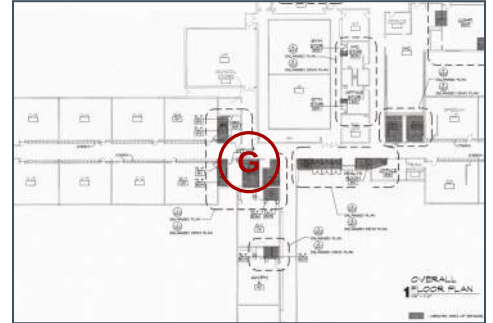
G40: General

Description: Stained bathroom walls

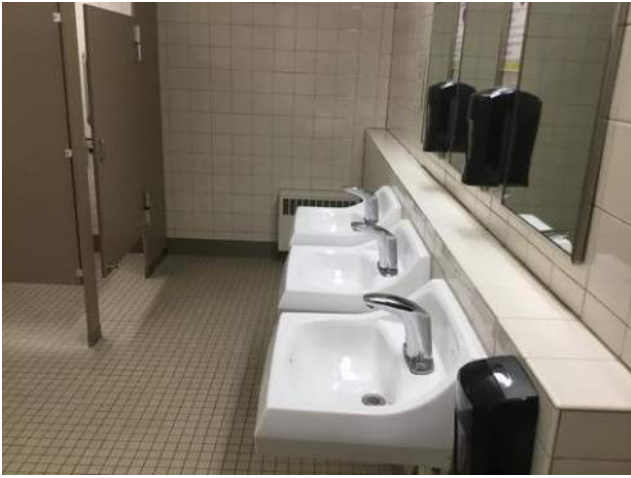
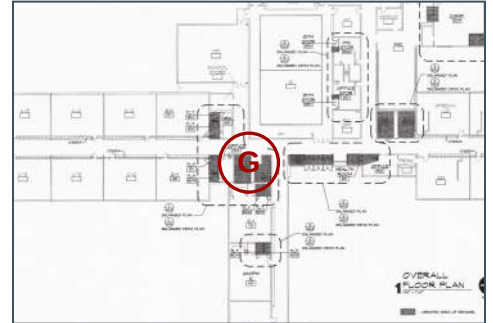
G41: General

Description: Floor and wall cracks

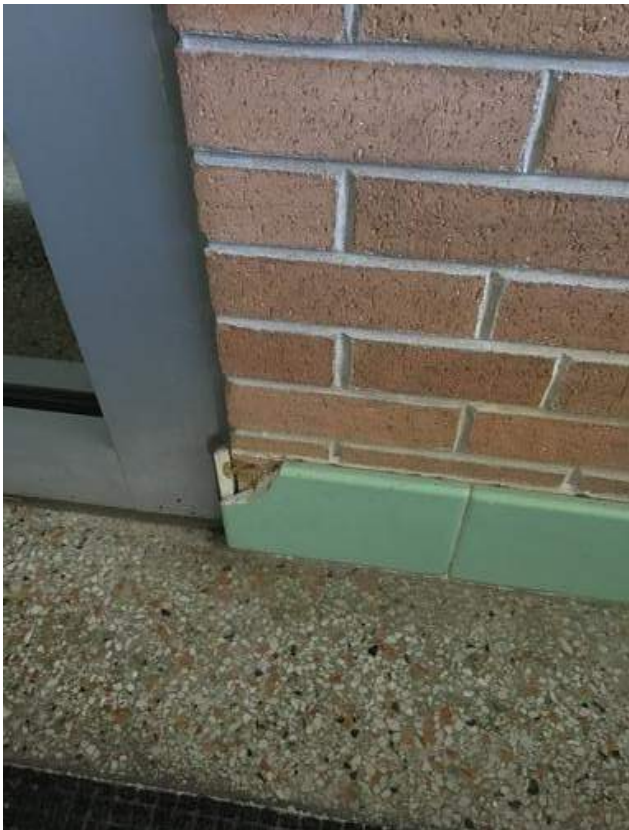
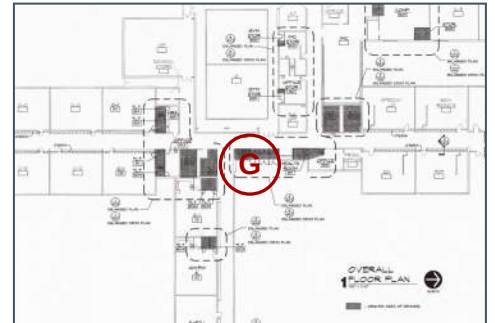
G42: General

Description: Wall cracks and holes in tile wall

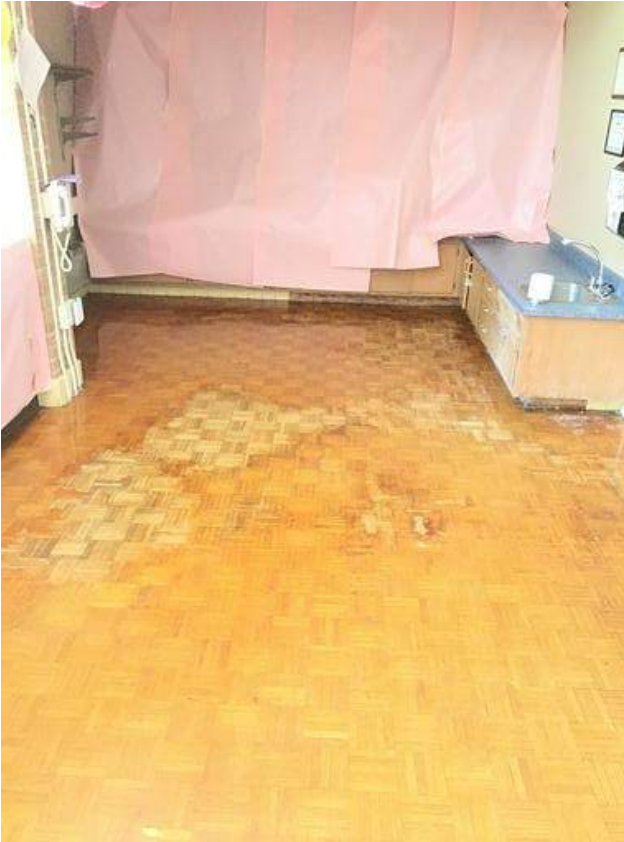
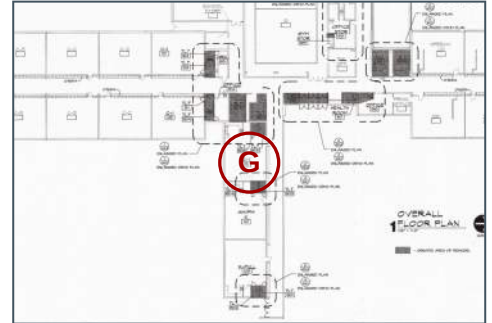
G44: General

Description: Stained wood floor and cracked wall base

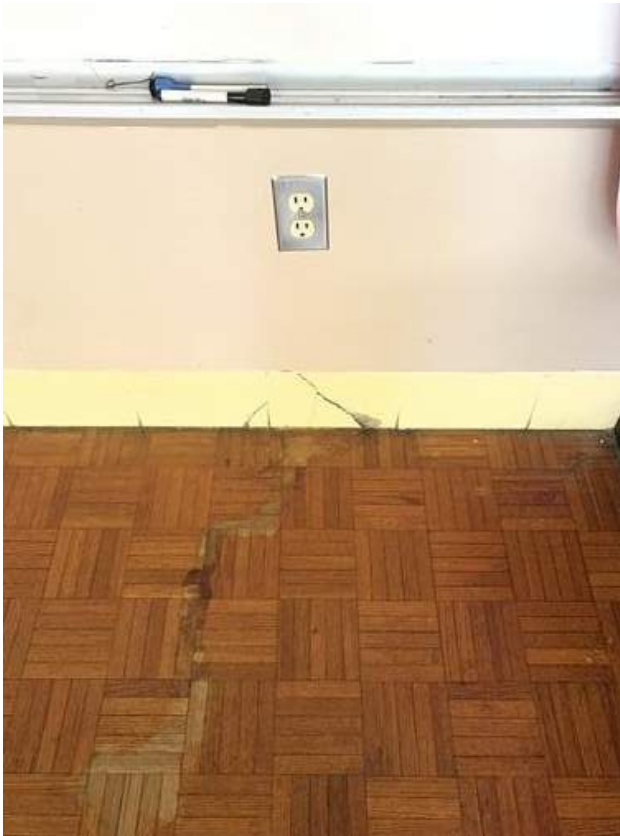
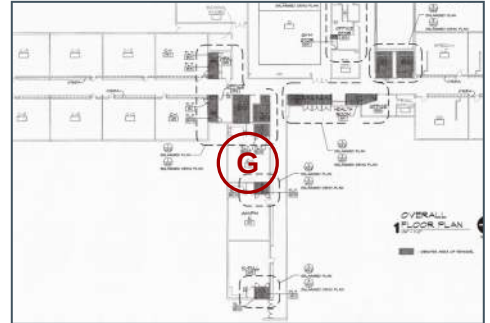
G45: General

Description: Needs caulking

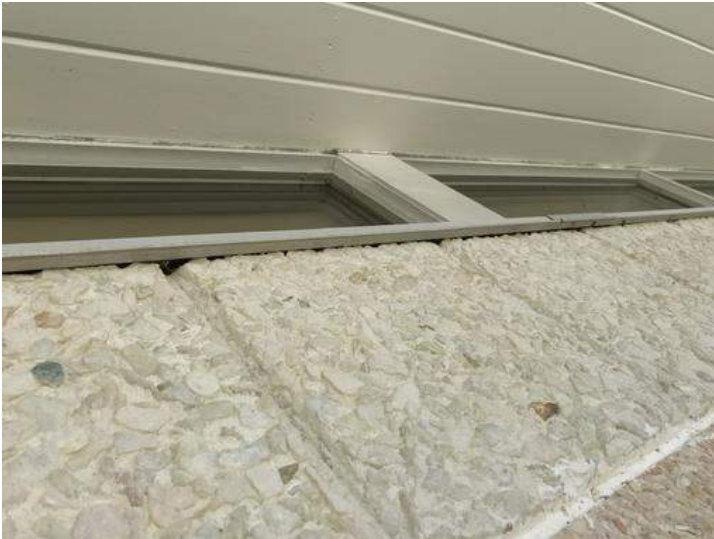
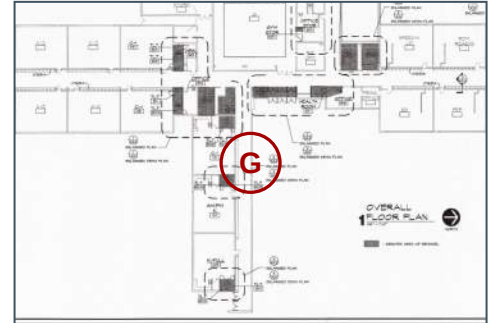
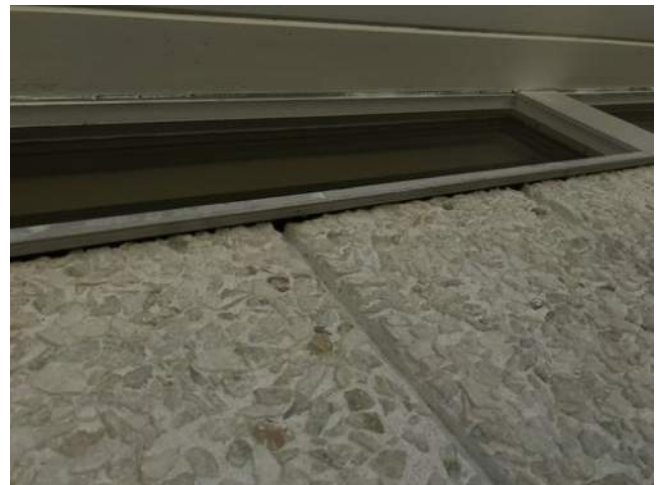
G46: General

Description: Window frame needs caulking

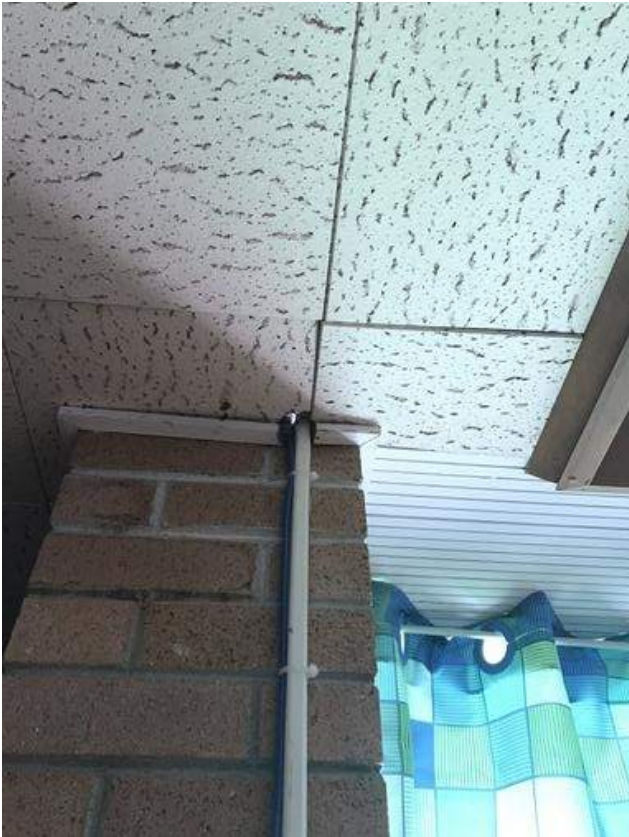
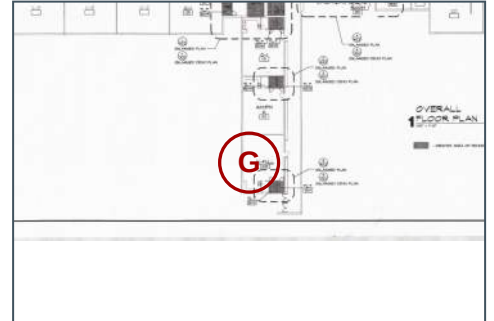
G50: General

Description: Damaged ceiling tile

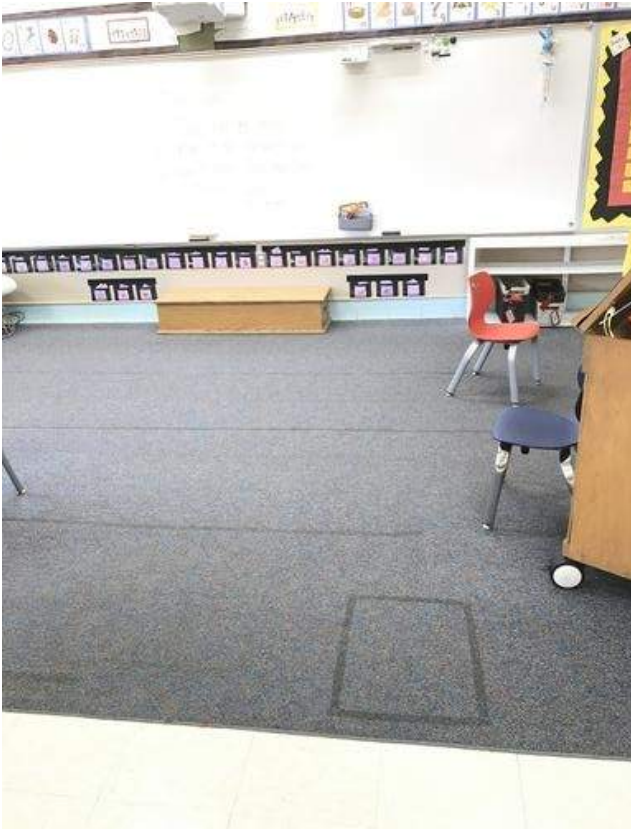
G54: General

Description: Wall scratches

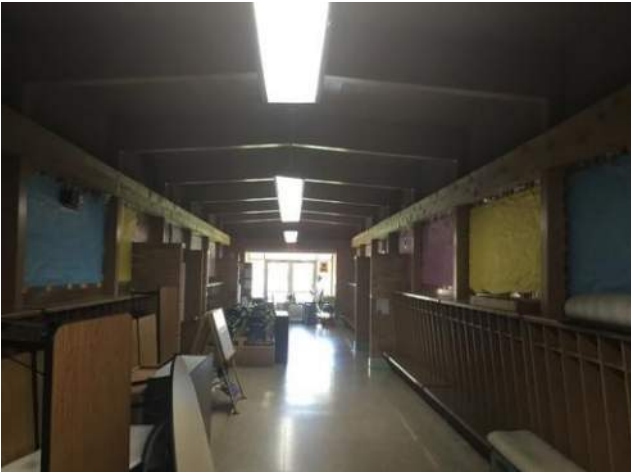
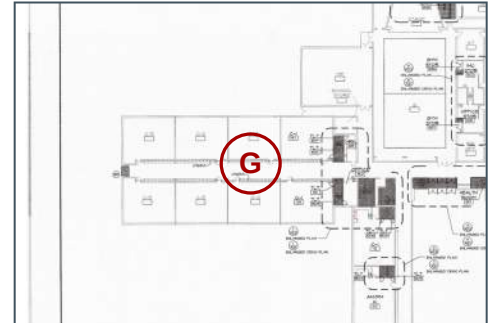
G58: General

Description: Scratched cabinetry

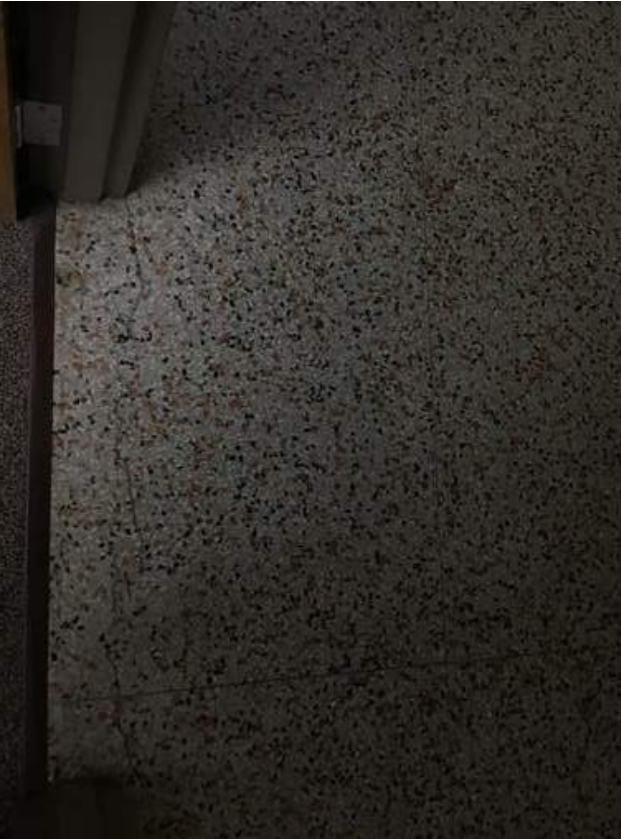
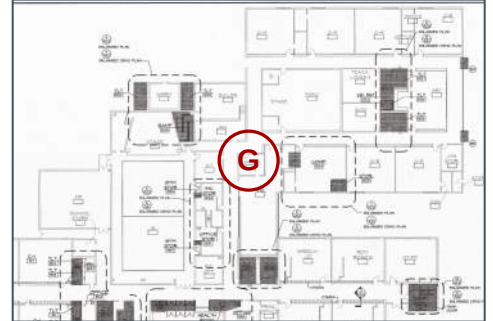
G67: General

Description: Crack in floor

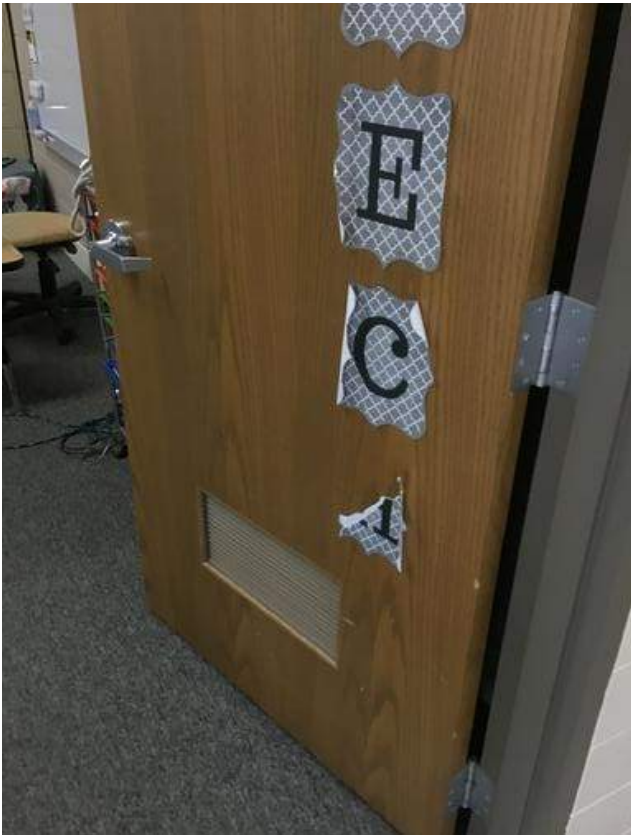
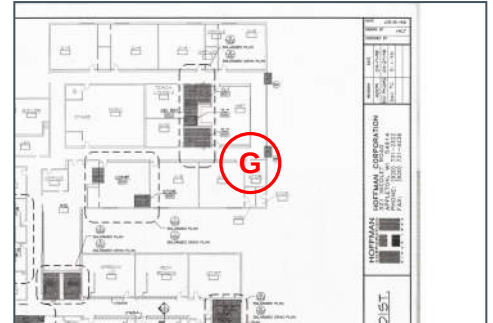
G78: General

Description: Scratches on door

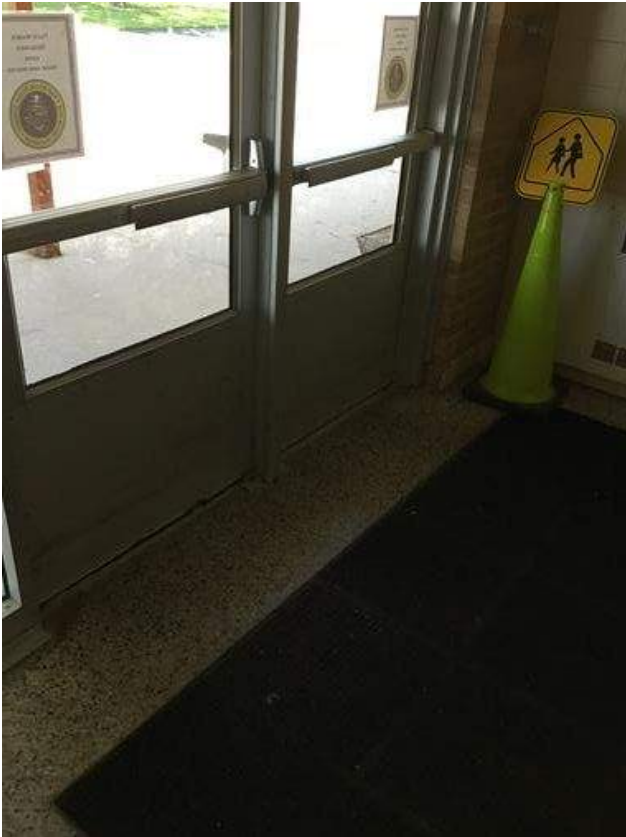
G79: General

Description: Windows need to be caulked

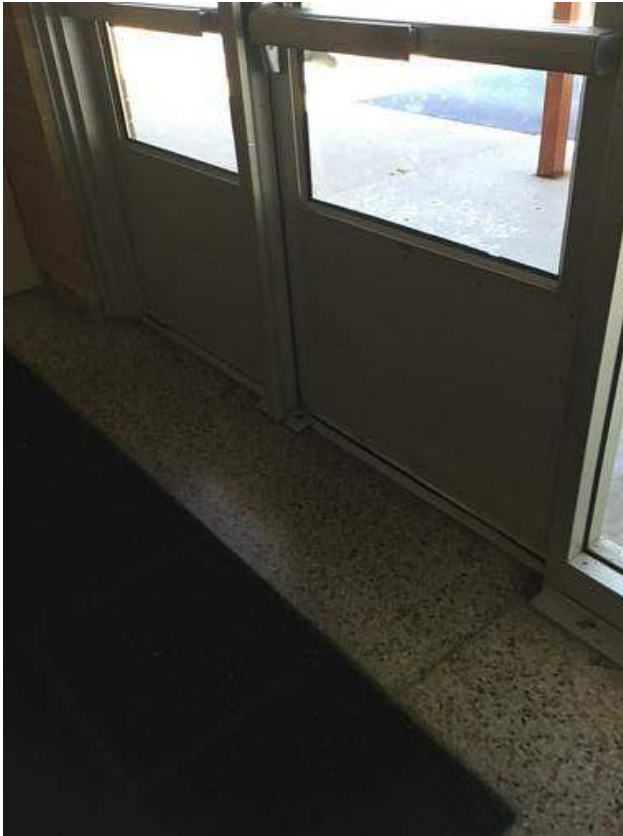
G83: General

Description: Cracks in tile base

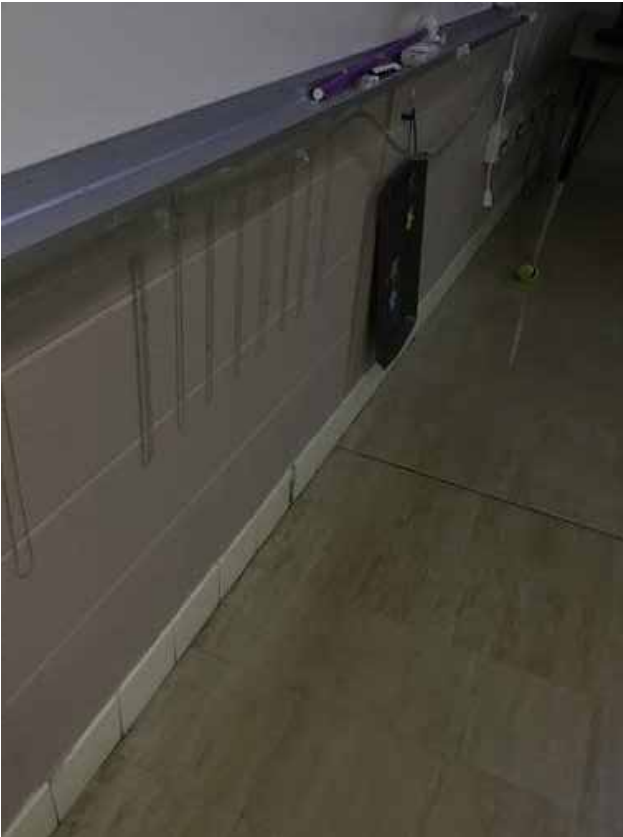
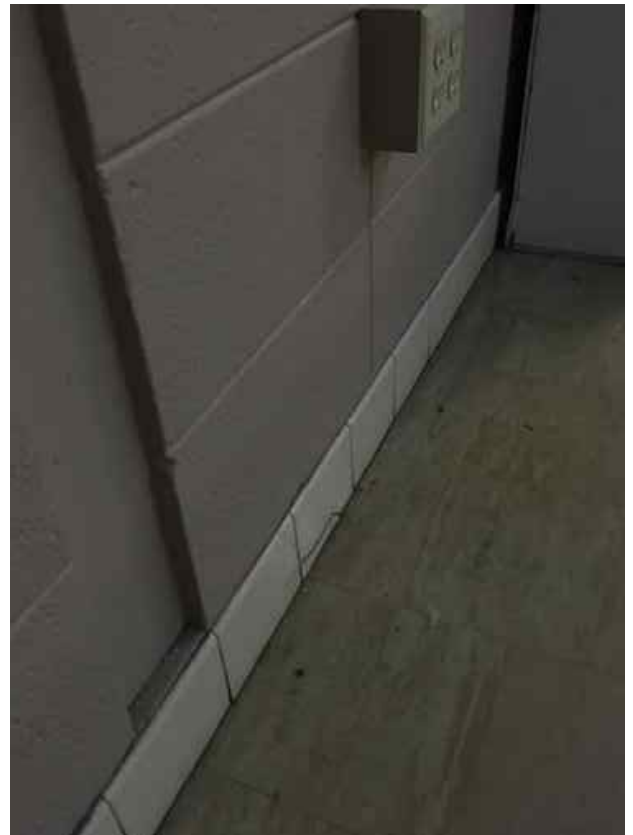
G84: General

Description: Cracks in tile base

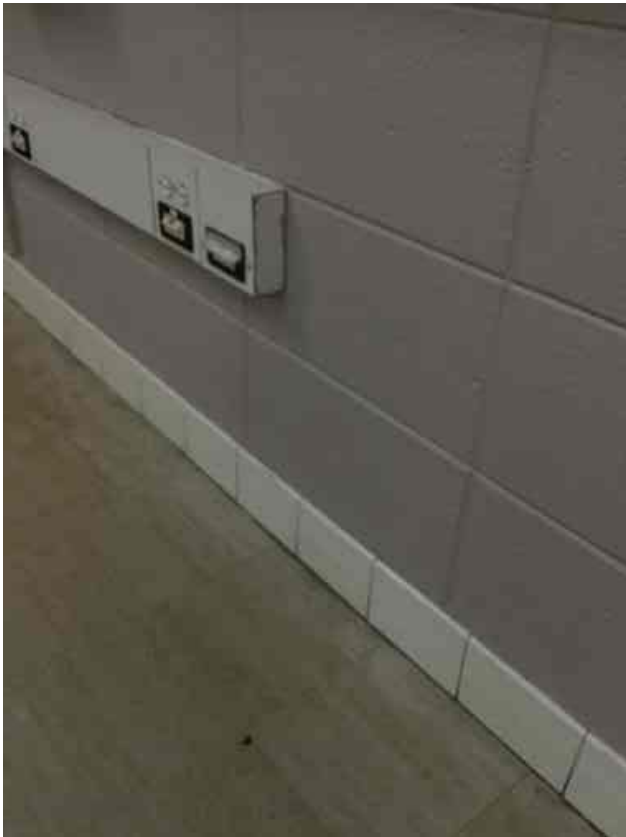
G85: General

Description: Cracks in tile base

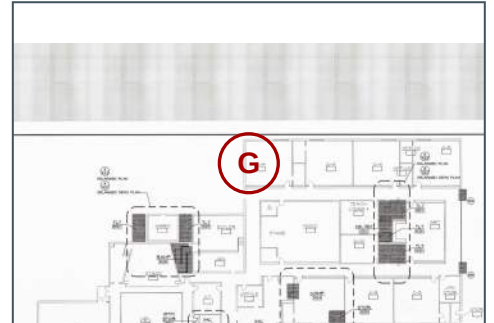
G86: General

Description: Cracks and holes in flooring

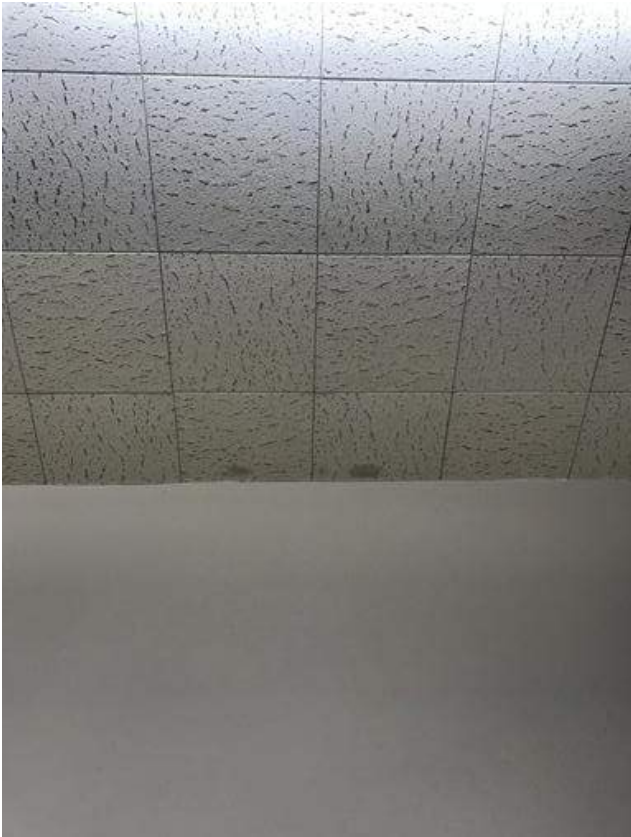
G91: General

Description: Stained ceiling

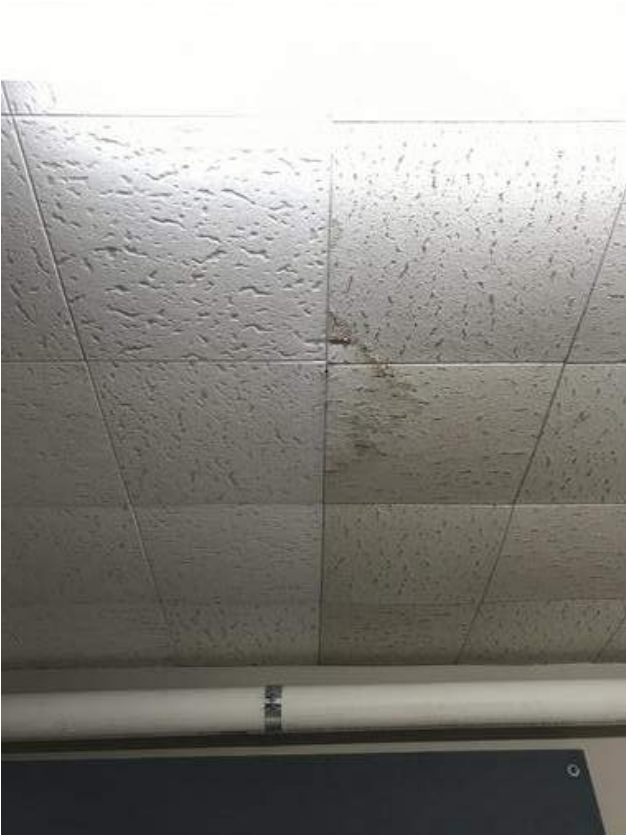
G92: General

Description: Stained ceiling

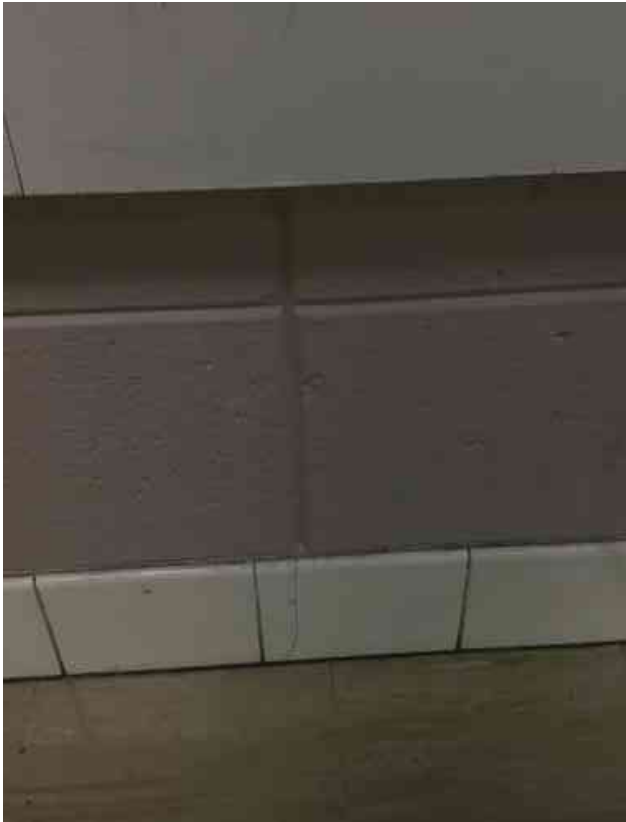
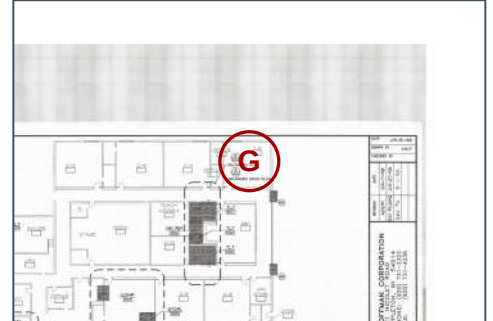
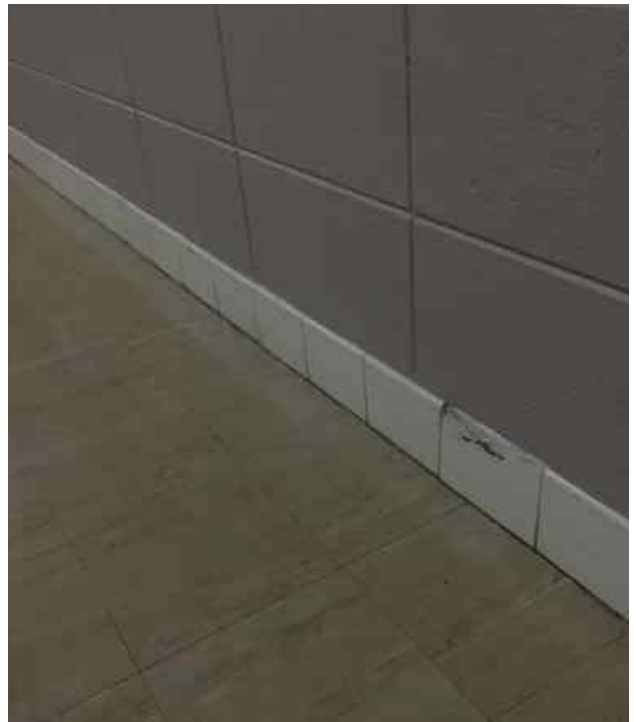
G97: General

Description: Tile base is chipped and cracked

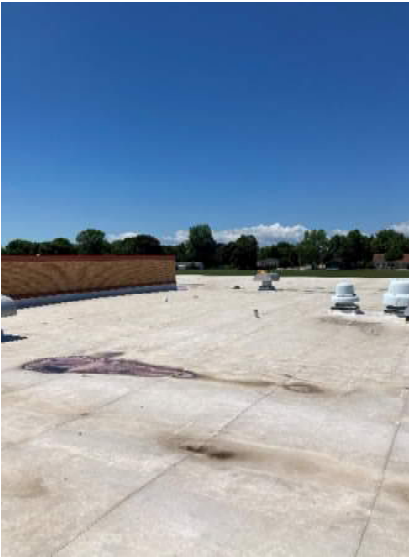
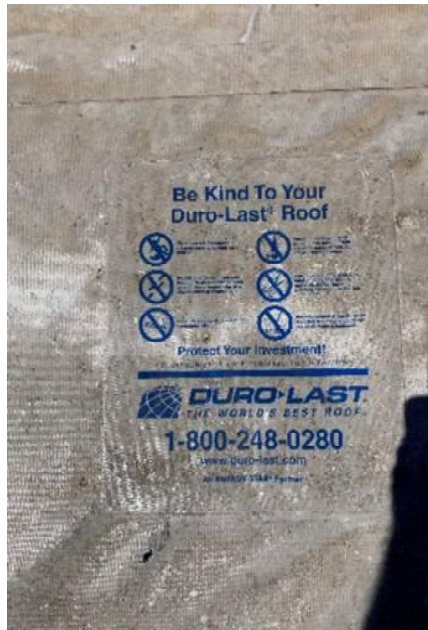
R1: Roof

Description: Duro-last roof installed two years ago

The roof is at the end of its useful life and will need to be replaced in the next 5 years.
