TWO RIVERS PUBLIC SCHOOLS

FACILITIES ASSESSMENT REPORT

08.19.21

Two Rivers School District Facilities Assessment July 2021

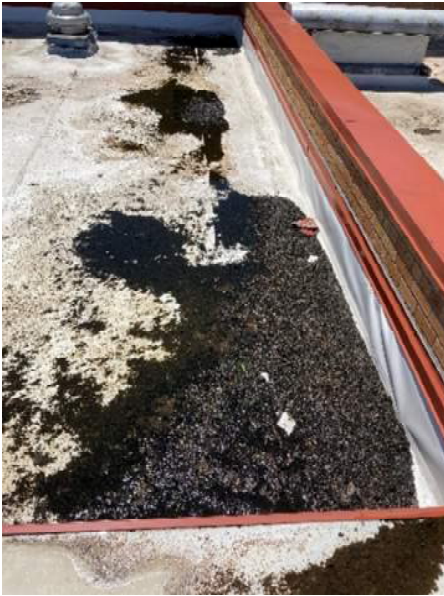
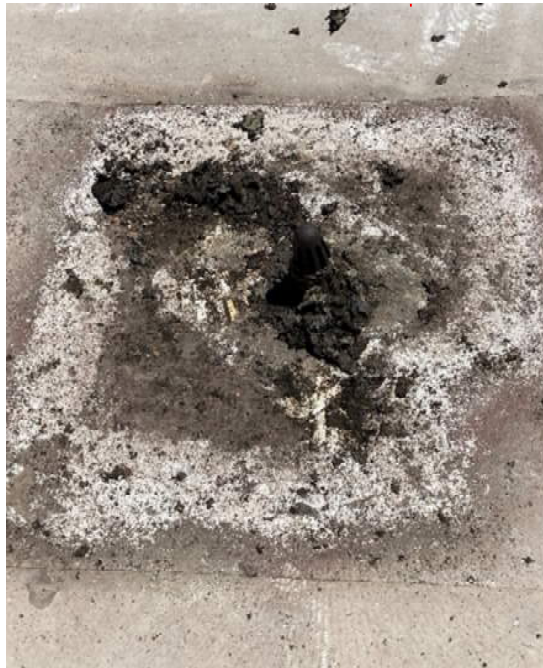
R2: Roof

Description: Roof holds debris

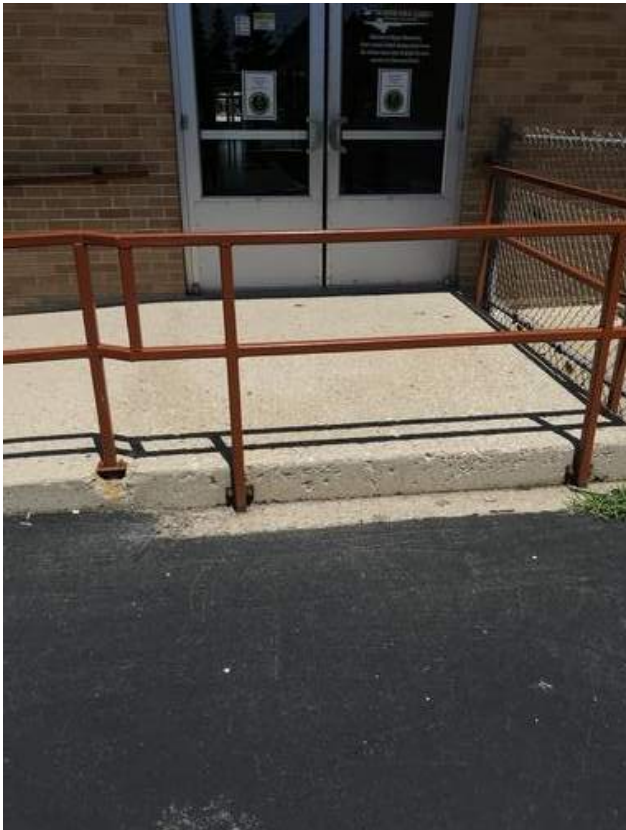
S1: Site Work

Description: Cracked concrete

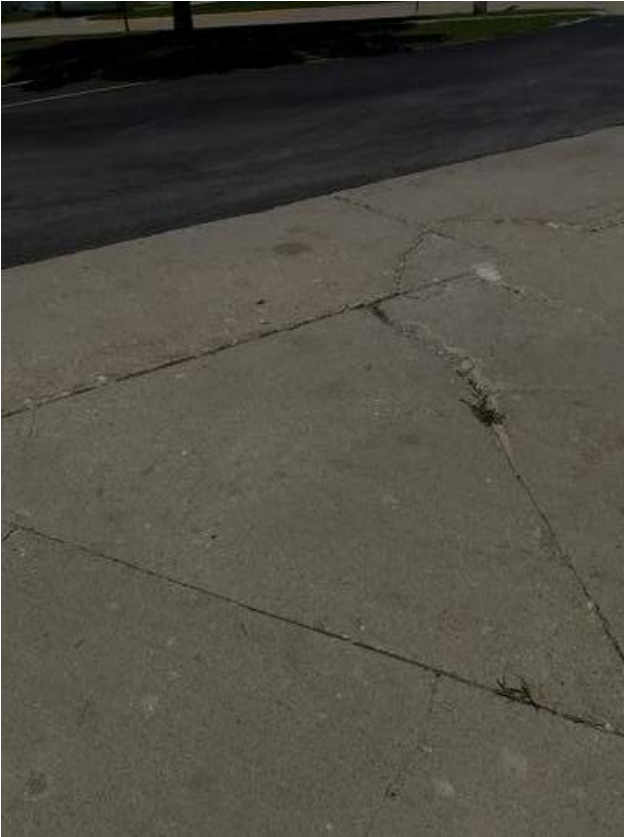
S2: Site Work

Description: Cracked concrete

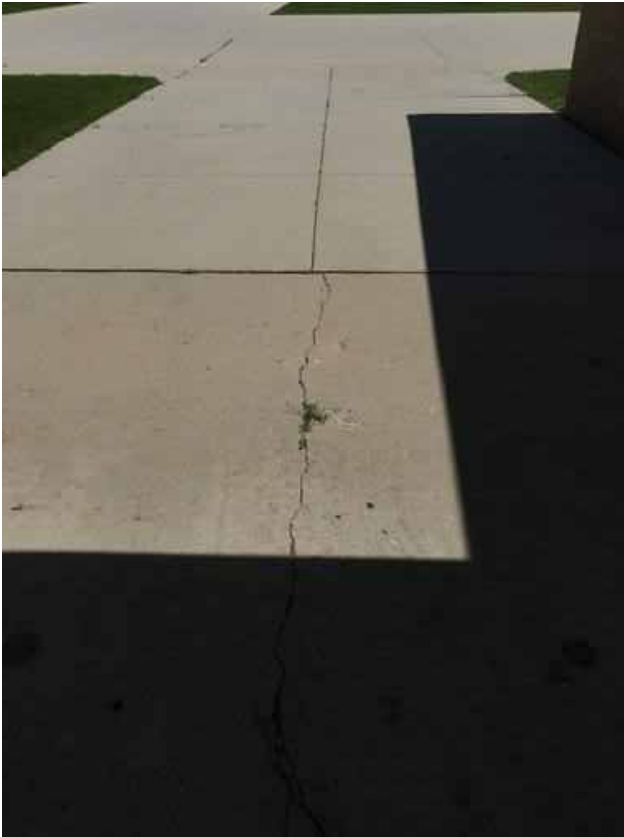
S3: Site Work

Description: Cracked concrete

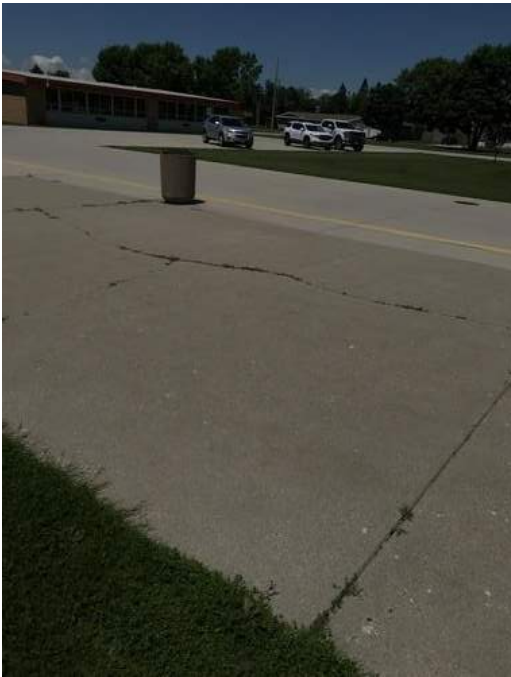
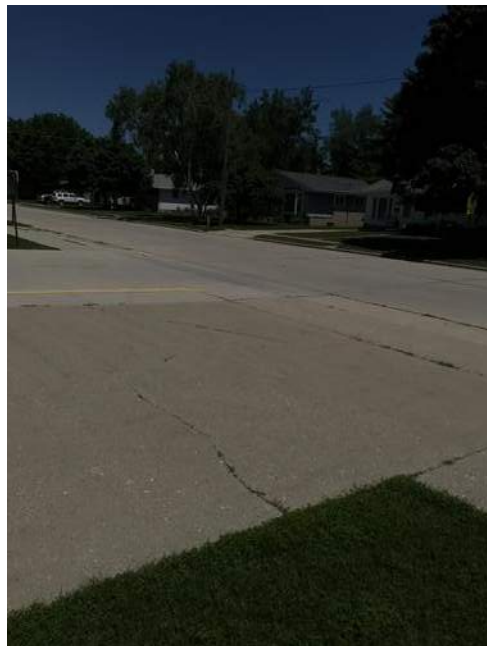
Description: Cracked concrete

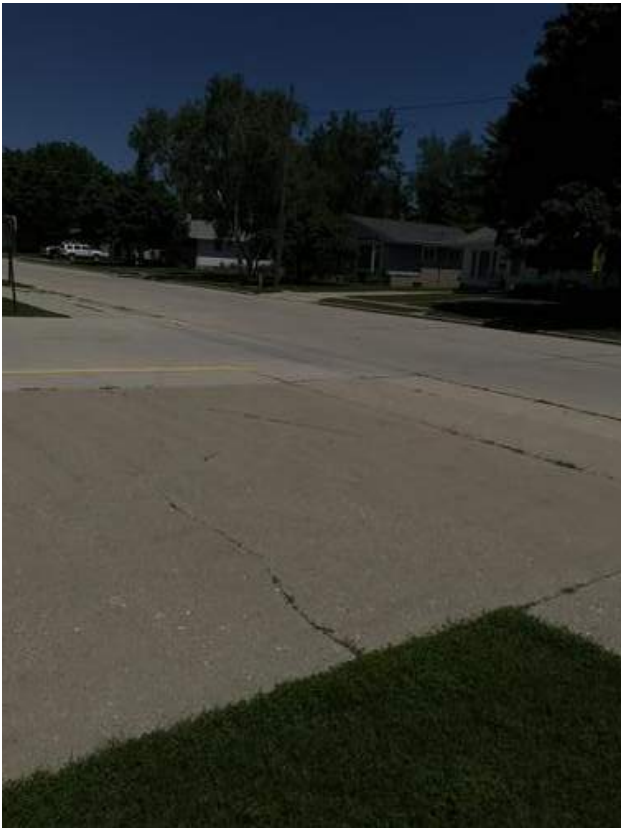
S6: Site Work

Description: Asphalt is in good shape and has minimal cracking

The sidewalks are settling below the stoops. The asphalt is cracking and will need to be replaced in 5 years.

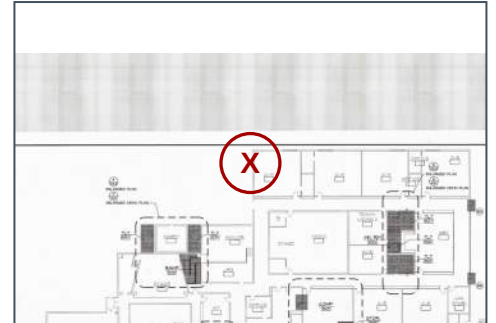
X1: Exterior

Description: Cracks in brick wall and missing mortar at base of wall

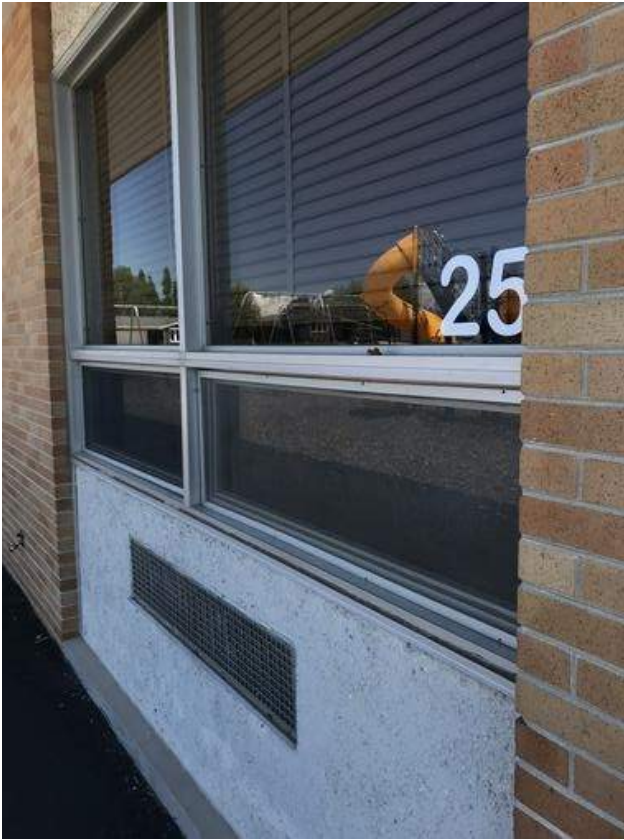
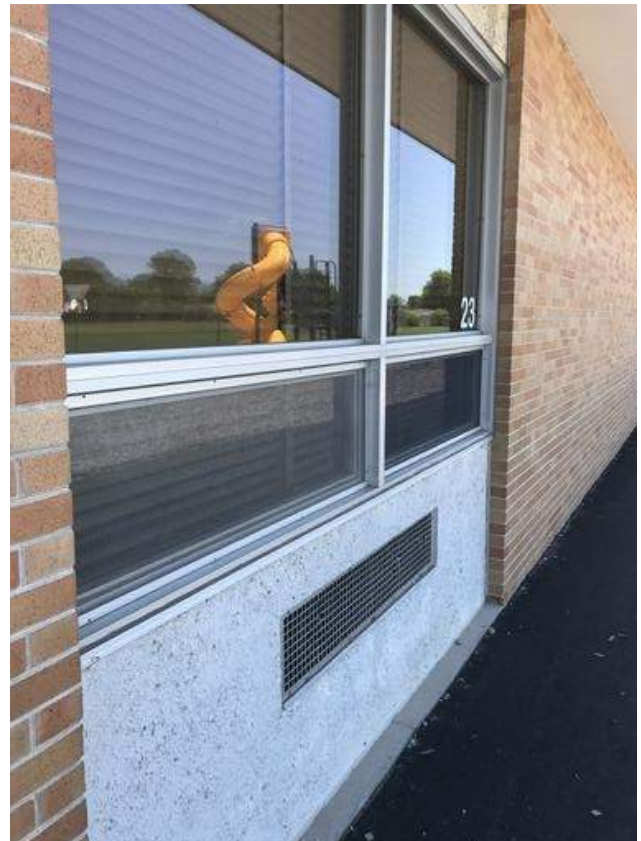
X2: Exterior

Description: Caulking needed at window

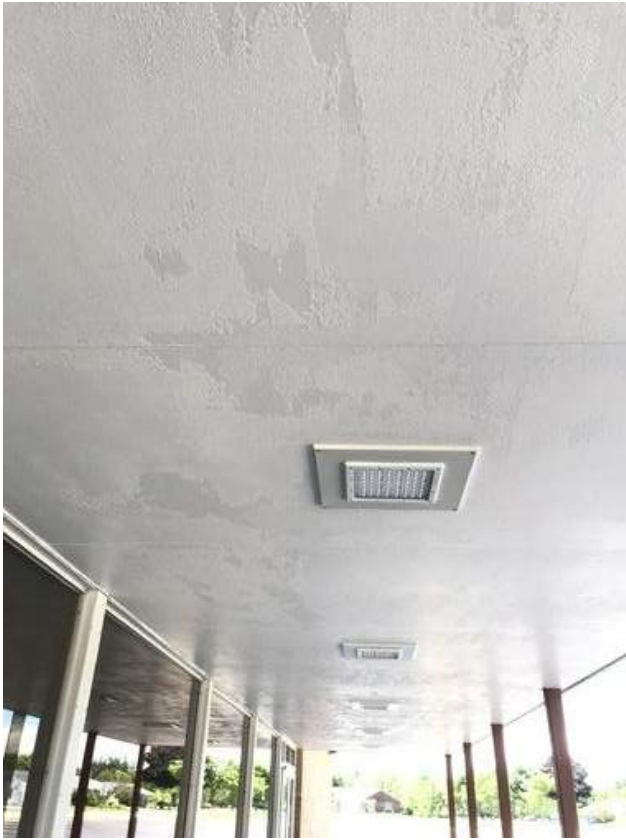
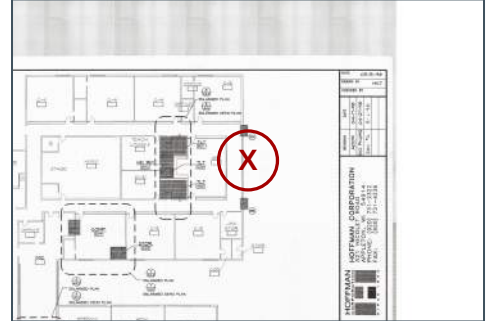
X3: Exterior

Description: Ceiling needs painting

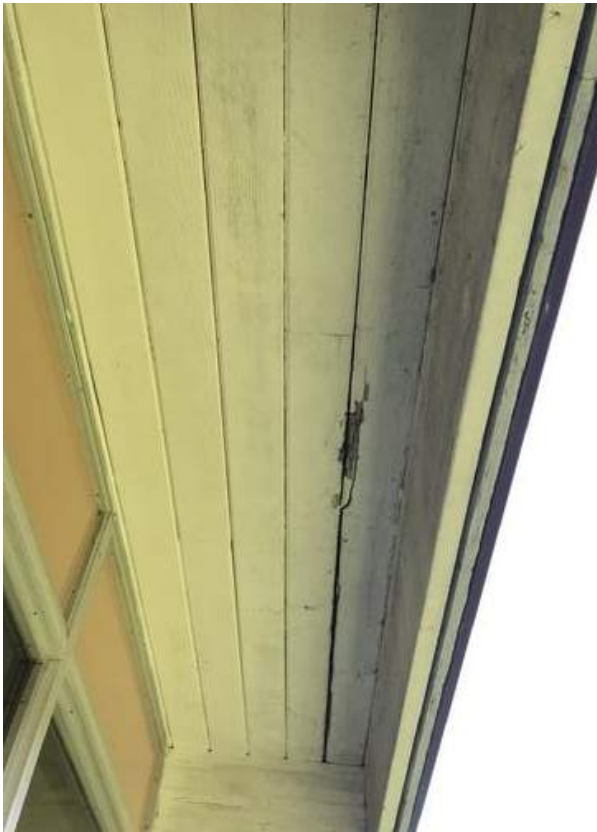
X4: Exterior

Description: Bottom of roof overhang is rotted around the entire exterior of building

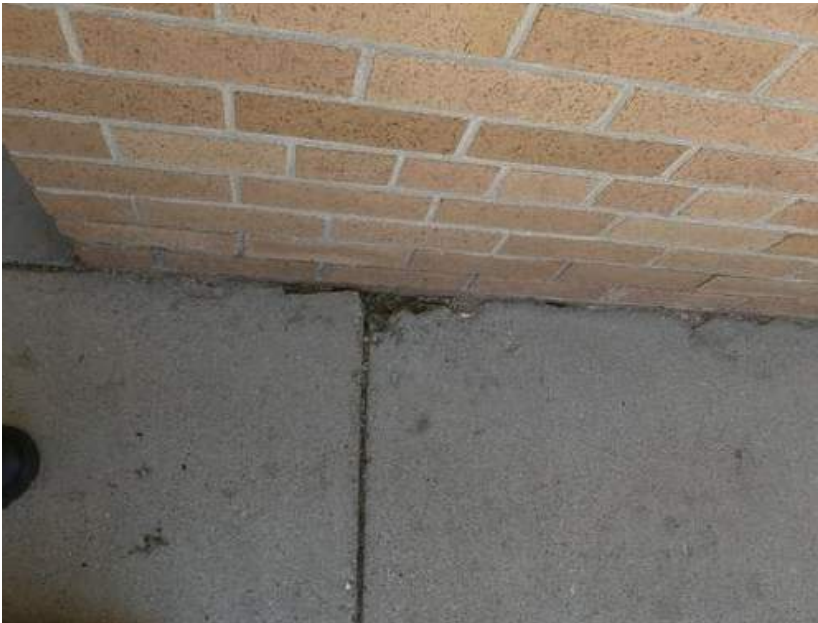
X5: Exterior

Description: Cracked concrete at base of wall

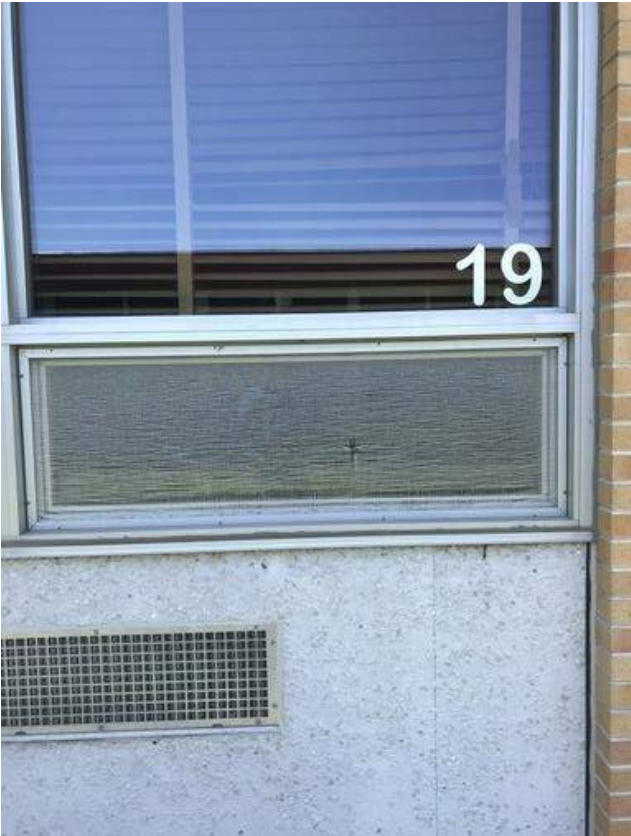
X6: Exterior

Description: Damaged window screens

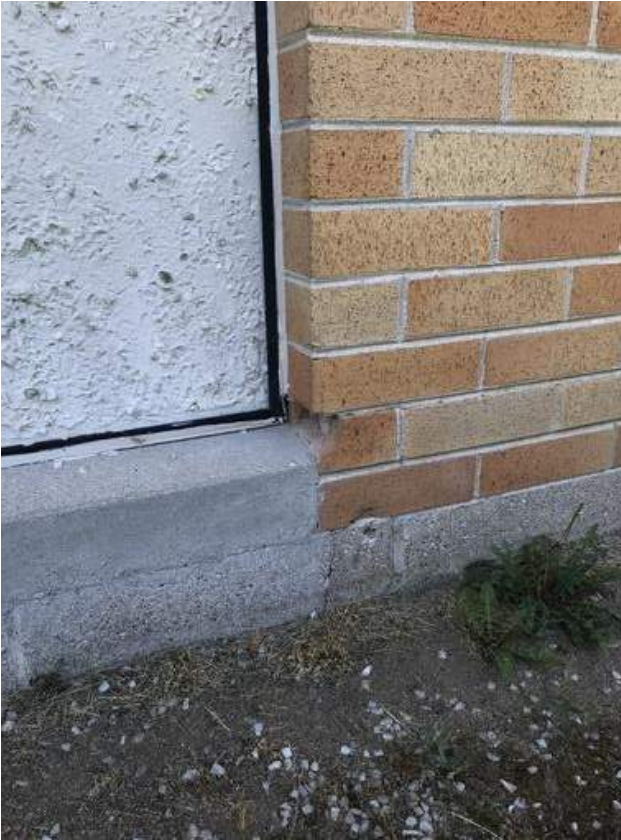
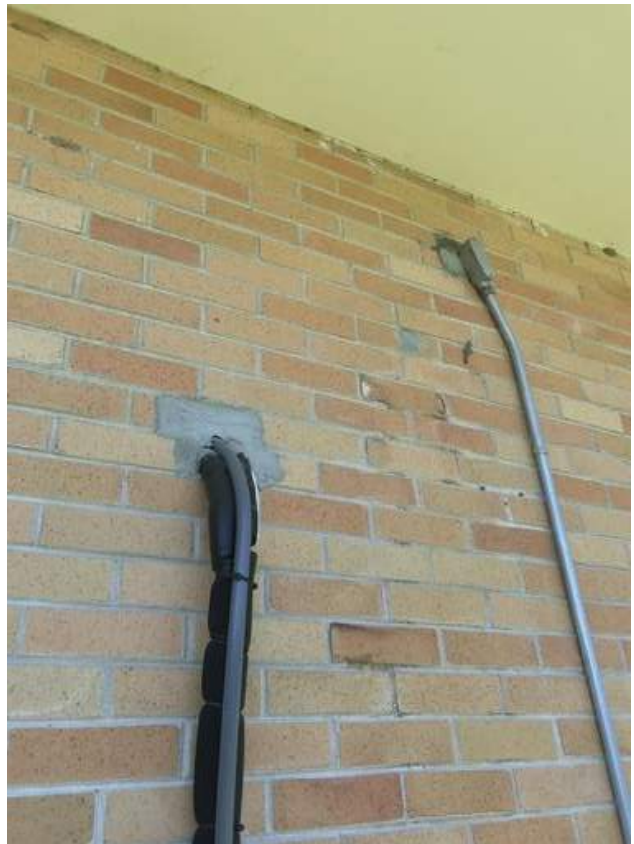
X7: Exterior

Description: Damaged brick

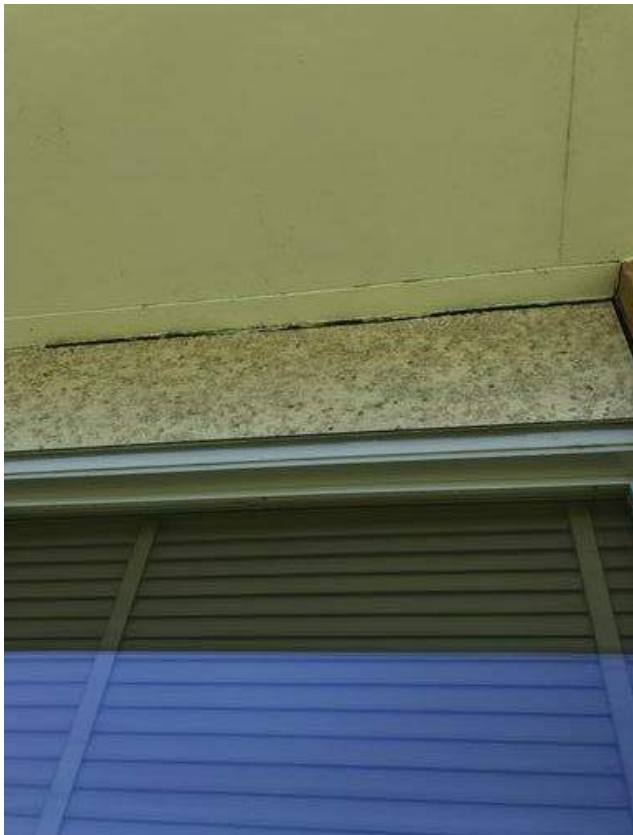
X9: Exterior

Description: Wall stains and cracks

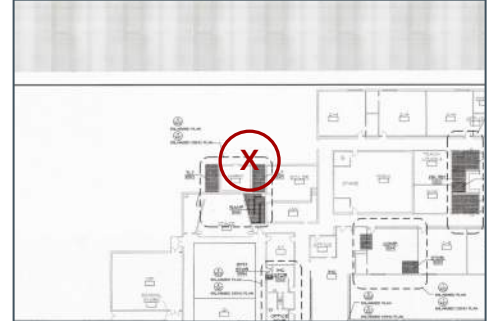
X13: Exterior

Description: Cracked concrete

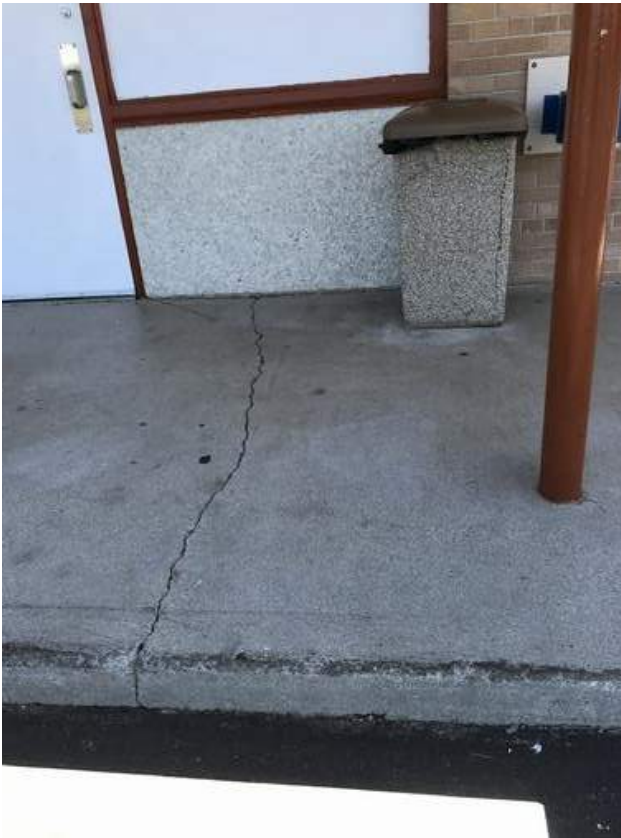
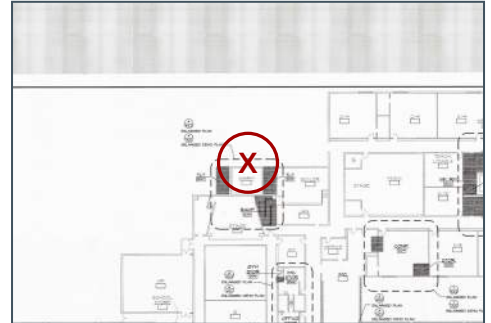
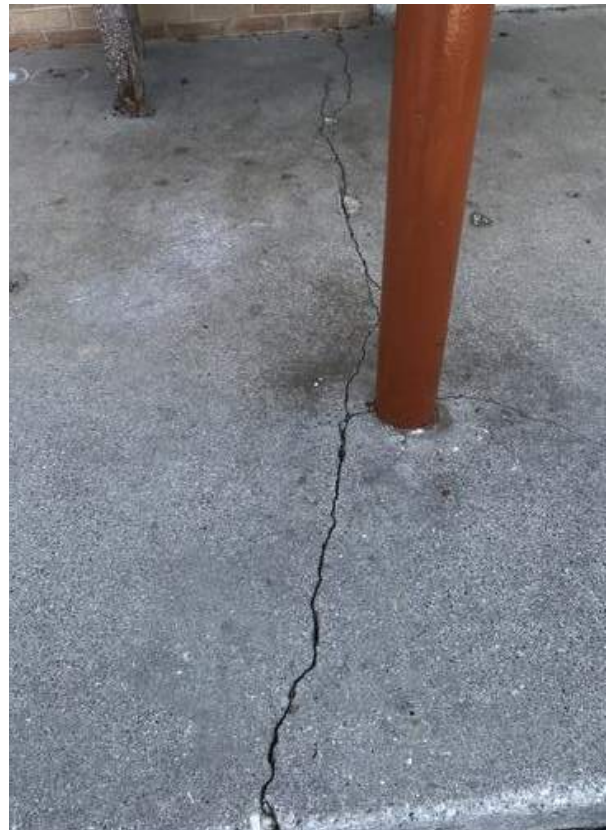
X14: Exterior

Description: Wall cracks

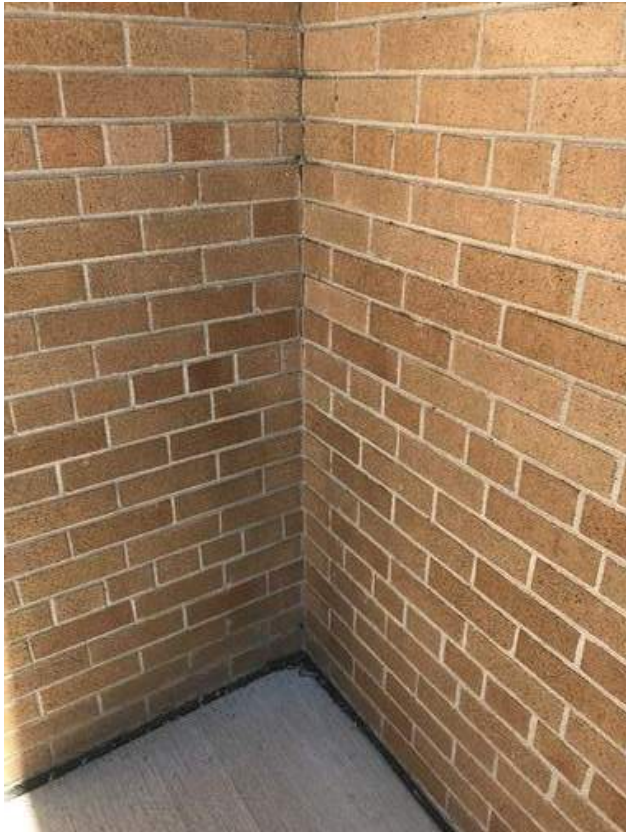
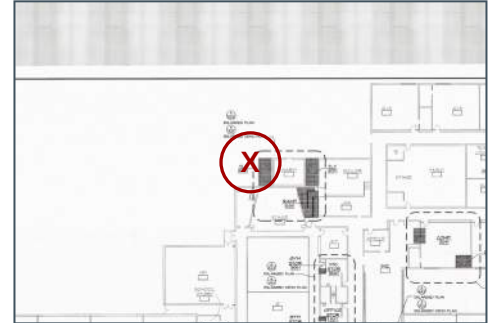
X15: Exterior

Description: Missing mortar and cracked brick

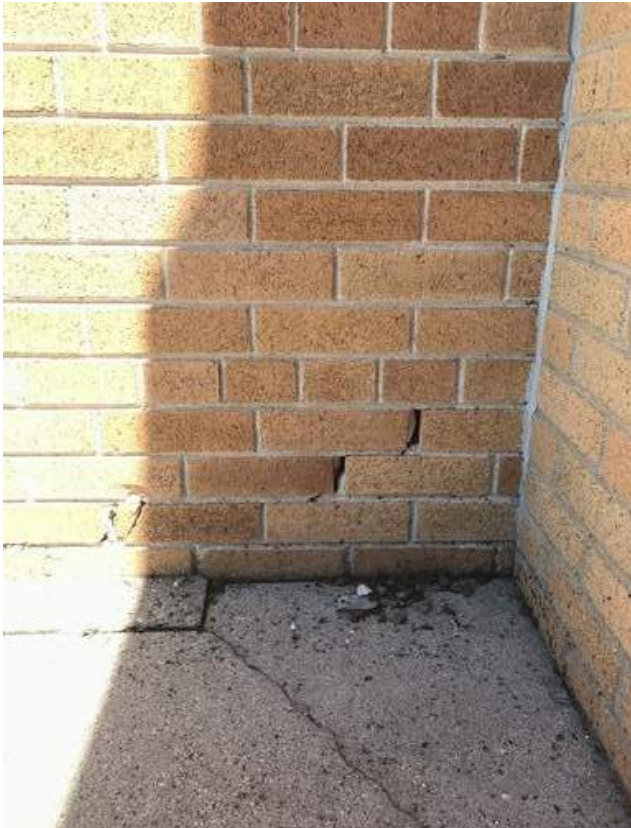
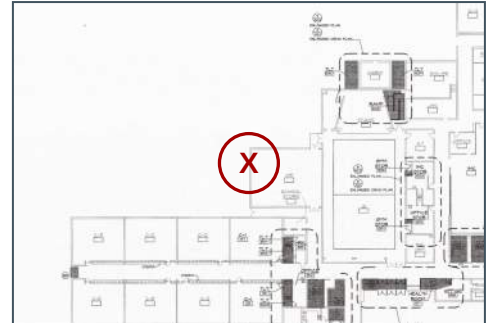
X16: Exterior

Description: Cracked concrete and cracked mortar

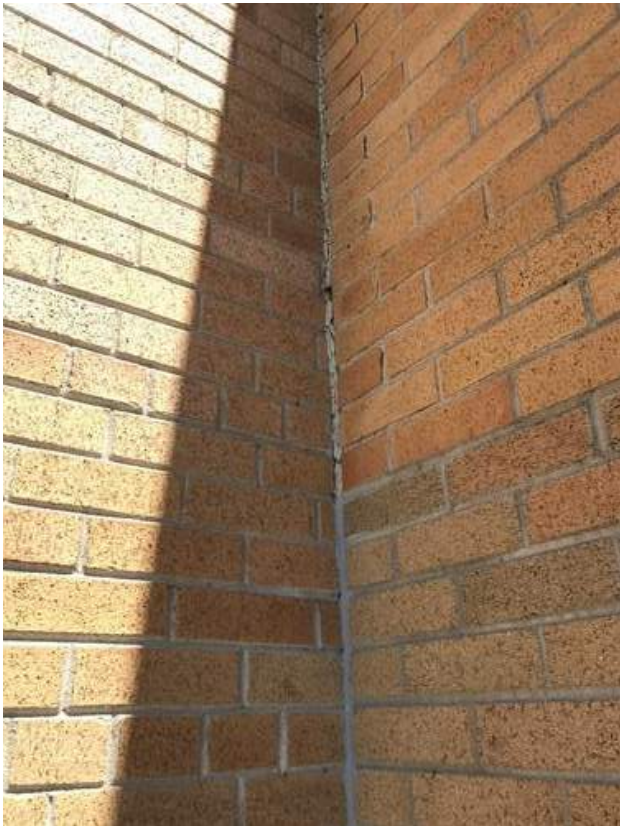
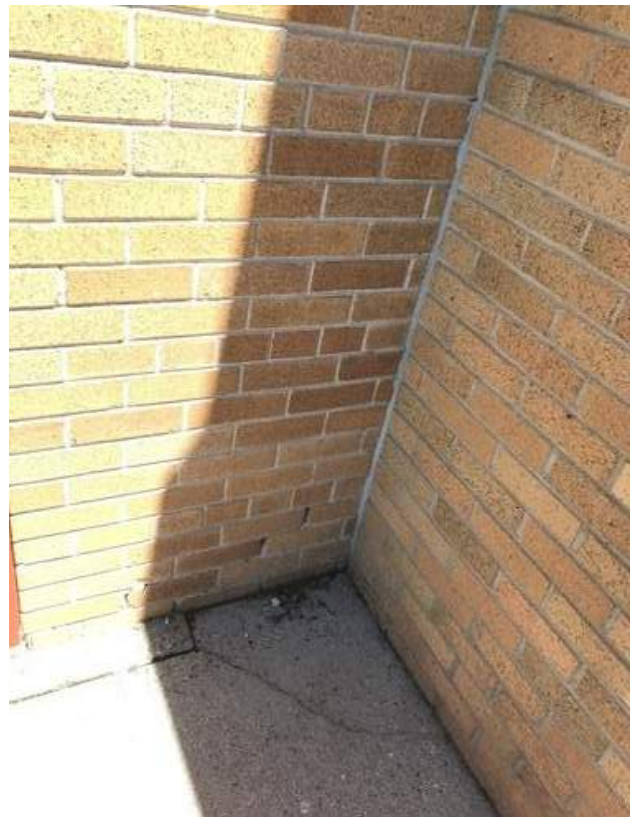
X17: Exterior

Description: Wall cracks

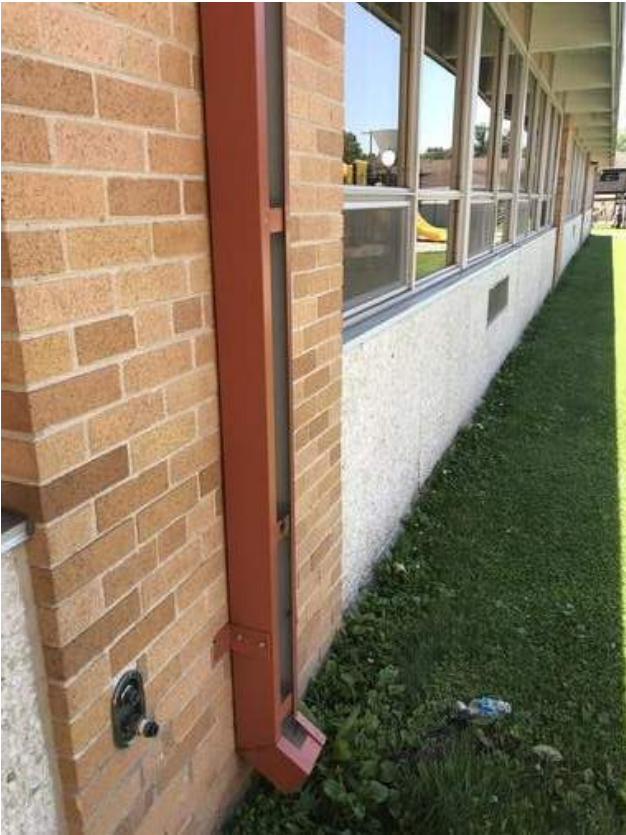
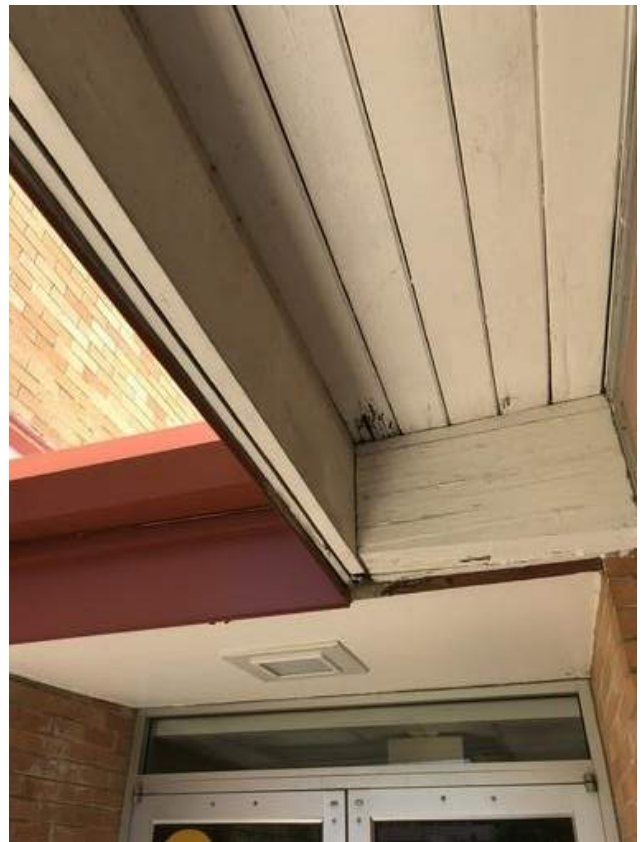
X19: Exterior

Description: Rotted wood at overhang

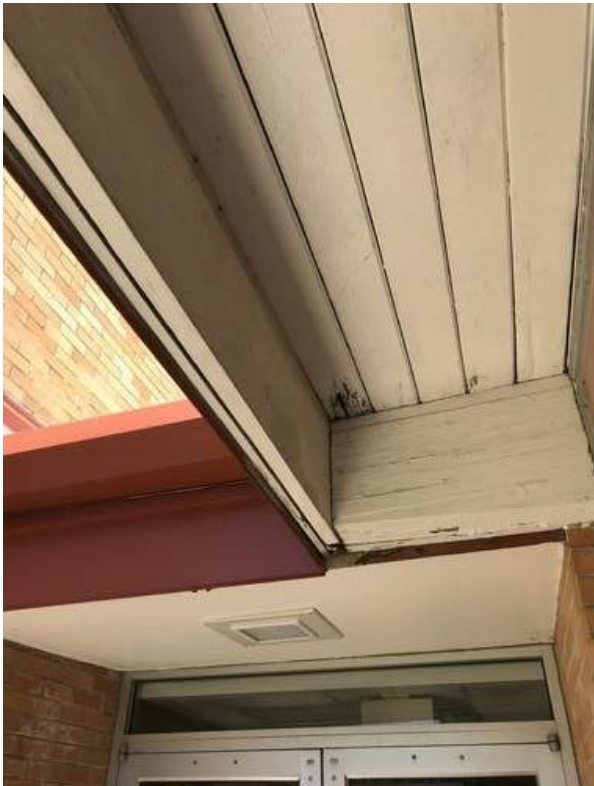
X20: Exterior

Description: Expanded concrete joints

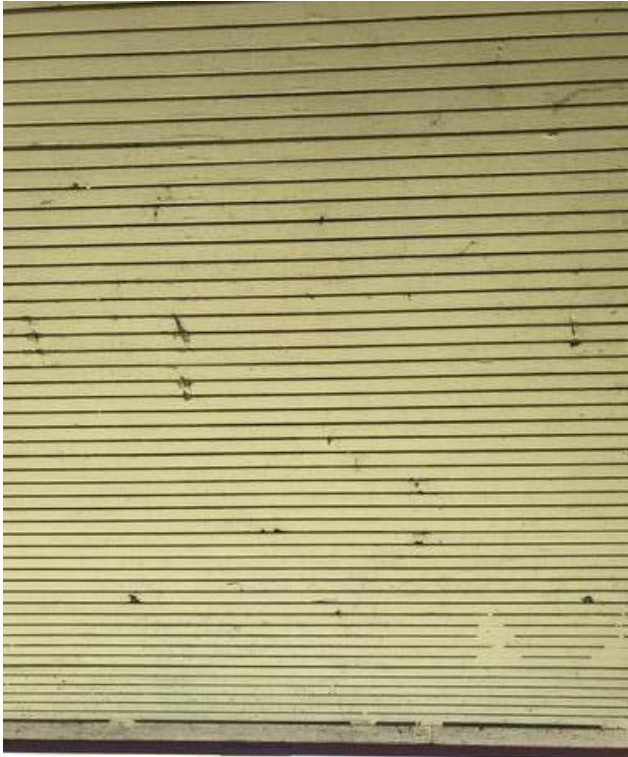
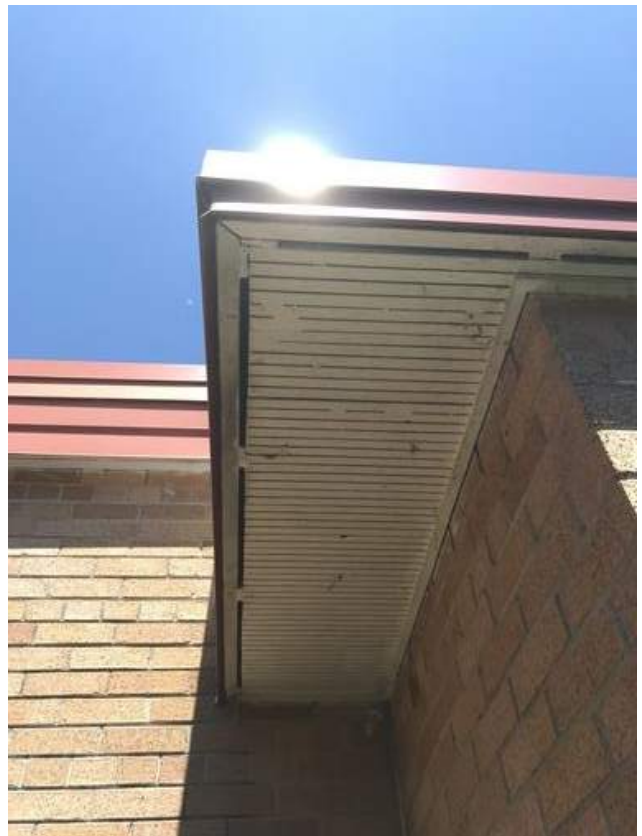
X24: Exterior

Description: Rotted soffit

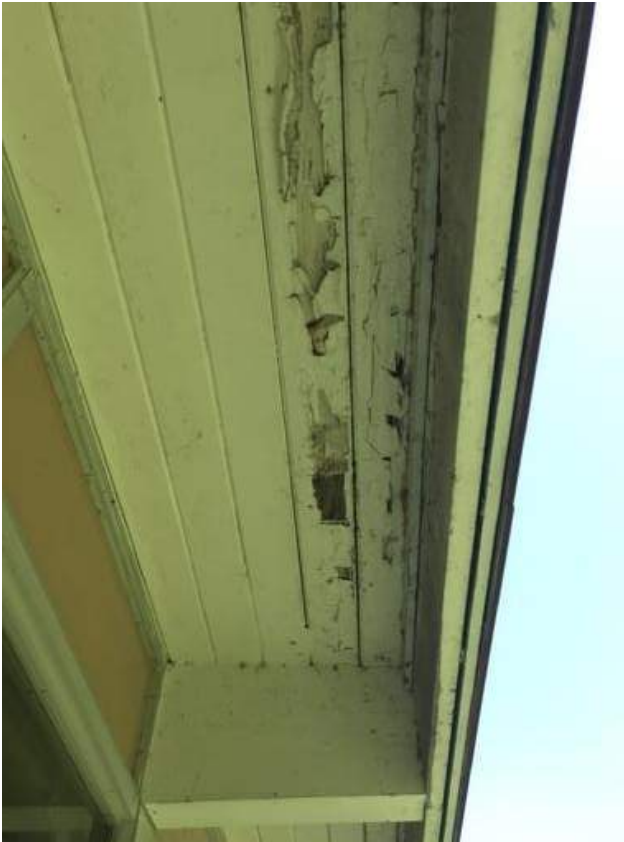
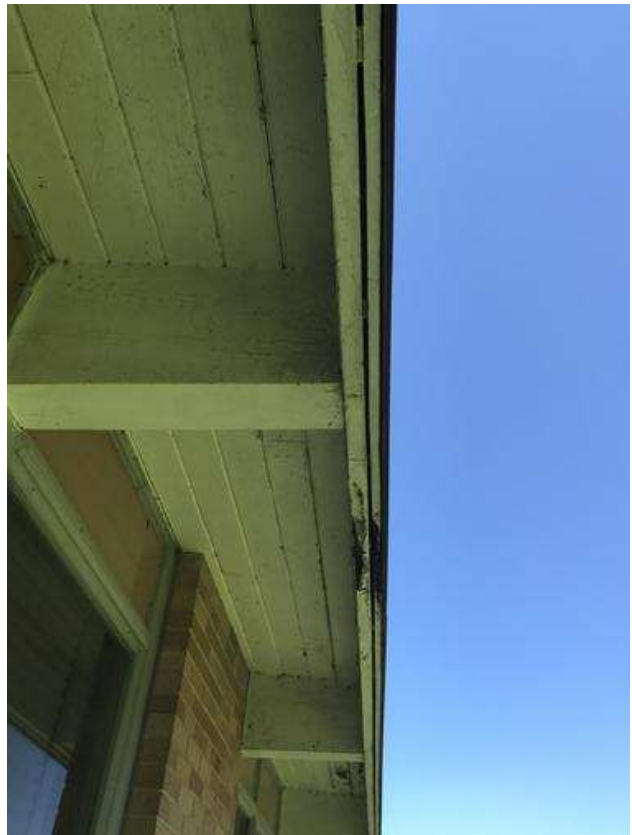
X26: Exterior

Description: Wood soffit is rotted

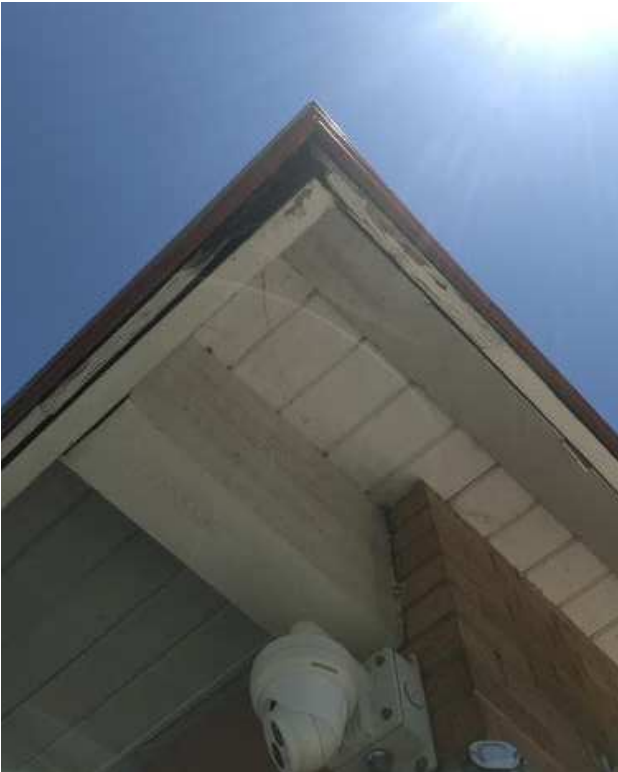
X27: Exterior

Description: Rotted soffit

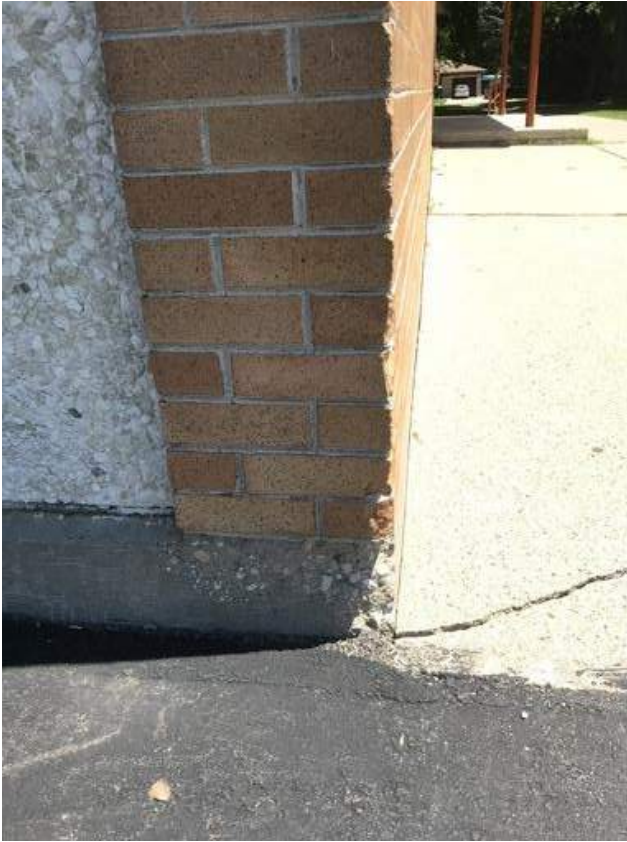
X28: Exterior

Description: Chipped corner of wall

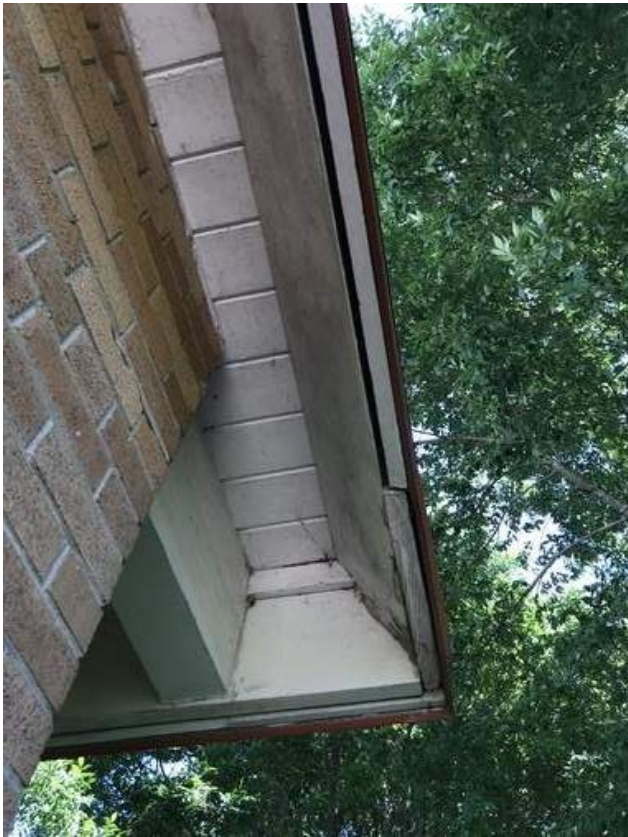
X29: Exterior

Description: Soffit is rotted

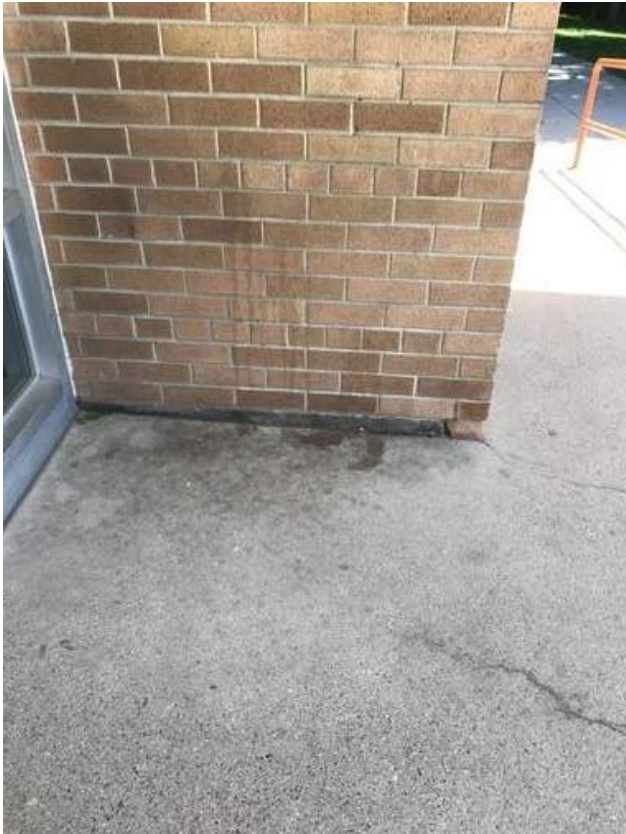
X30: Exterior

Description: Concrete cracks

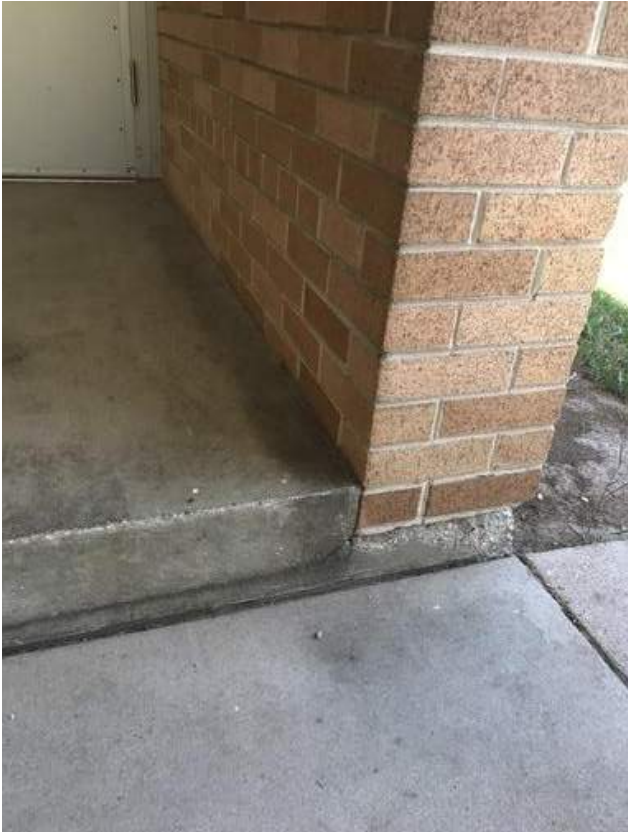
X31: Exterior

Description: Cracked concrete at base of wall

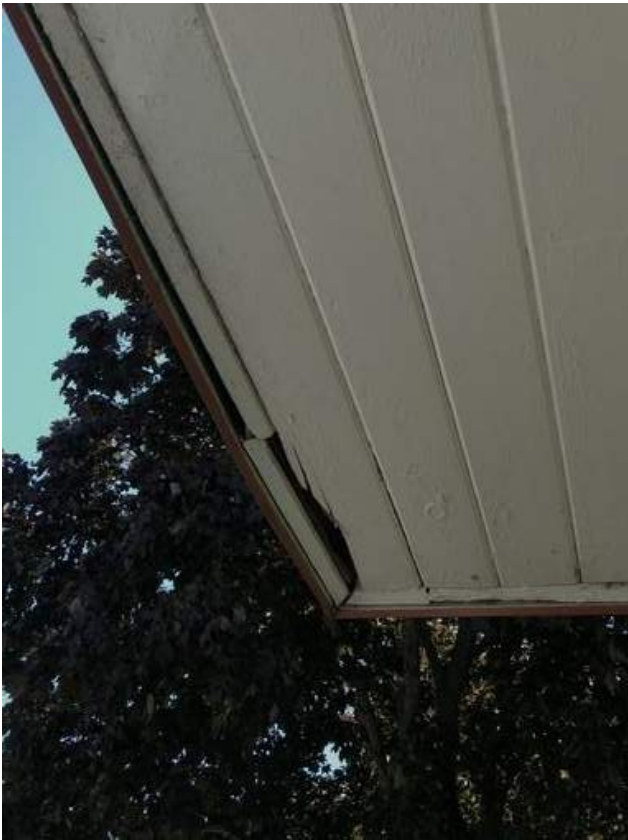
X32: Exterior

Description: Damaged wood soffit

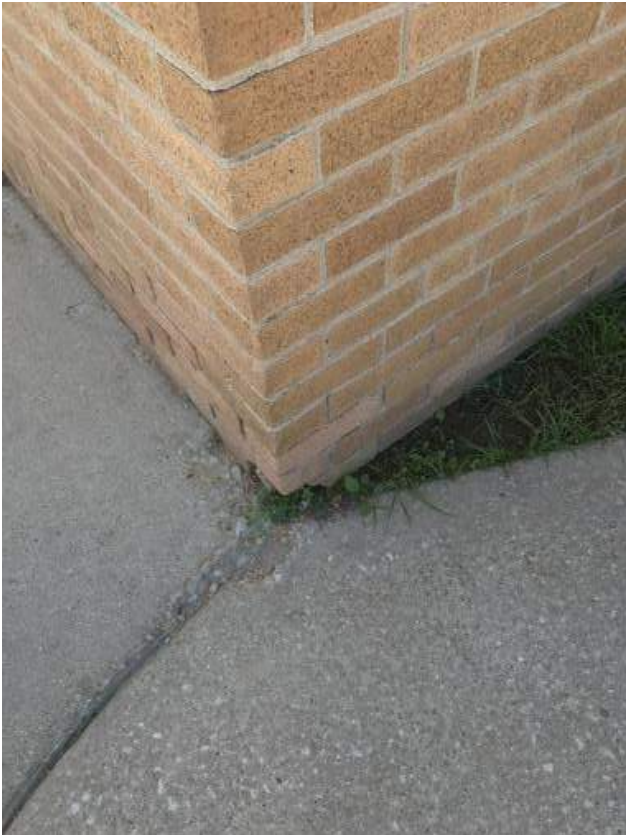
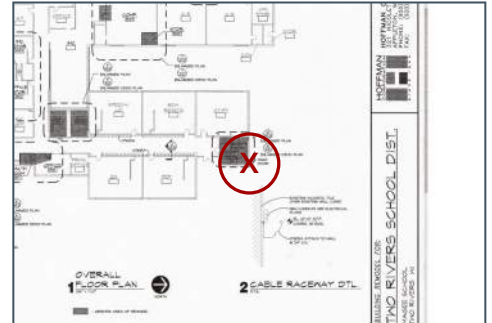
X33: Exterior

Description: Missing brick at bottom corner of wall

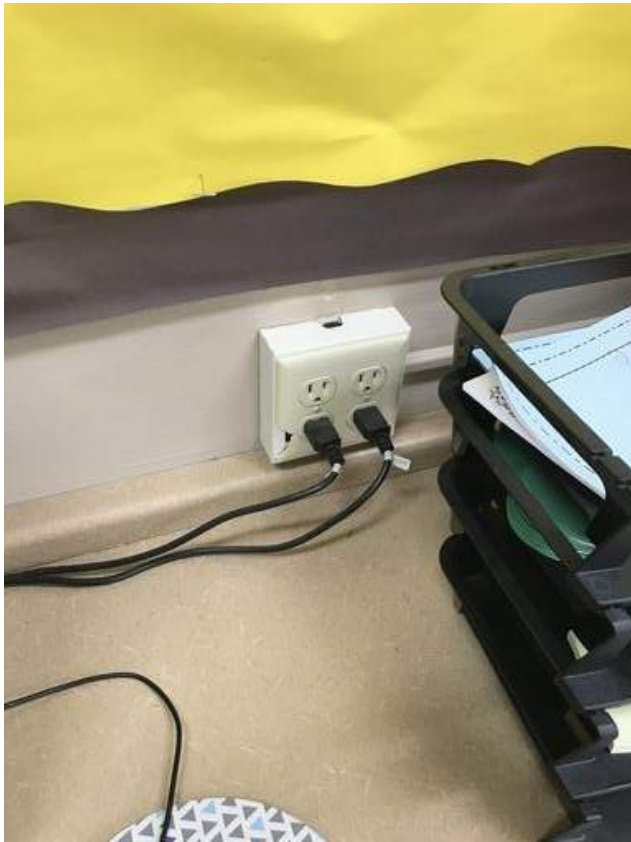
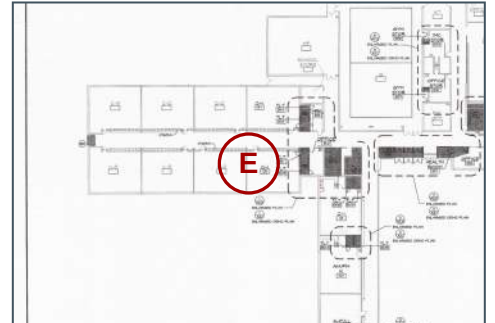
Description: Receptacle cover cracked

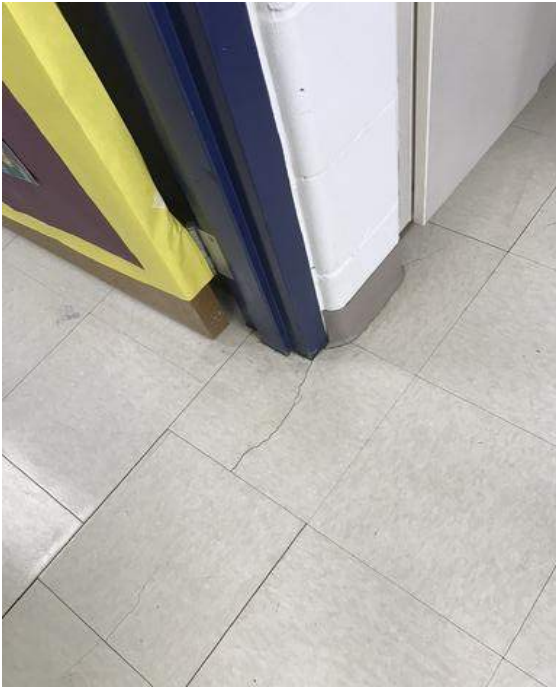
Description: Cracked floor tile

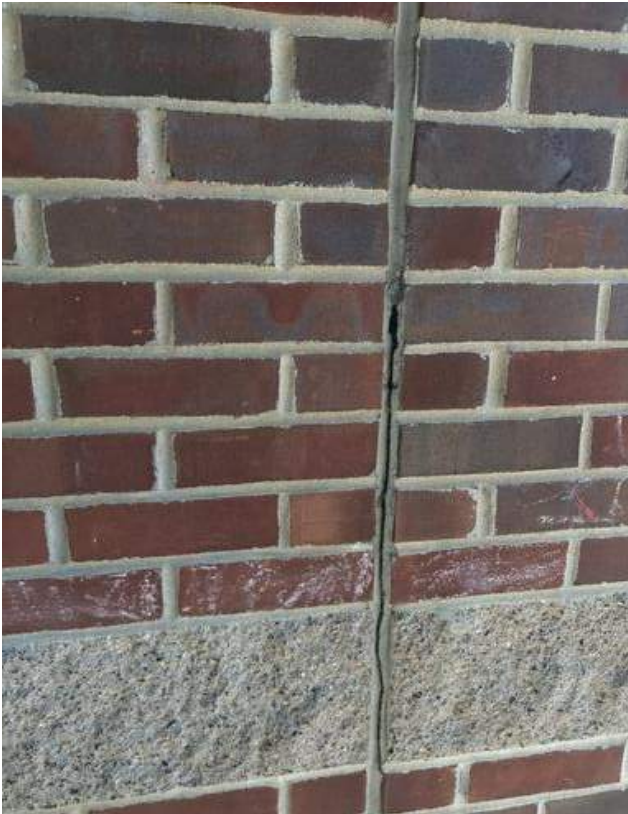
G2: General

Description: Joint needs to be caulked

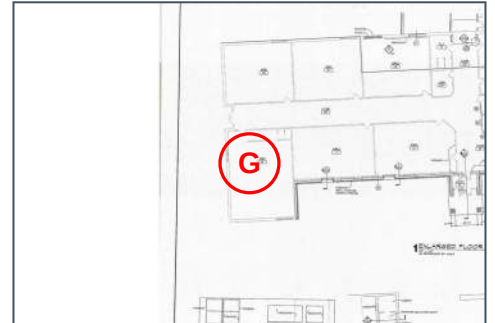
G3: General

Description: Floor cracks

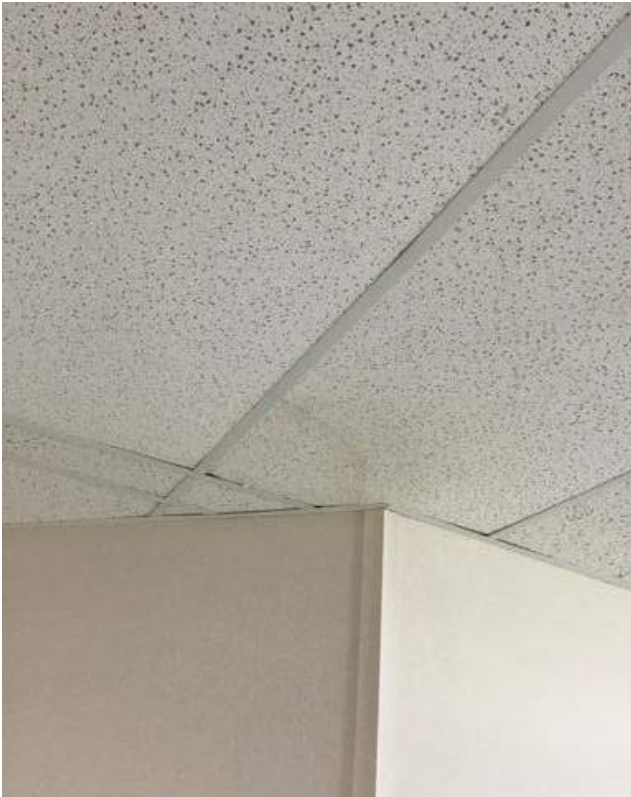
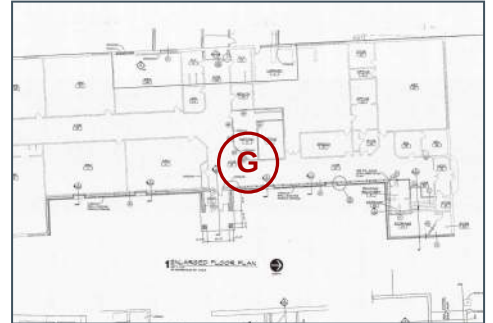
G5: General

Description: Stained ceiling

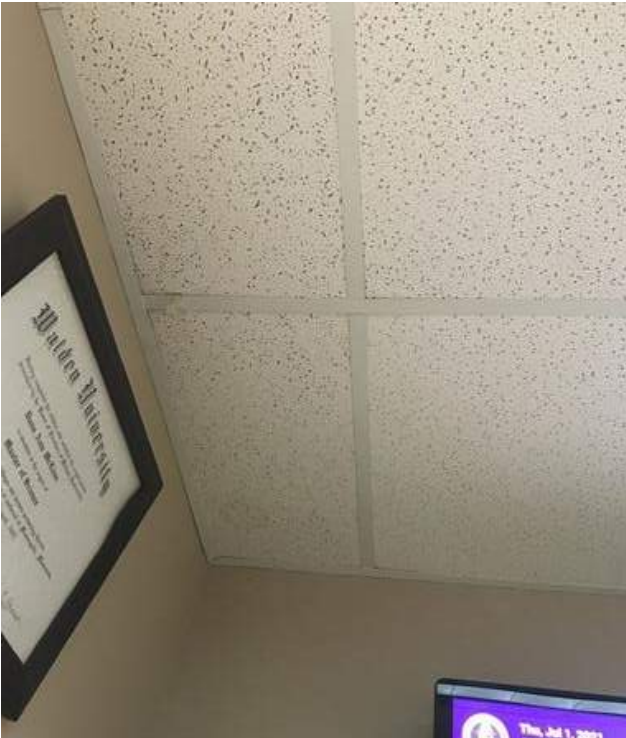
G6: General

Description: Stained ceiling

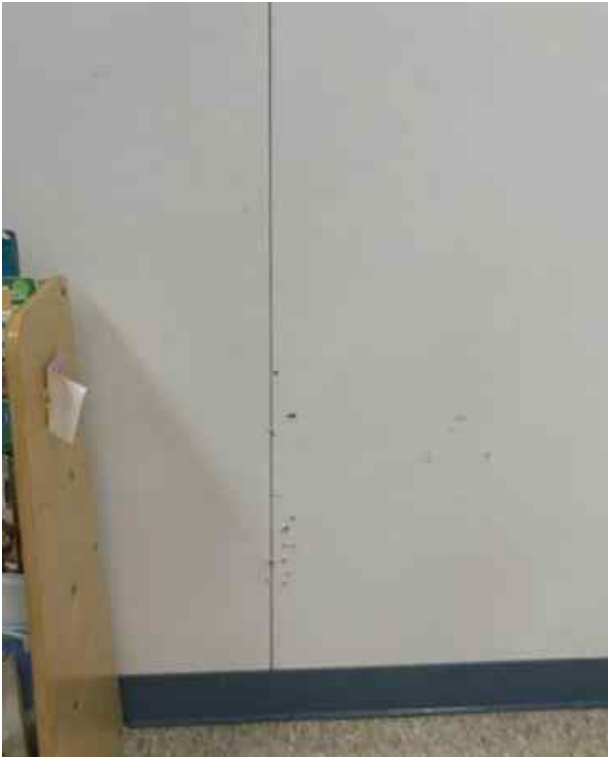
G7: General

Description: Scuffs on wall
