TWO RIVERS PUBLIC SCHOOLS

FACILITIES ASSESSMENT REPORT

08.19.21

Two Rivers School District Facilities Assessment July 2021

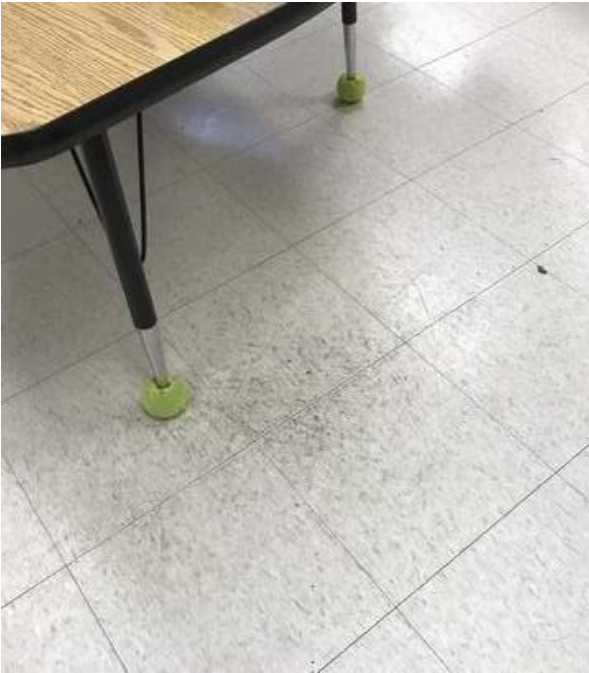
G8: General

Description: Scratches on floor

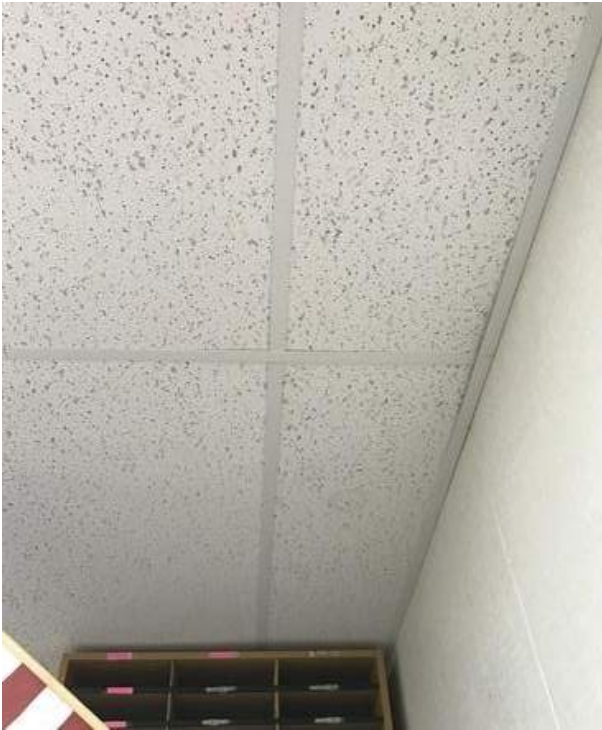
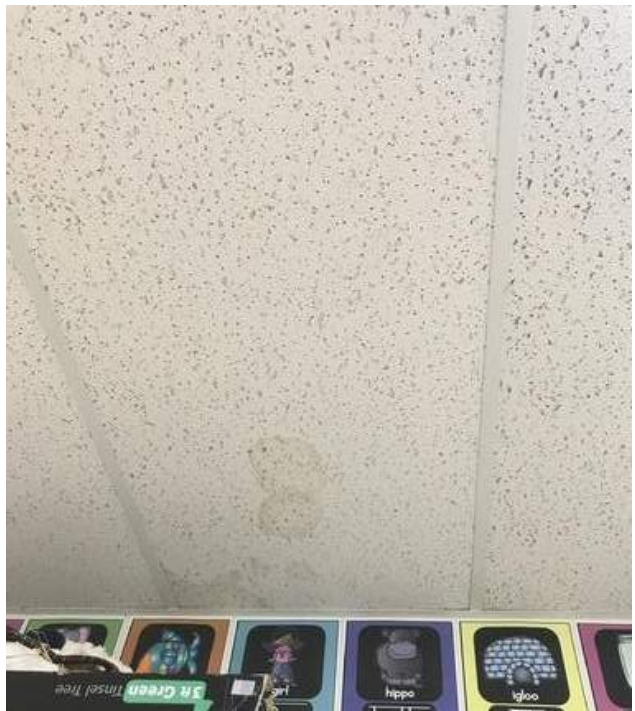
G9: General

Description: Stained ceiling

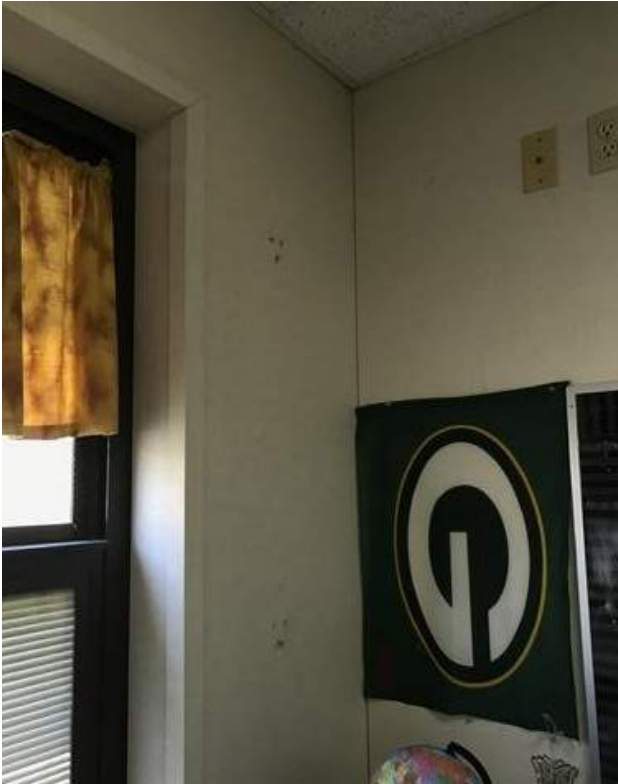
G11: General

Description: Holes in wall

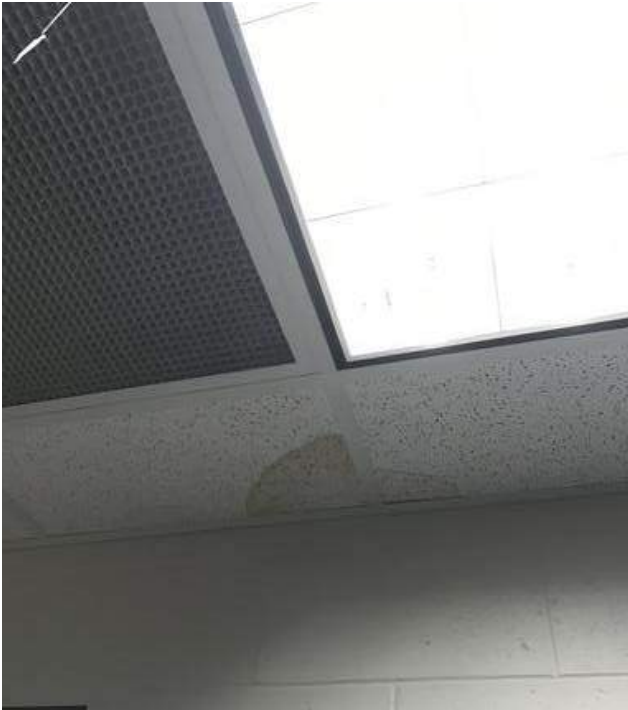
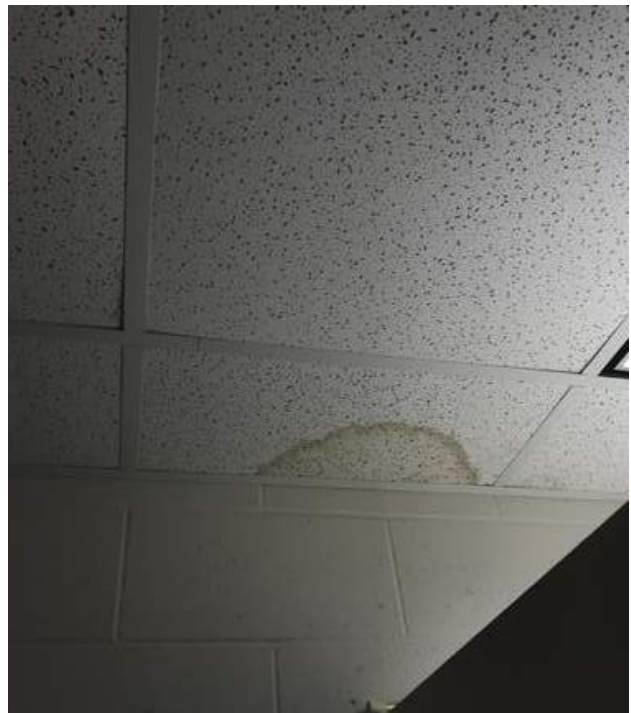
G12: General

Description: Stained ceiling

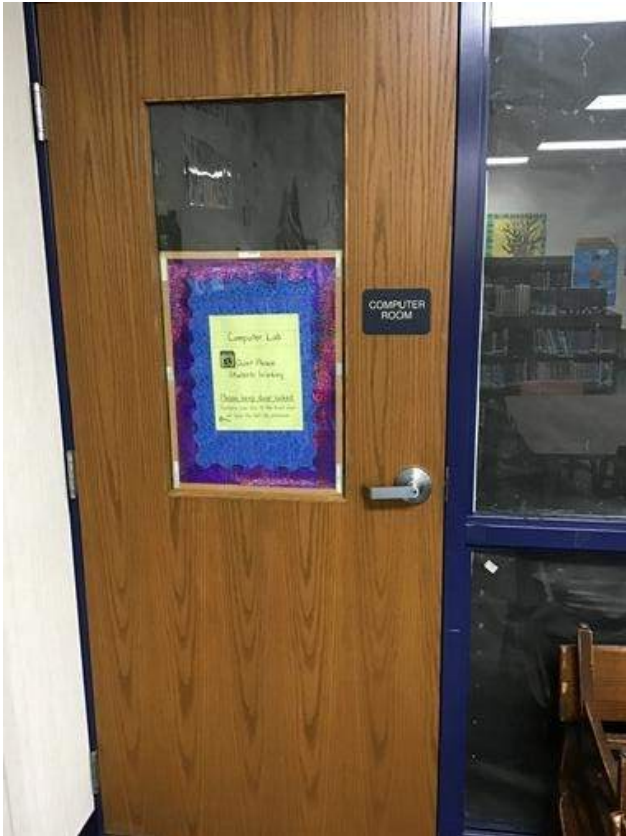
G13: General

Description: Door frame scratches and panel

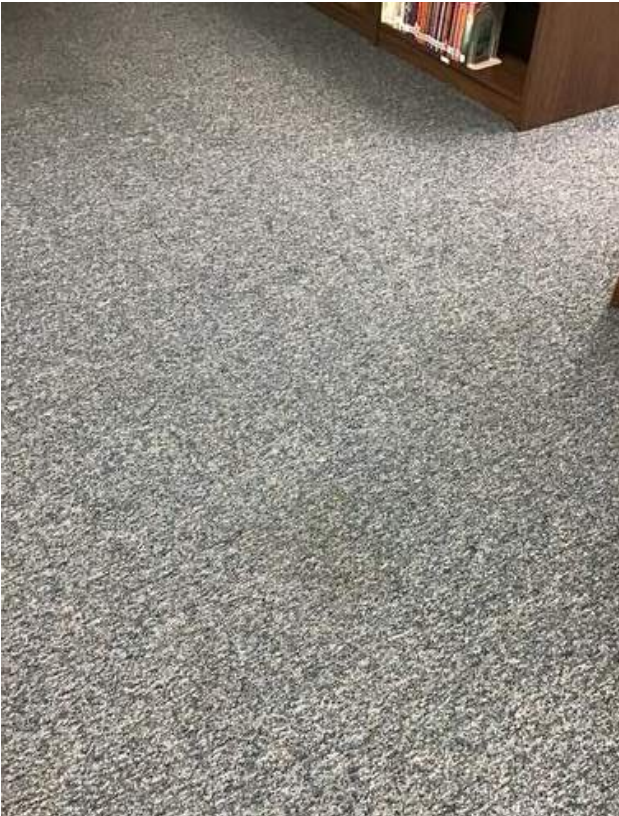
G14: General

Description: Stained carpet

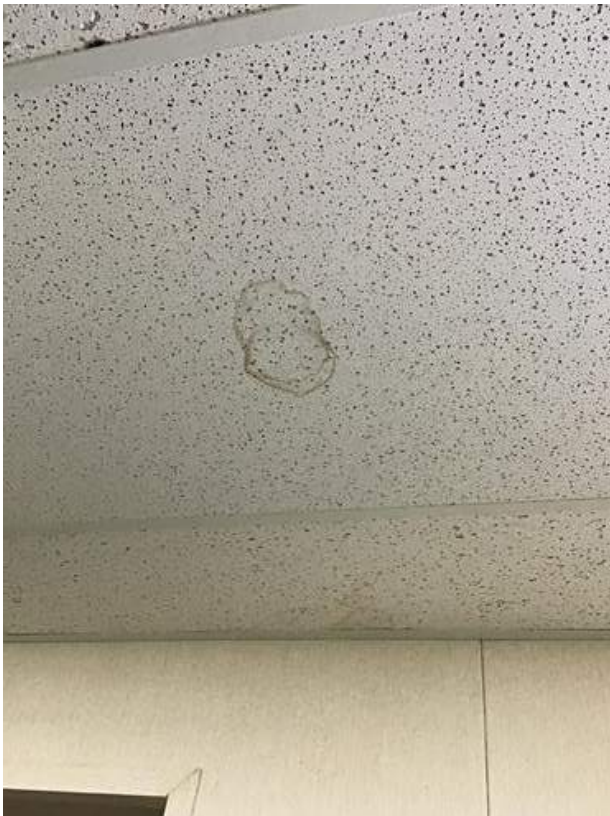
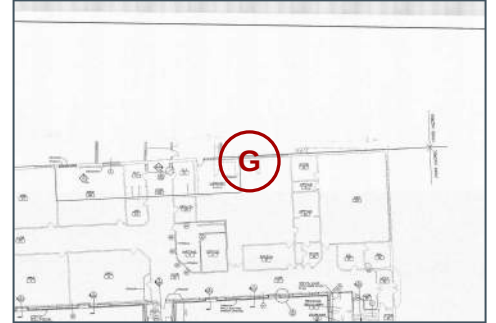
G15: General

Description: Stained ceiling

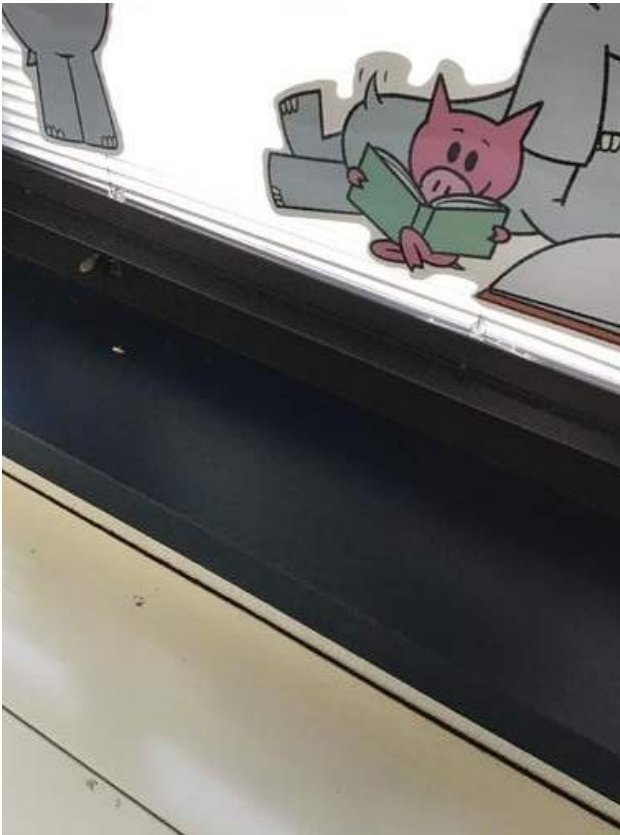
G16: General

Description: Window needs caulk

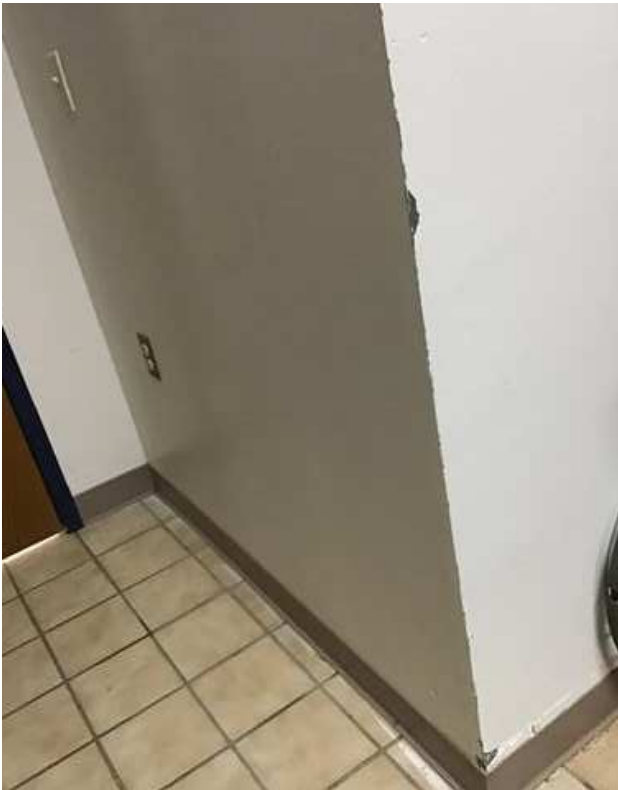
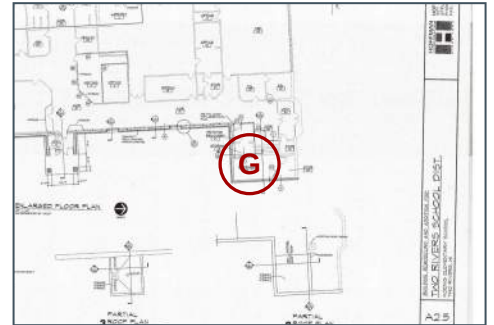
G17: General

Description: Chipped at corner of wall

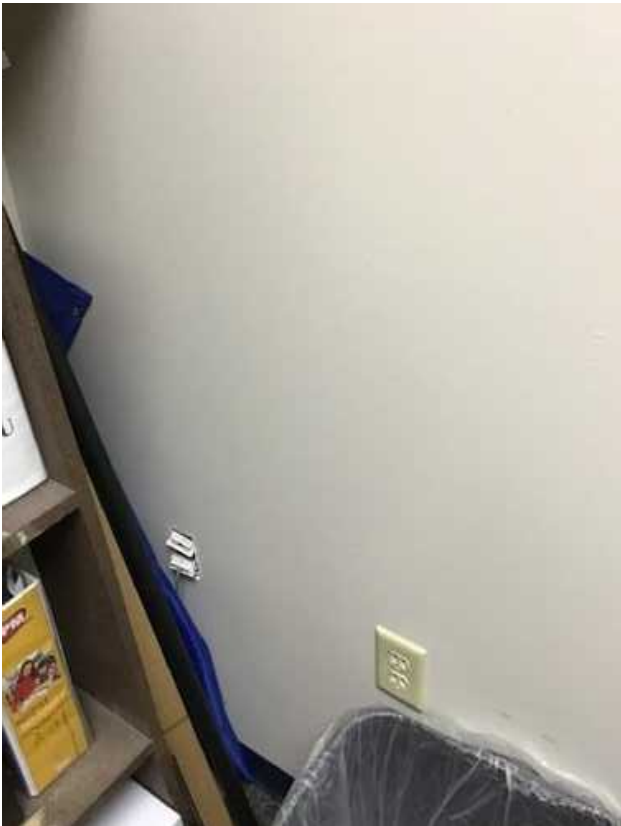
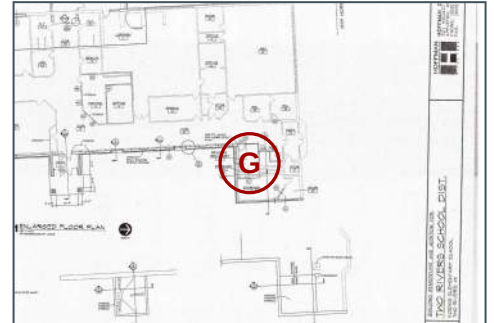
G18: General

Description: Wall cover needed for data cables

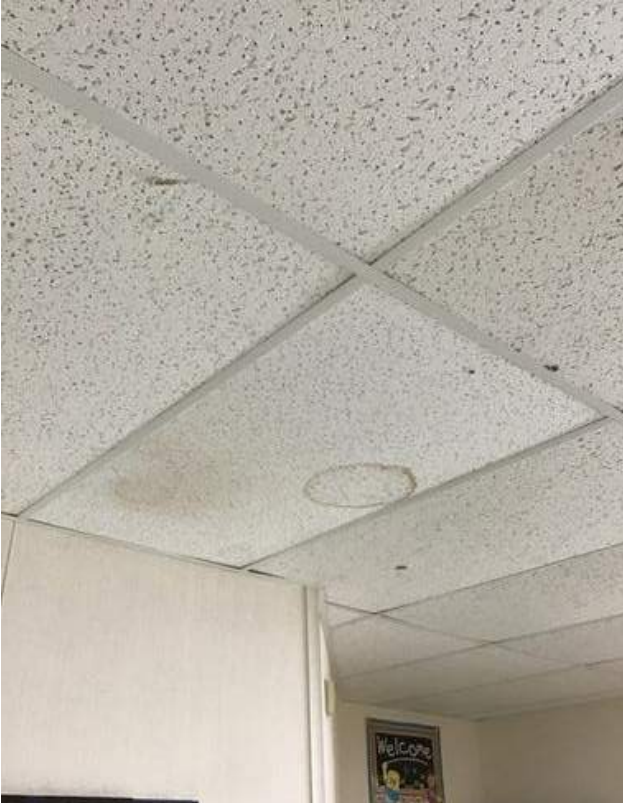
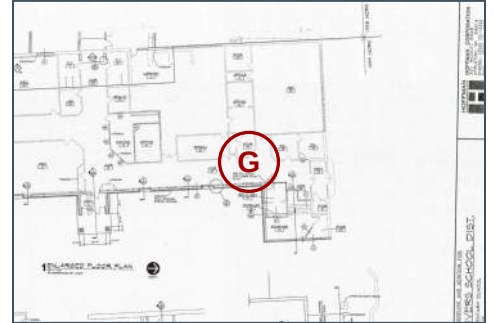
G19: General

Description: Stained ceiling

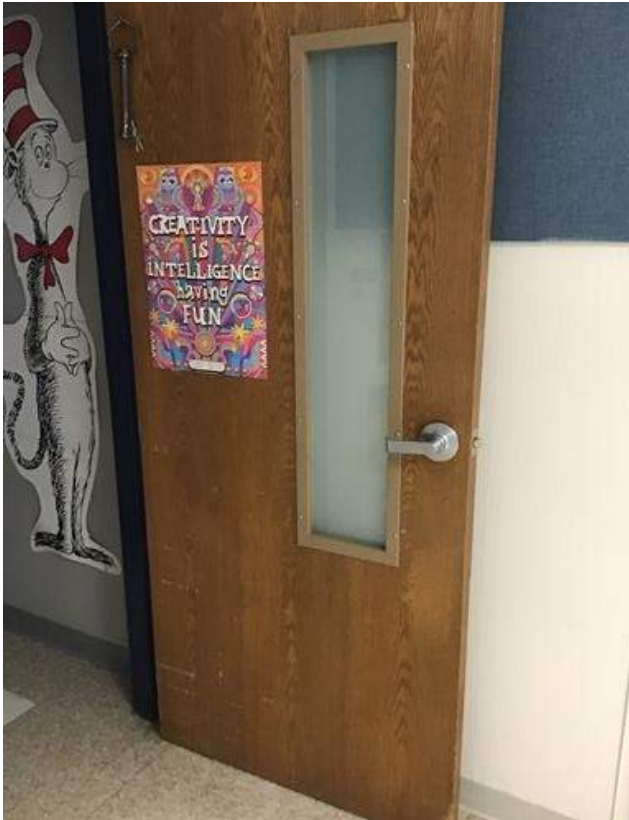
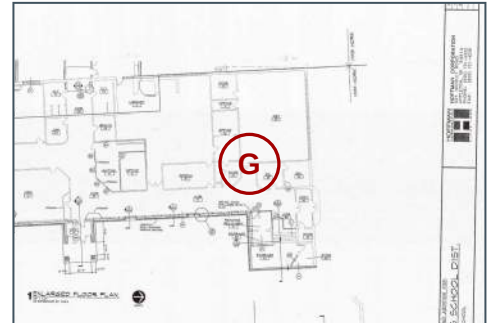
G20: General

Description: Scratches on door

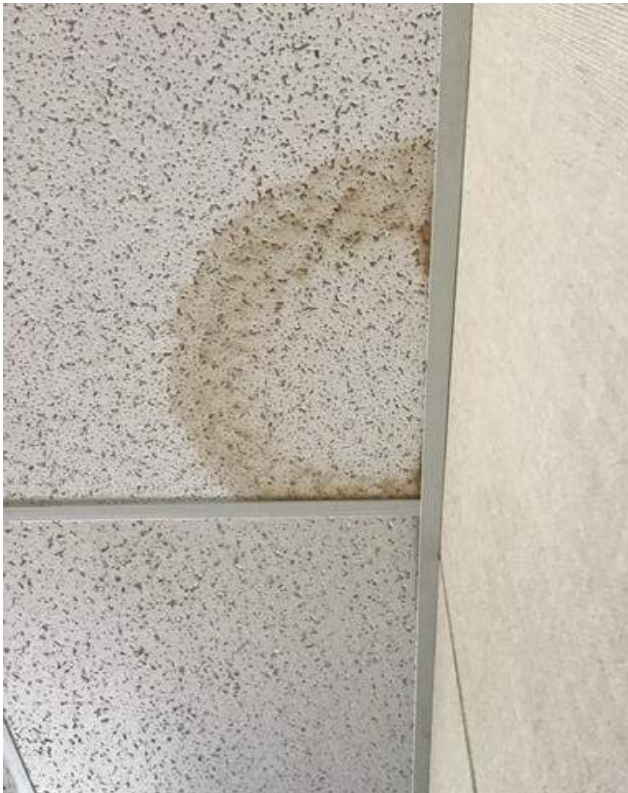
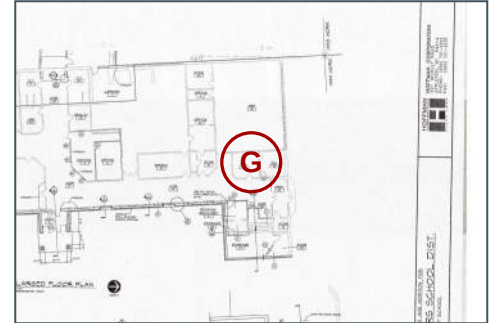
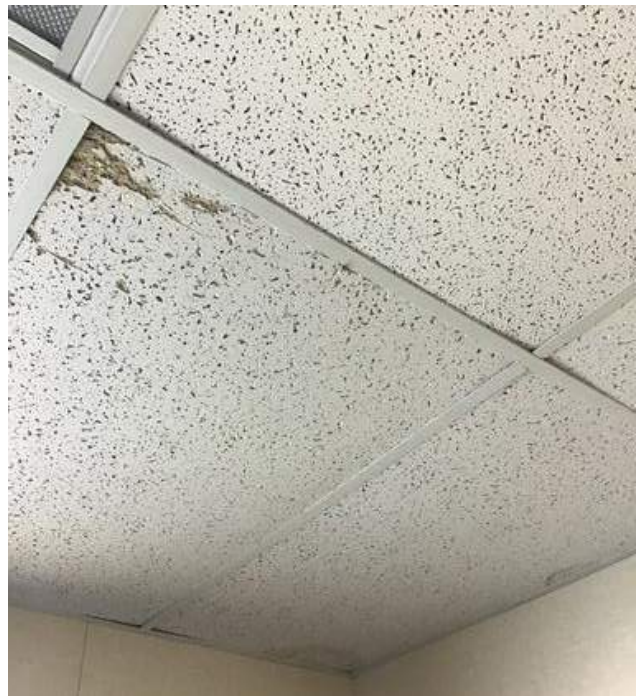
G21: General

Description: Stained ceiling tile

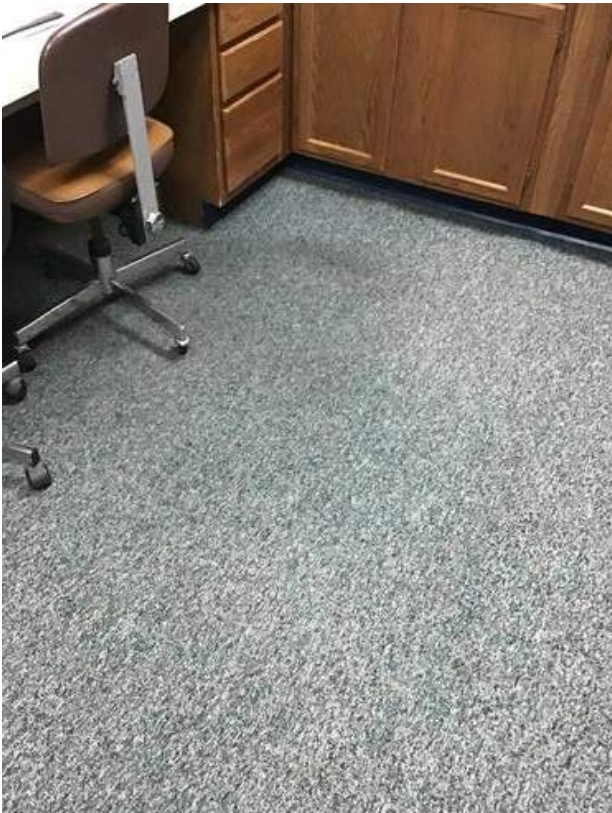
G23: General

Description: Stained carpet

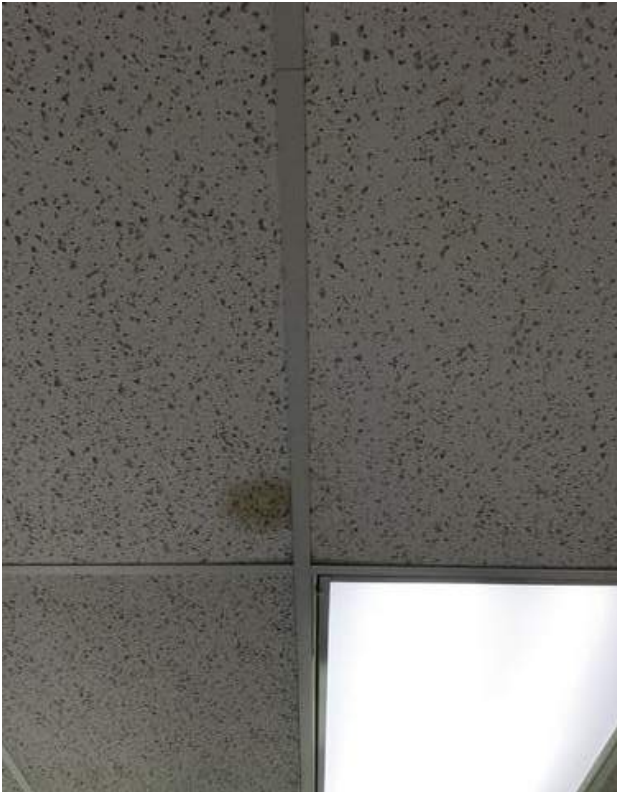
G24: General

Description: Stained ceiling tile

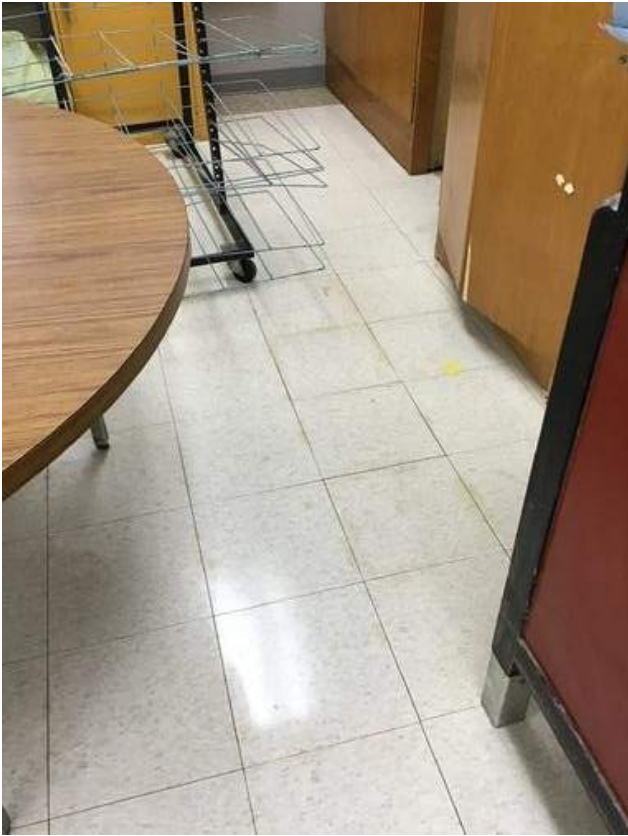
G26: General

Description: Cracks in floor

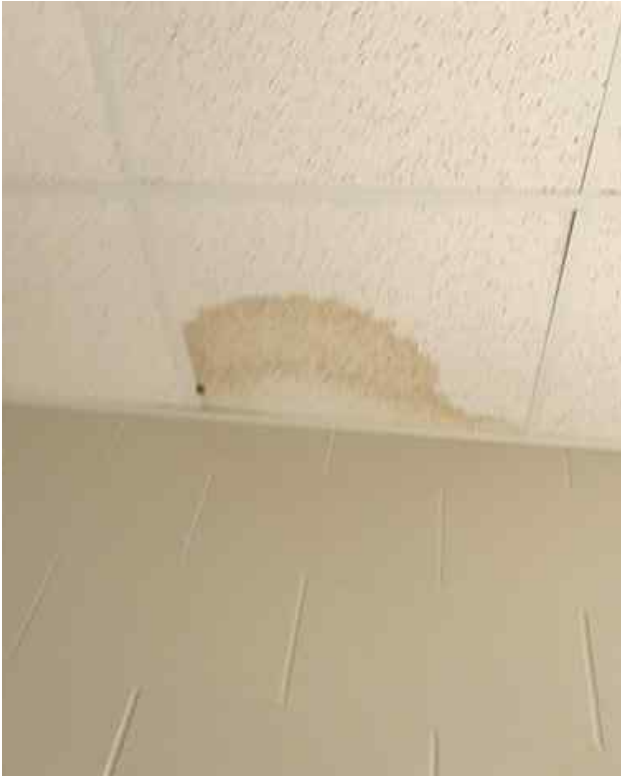
G27: General

Description: Stained ceiling tile

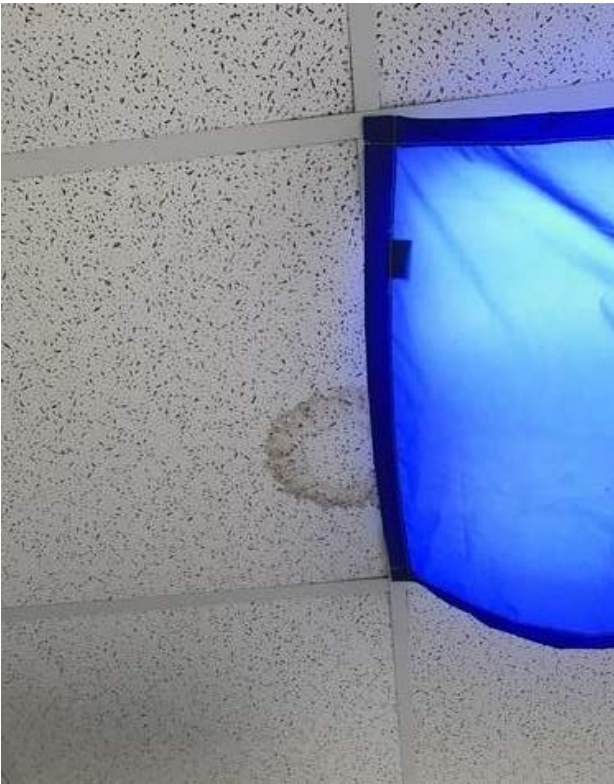
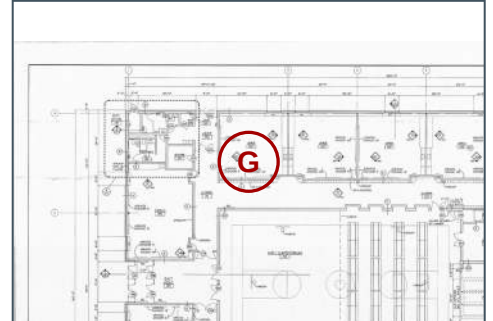
G28: General

Description: Stained ceiling tile

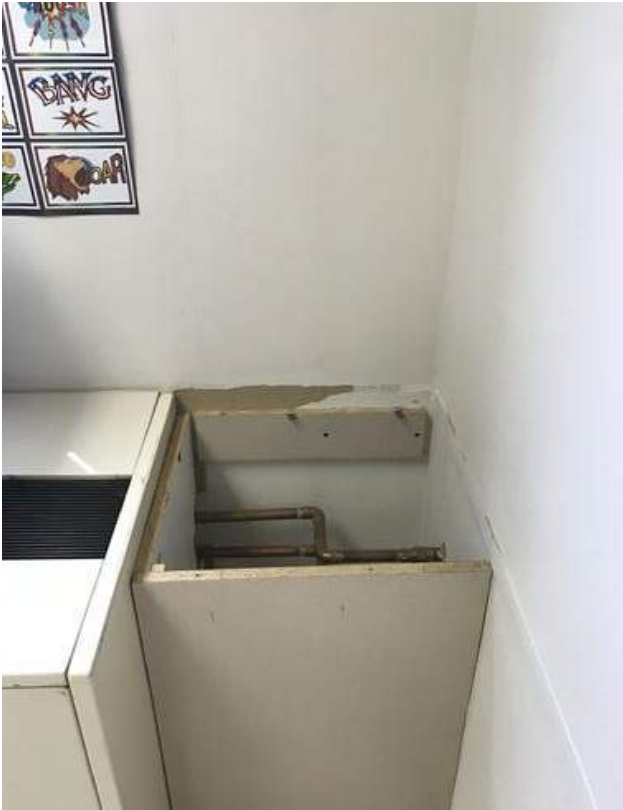
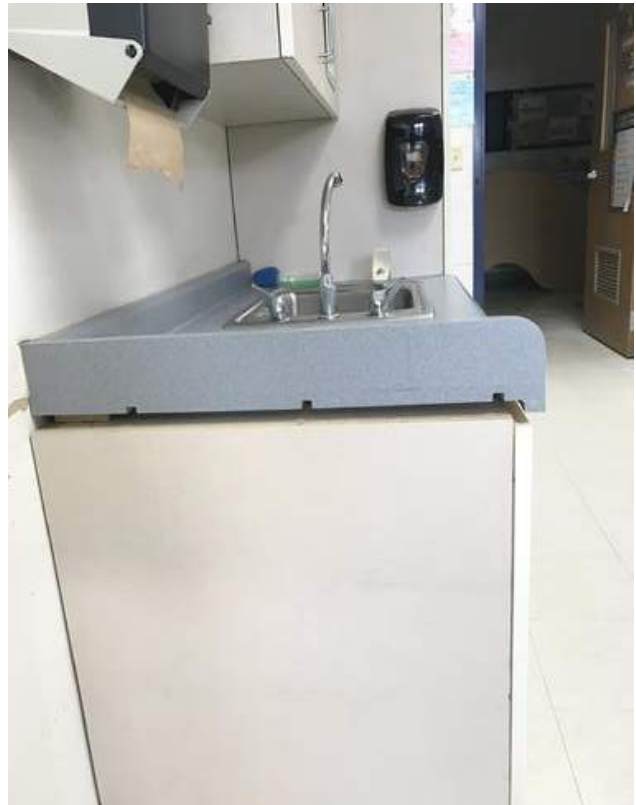
G30: General

Description: Counter tops and casework to be added

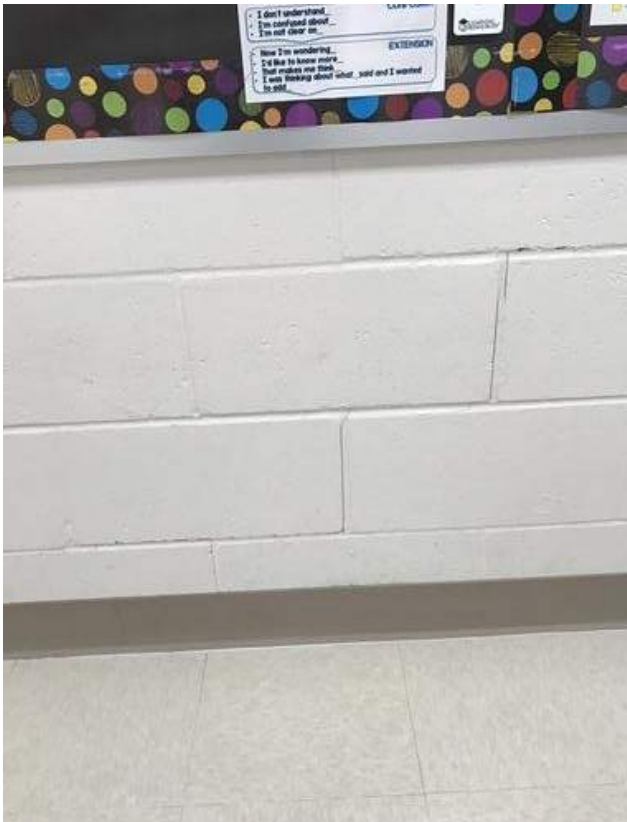
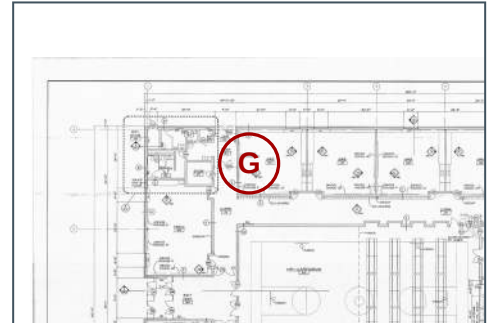
G31: General

Description: Cracks in CMU wall

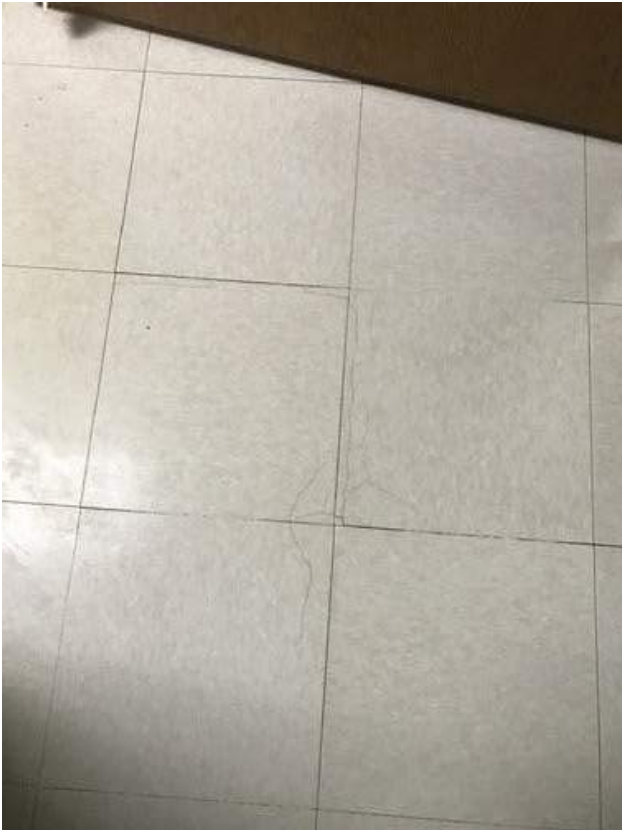
G32: General

Description: Cracks in floor

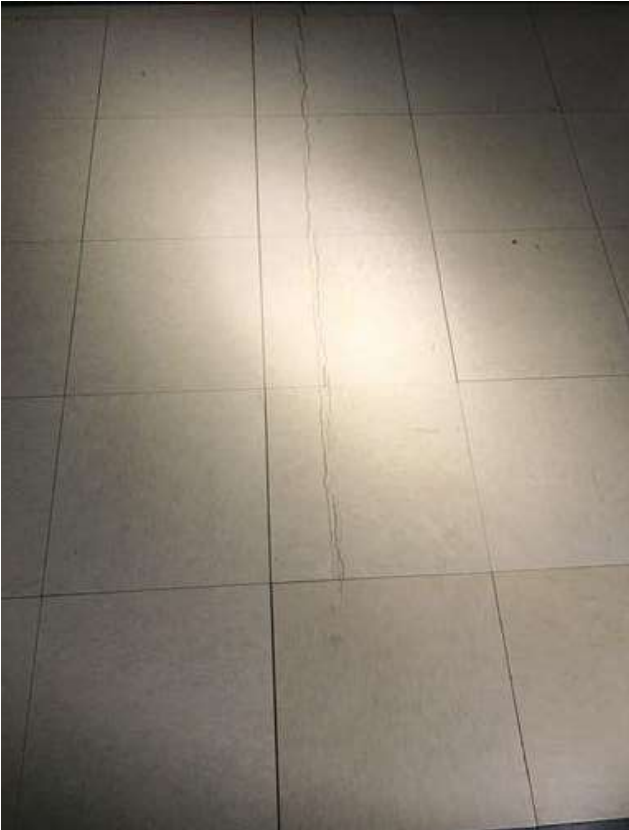
G33: General

Description: Cracks in floor

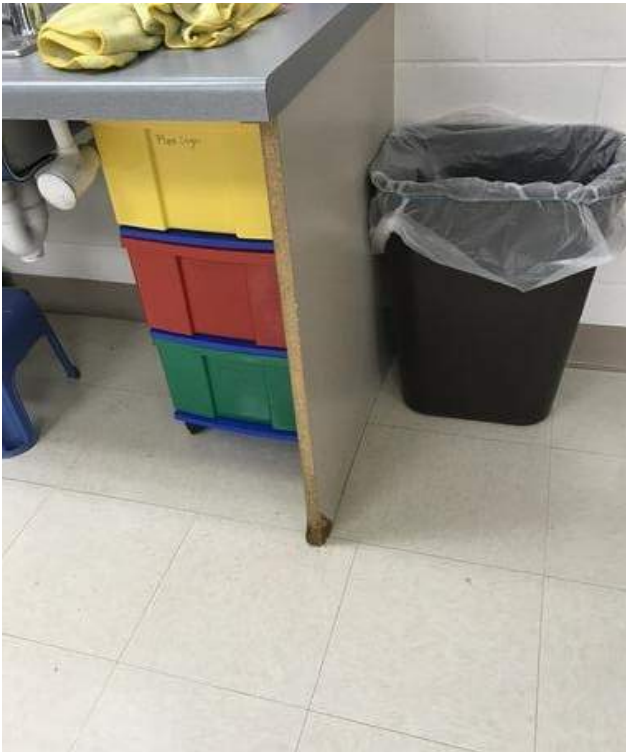
G34: General

Description: Laminate is peeling off counter top

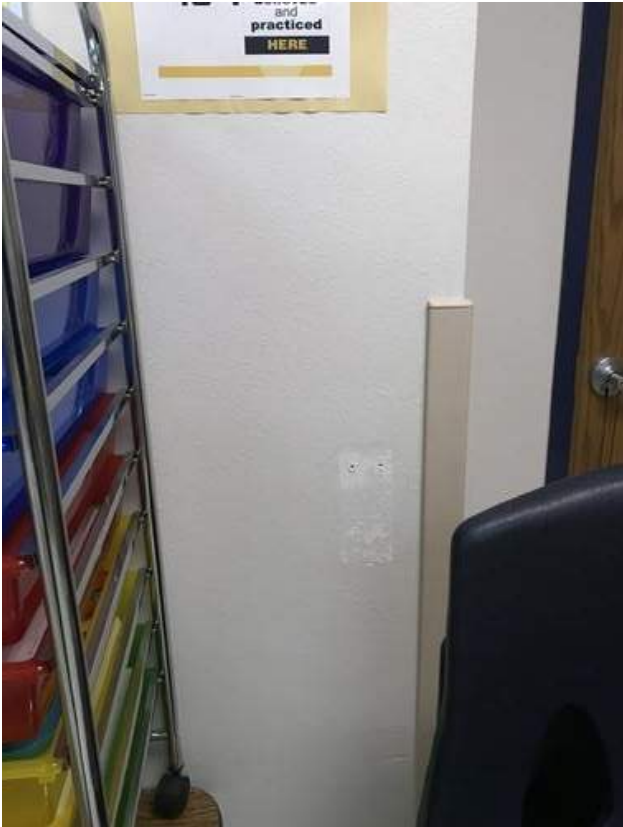
G35: General

Description: Walls needs patching and paint

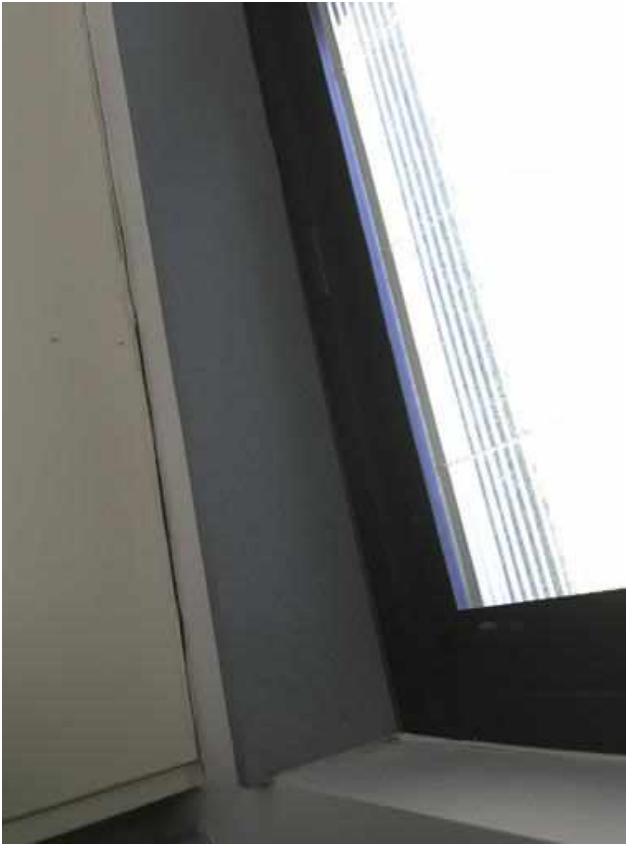
G36: General

Description: Window needs to be caulked

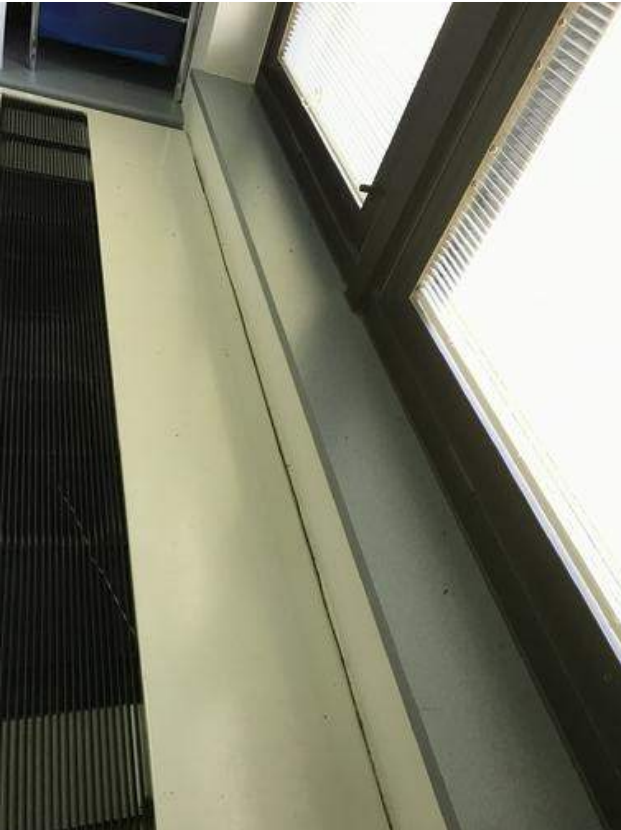
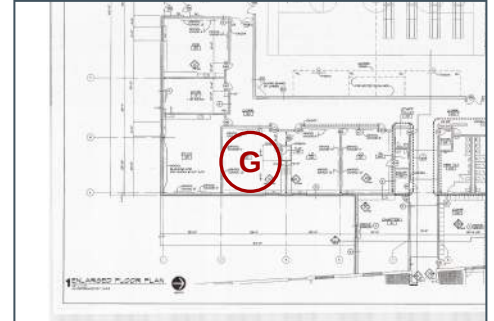
G38: General

Description: Window needs caulking

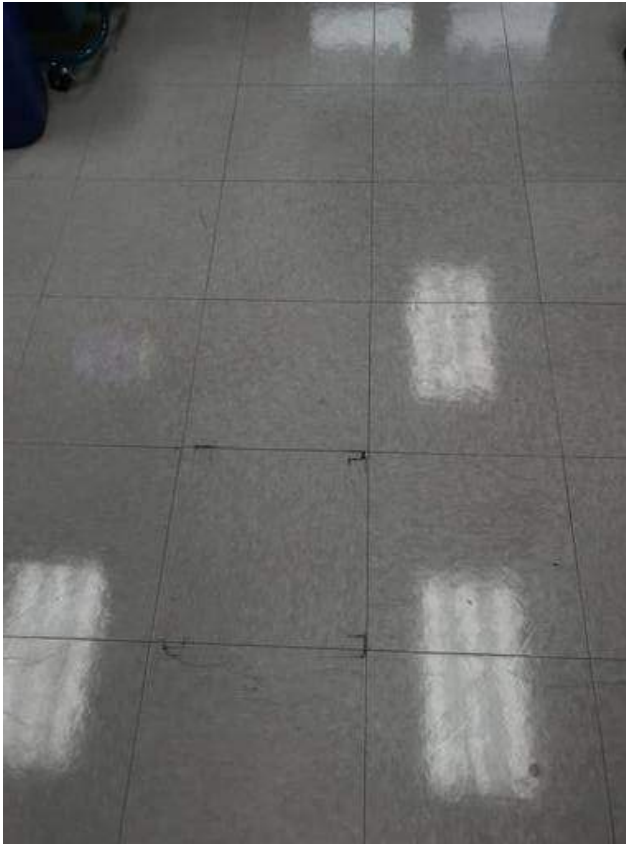
G39: General

Description: Cracks in floor

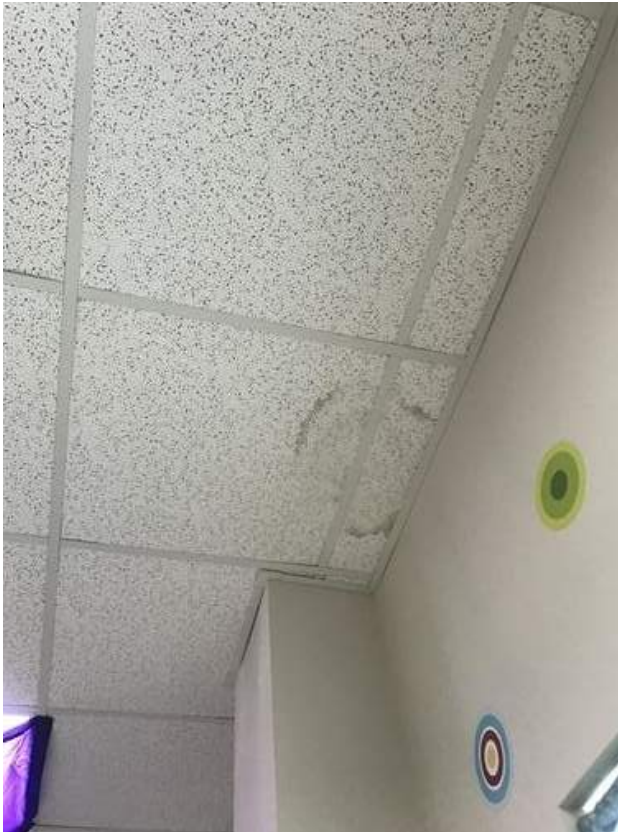
G40: General

Description: Stained ceiling tile

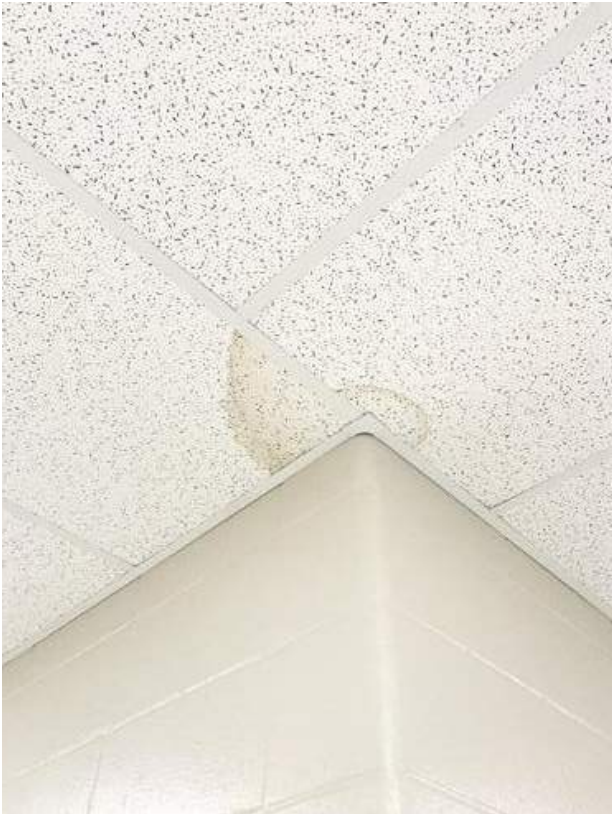
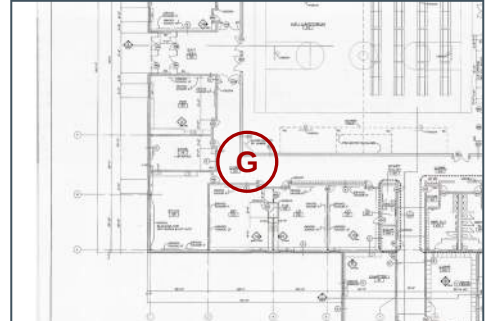
G41: General

Description: Stained ceiling tile

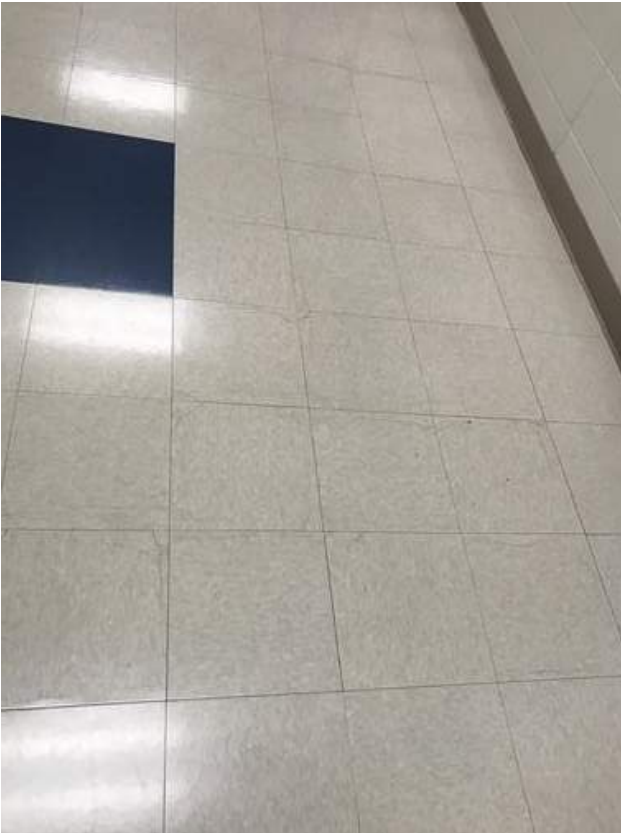
G42: General

Description: Cracks in floor

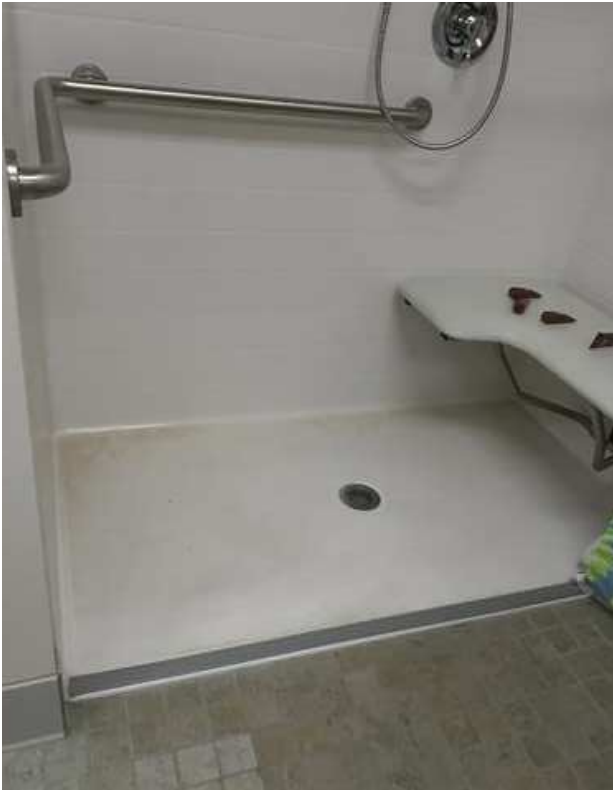
G43: General

Description: Stained shower

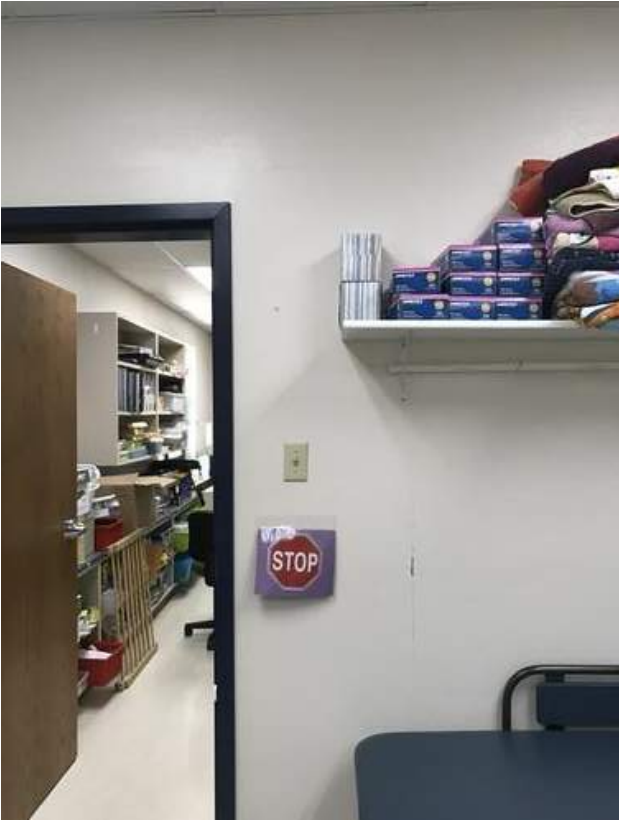
G44: General

Description: Crack in drywall

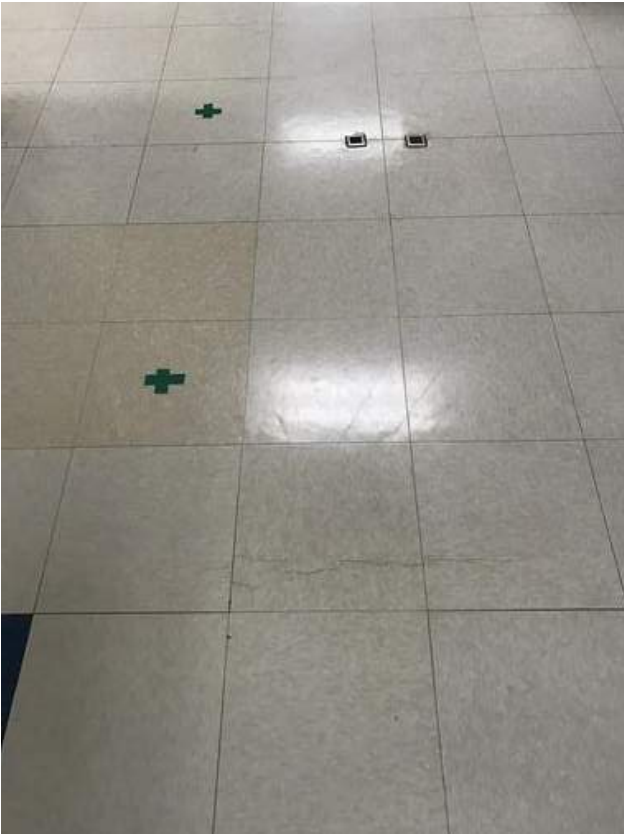
G45: General

Description: Cracks in floor

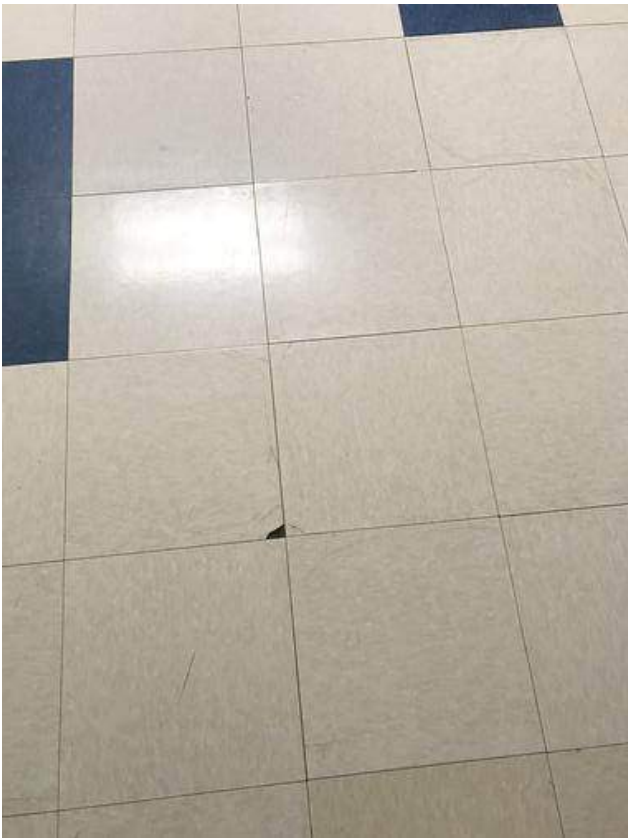
G46: General

Description: Cracks in floor

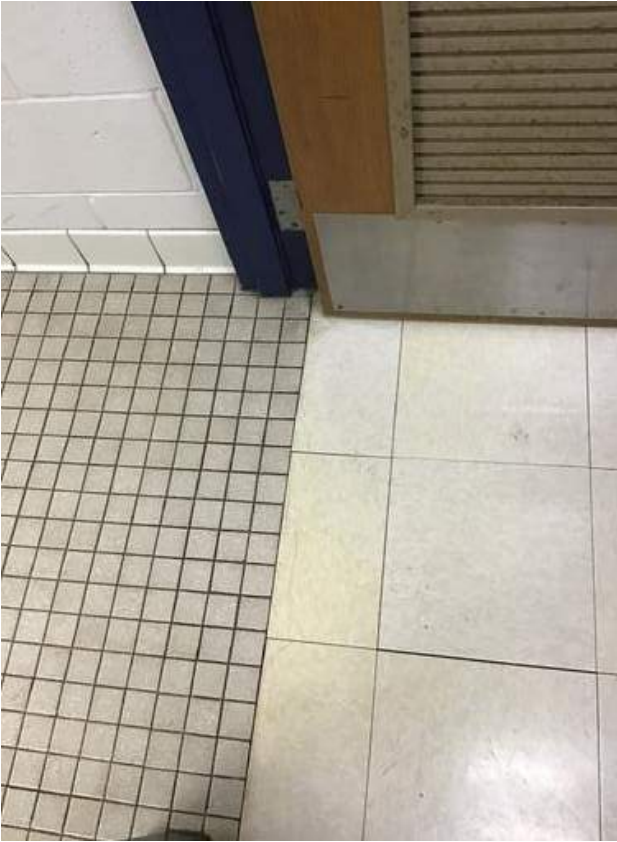
G50: General

Description: Cracks in floor

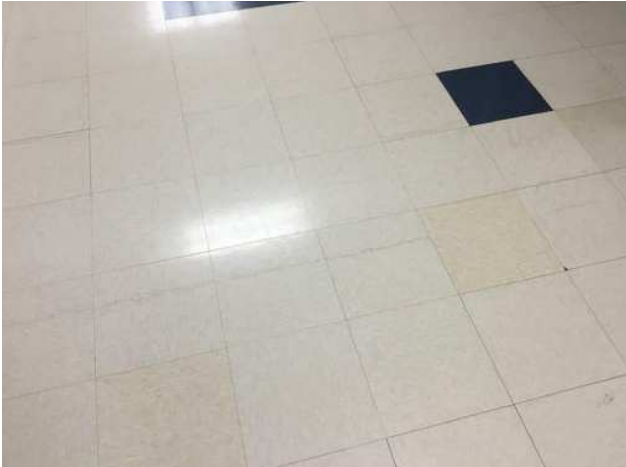
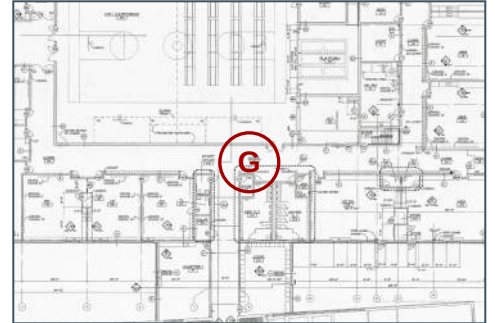
G51: General

Description: Crack in CMU wall

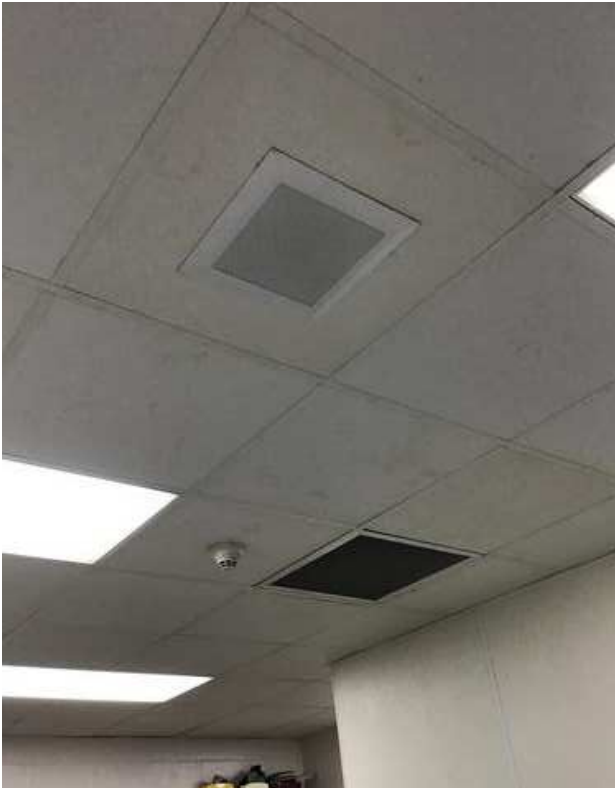
G53: General

Description: Stained ceiling tile

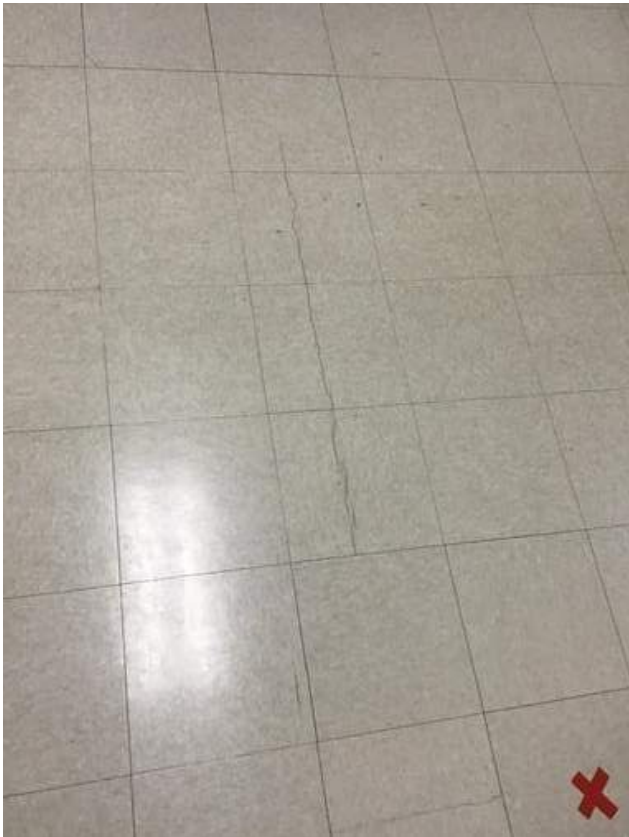
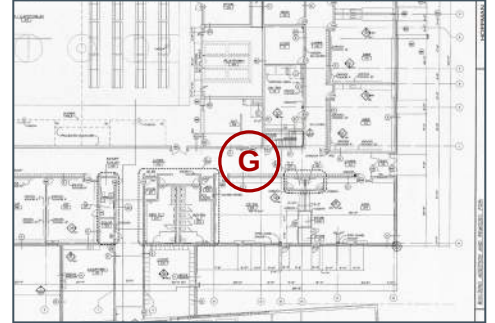
G55: General

Description: Cracks in floor
