TWO RIVERS PUBLIC SCHOOLS

FACILITIES ASSESSMENT REPORT

08.19.21

Two Rivers School District Facilities Assessment July 2021

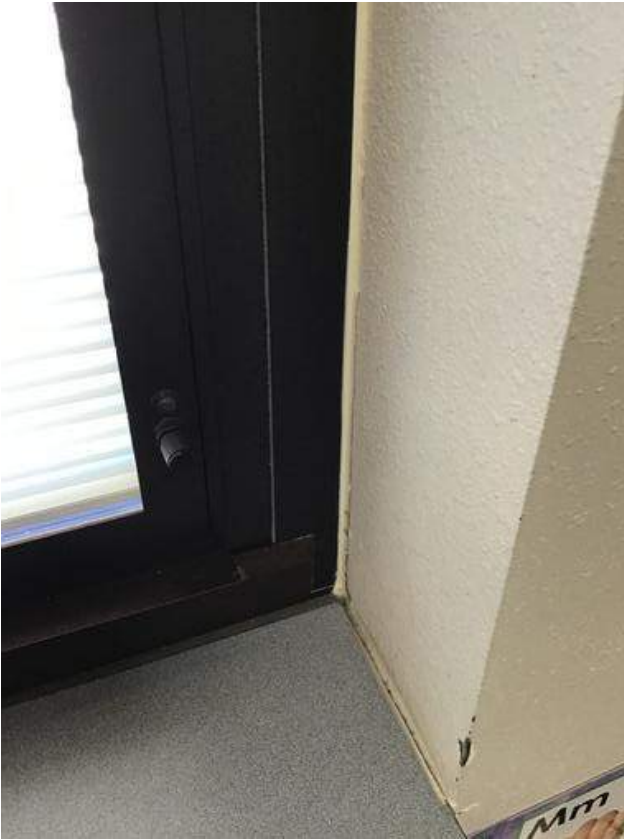
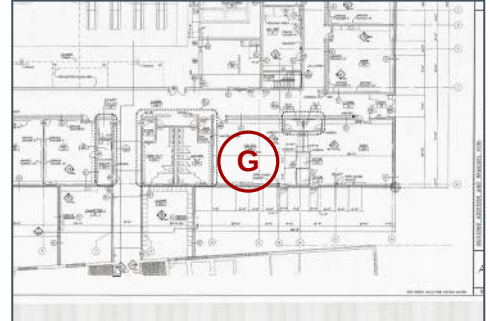
G58: General

Description: Cracks in floor

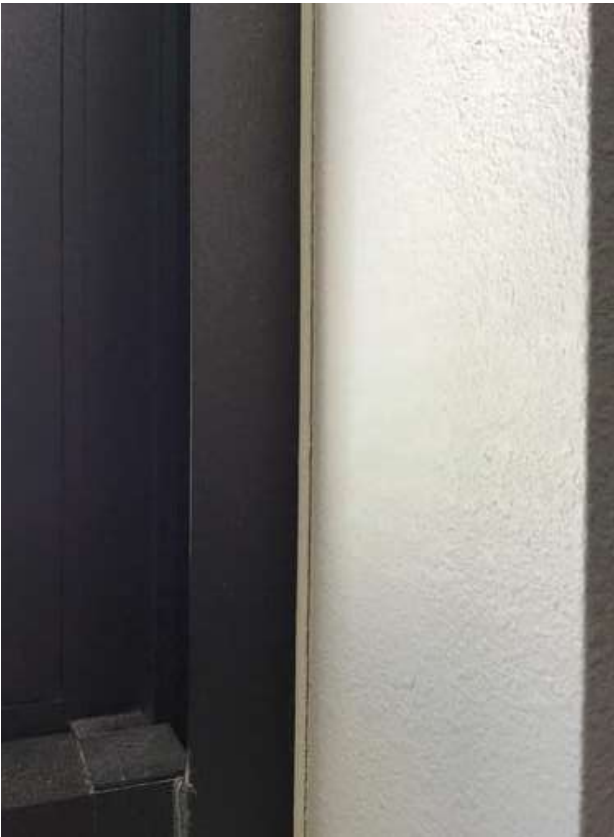
G61: General

Description: Stained carpet

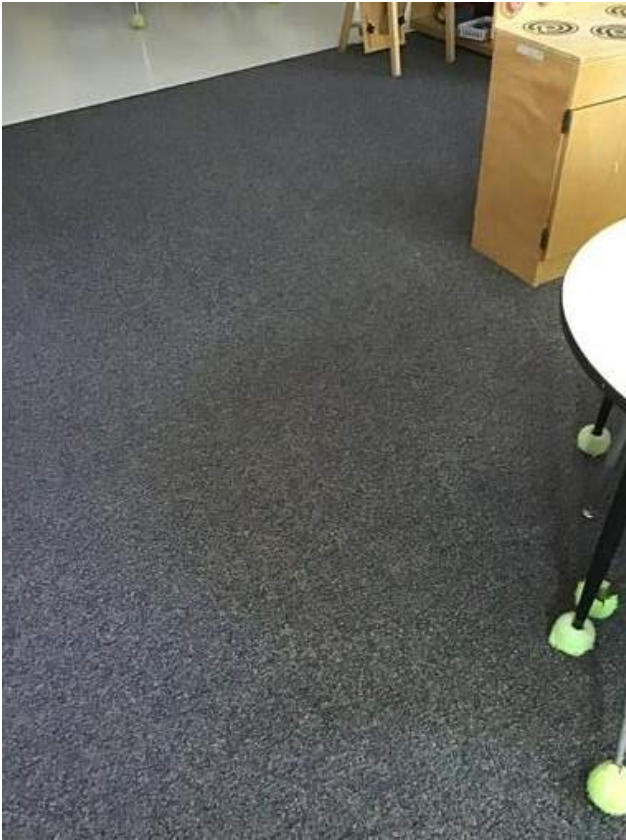
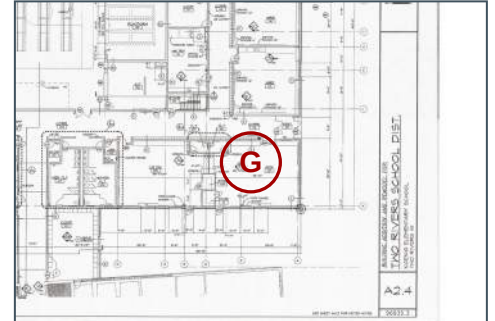
G62: General

Description: Cracks in floor

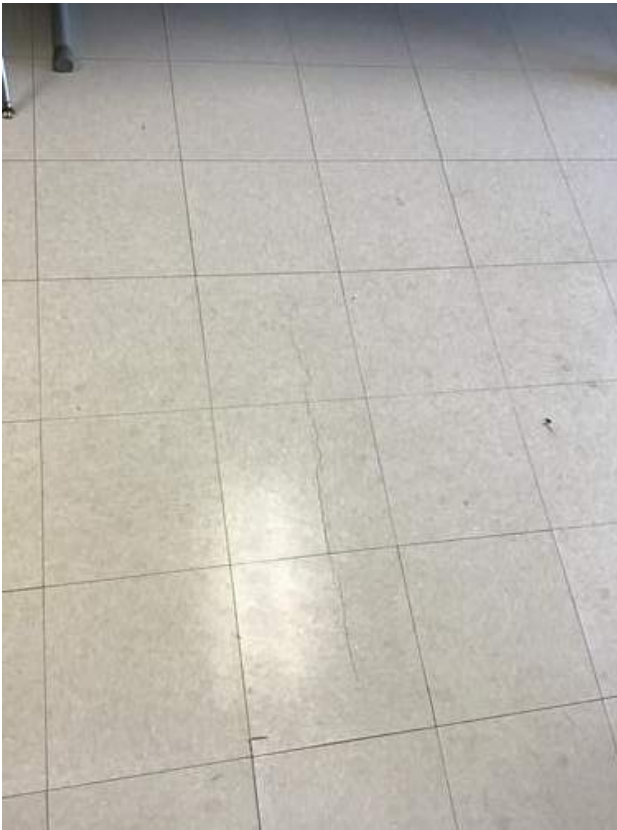
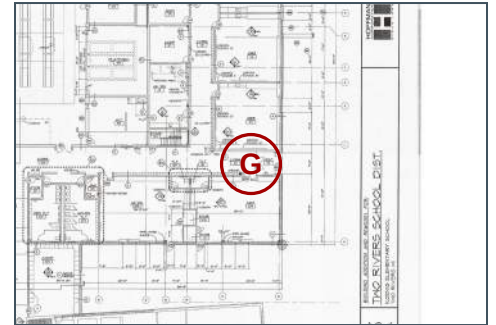
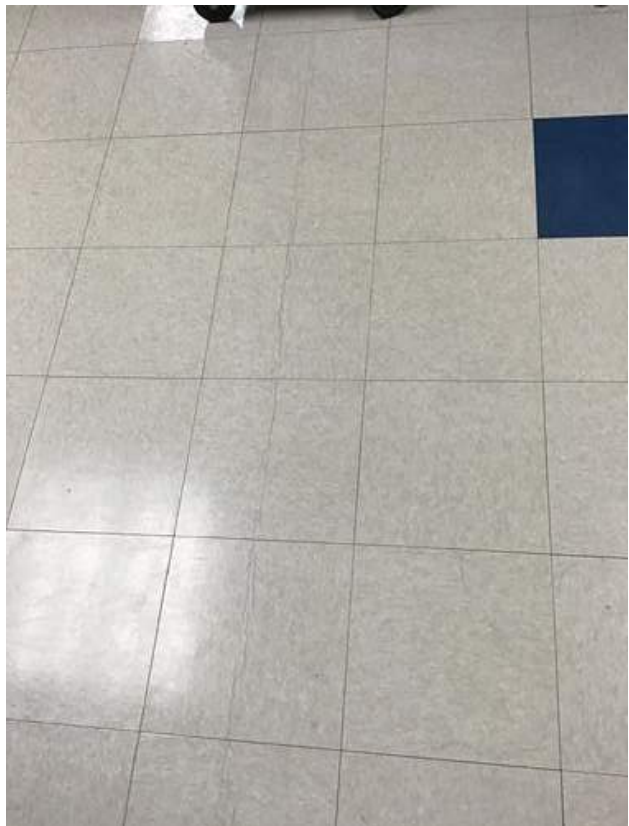
G63: General

Description: Crack in concrete floor on second level

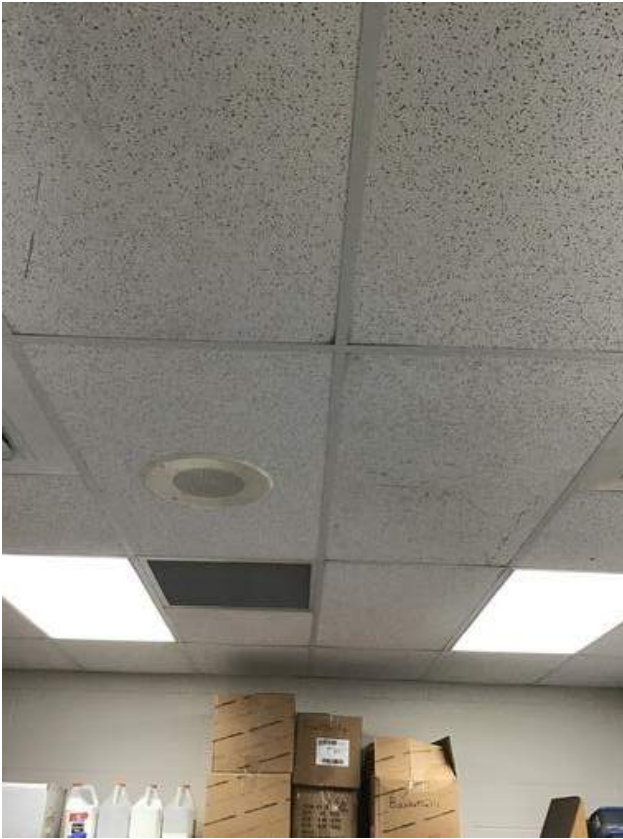
G65: General

Description: Stained ceiling tiles

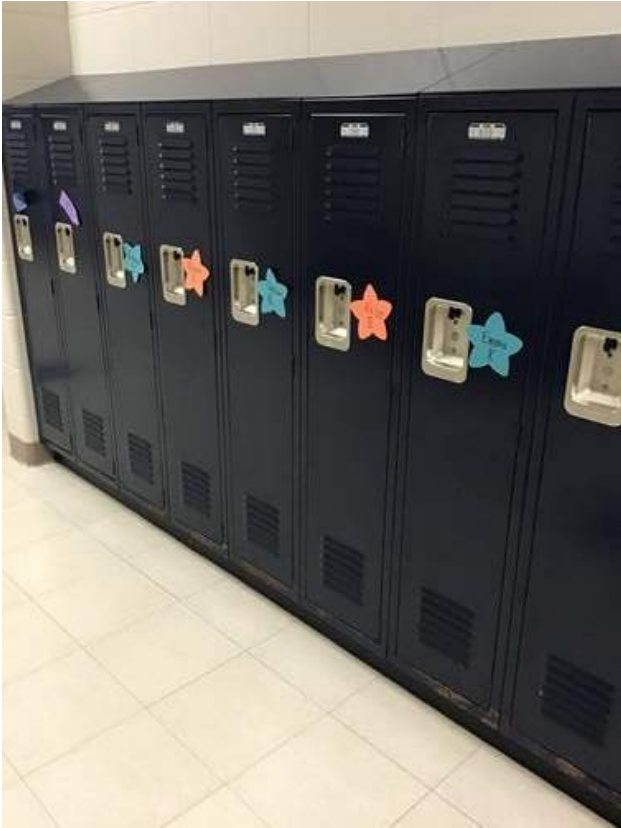
G66: General

Description: Rusting at bottom of lockers

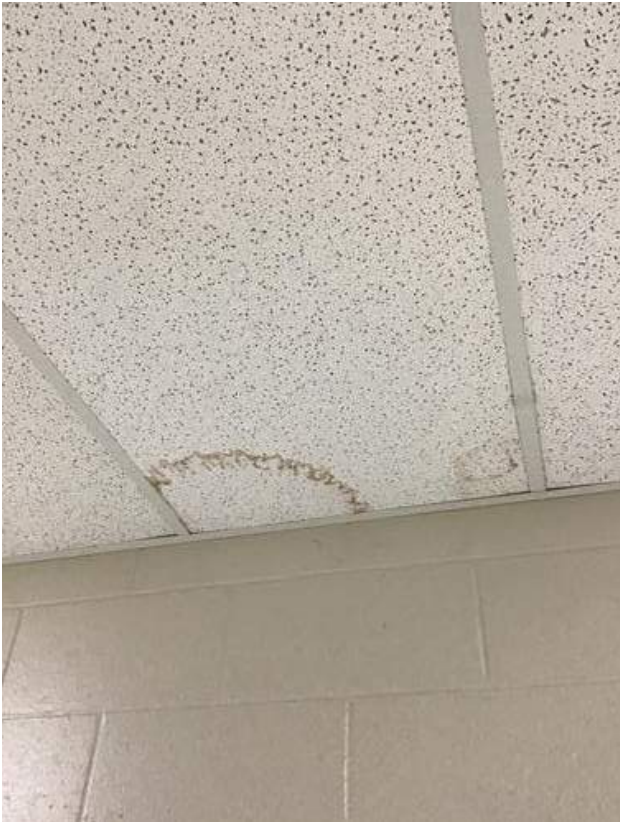
G67: General

Description: Stain in ceiling tile

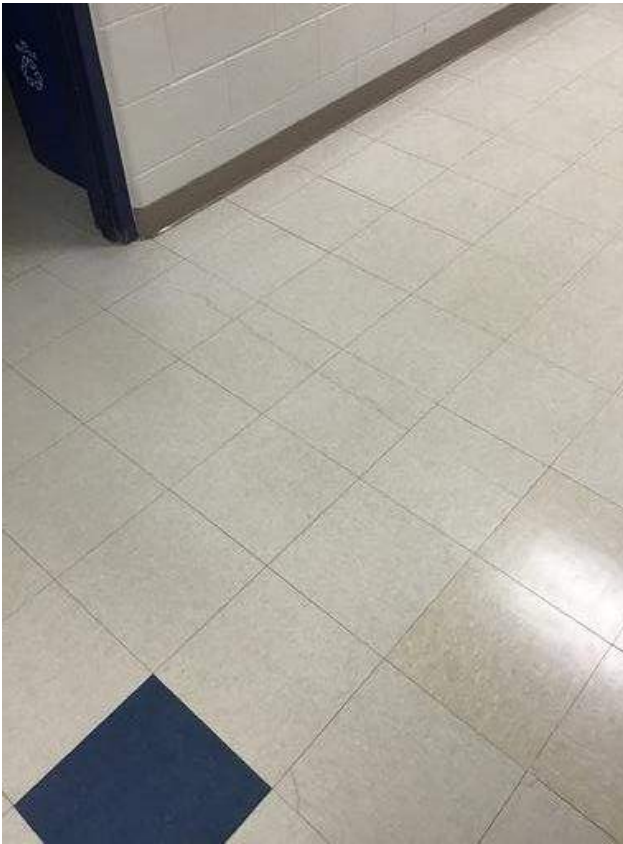
G68: General

Description: Floor has cracks

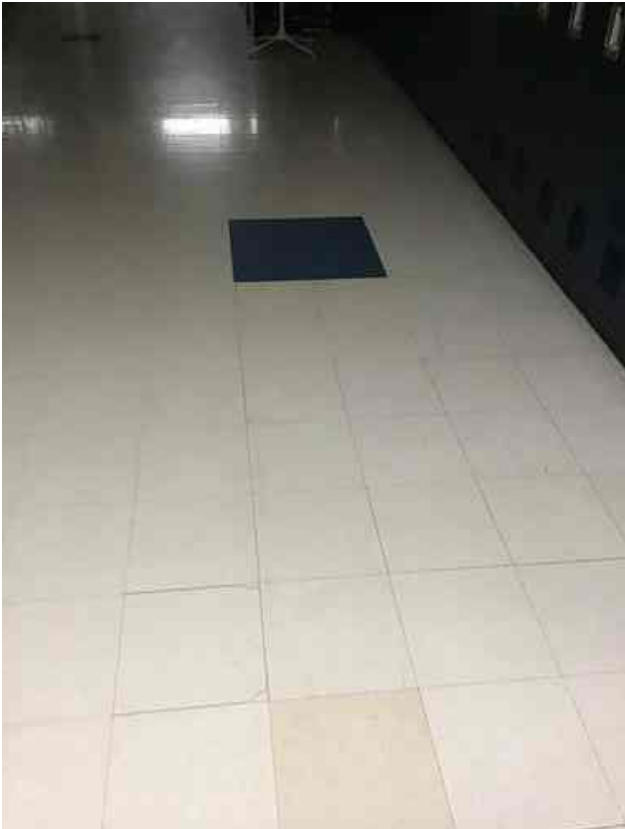
G70: General

Description: Floor has cracks

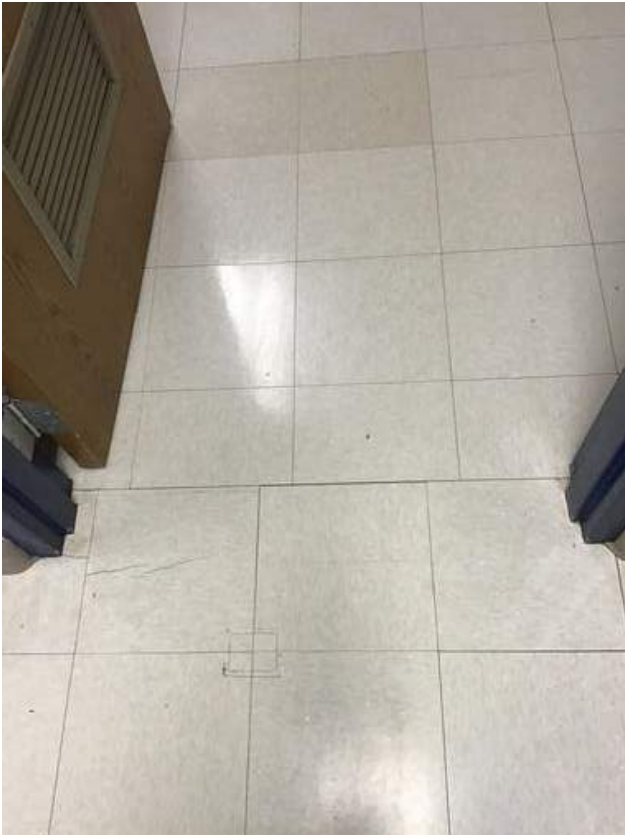
G71: General

Description: Floor has cracks

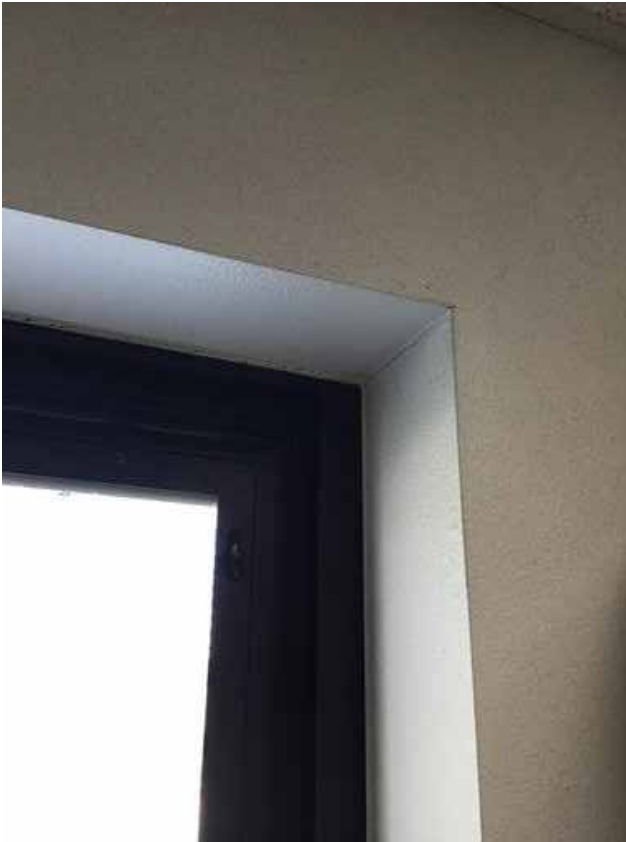
G72: General

Description: Need window caulking and drywall is cracked at the corner of the window

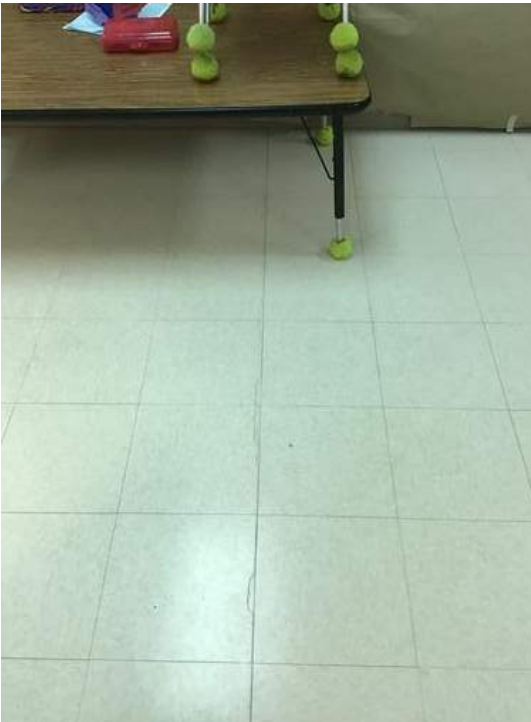
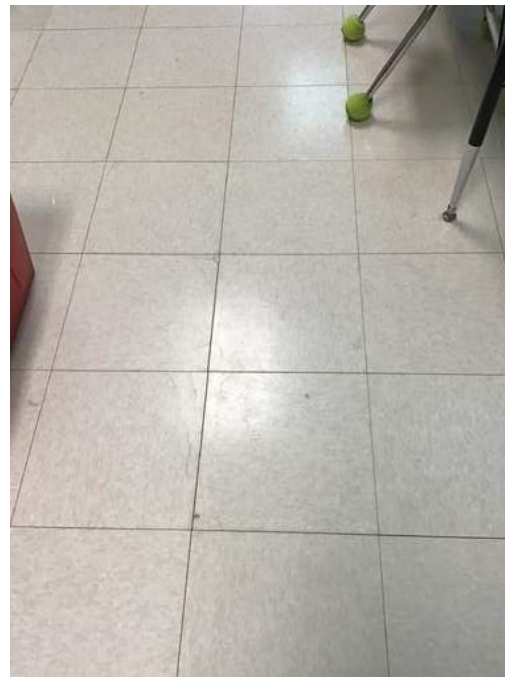
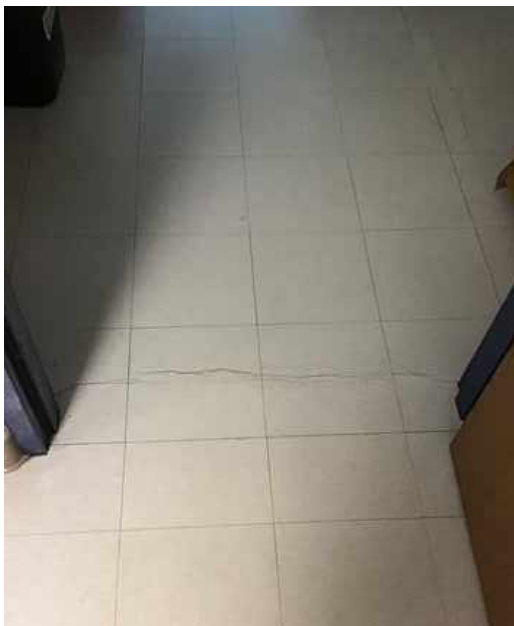
G73: General

Description: Cracks in floor

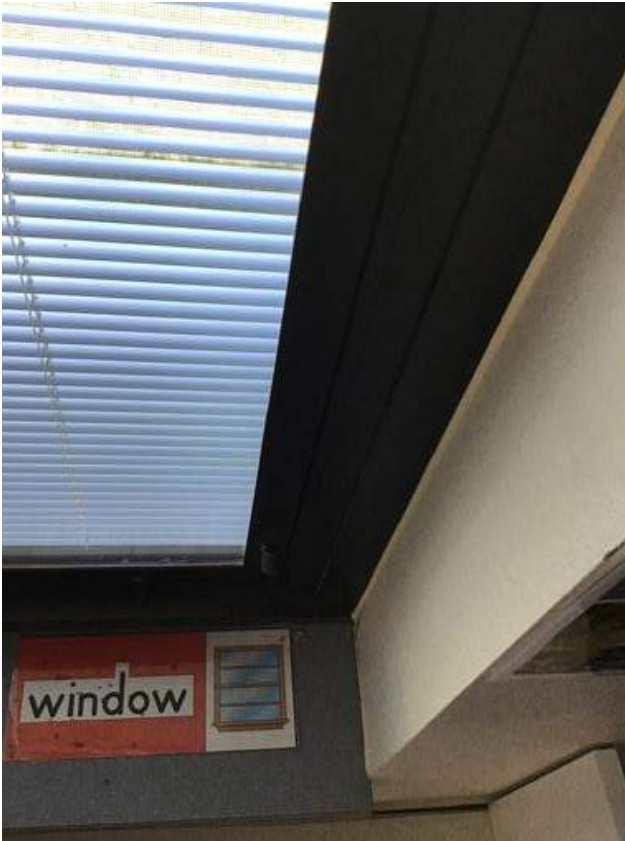
G74: General

Description: Window needs caulking

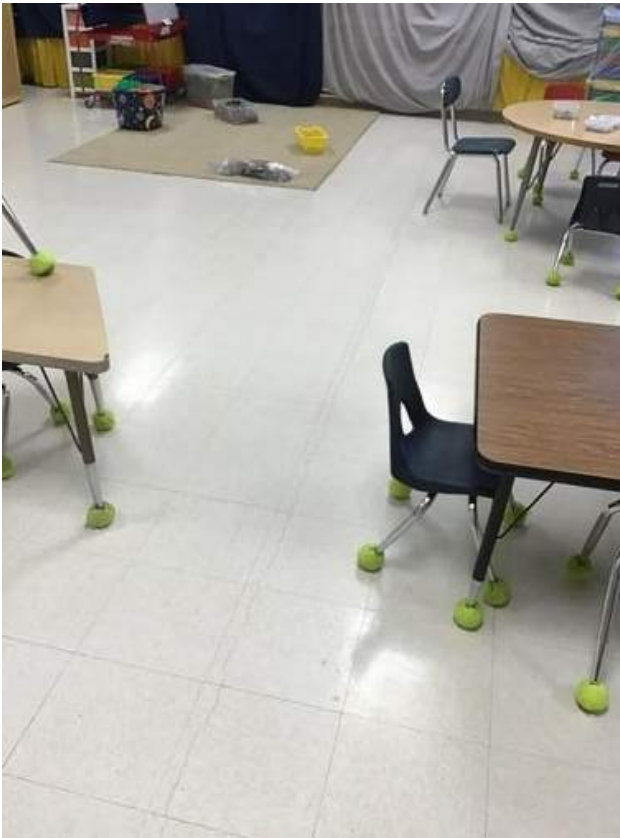
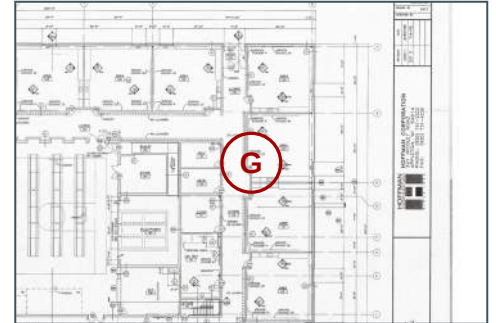
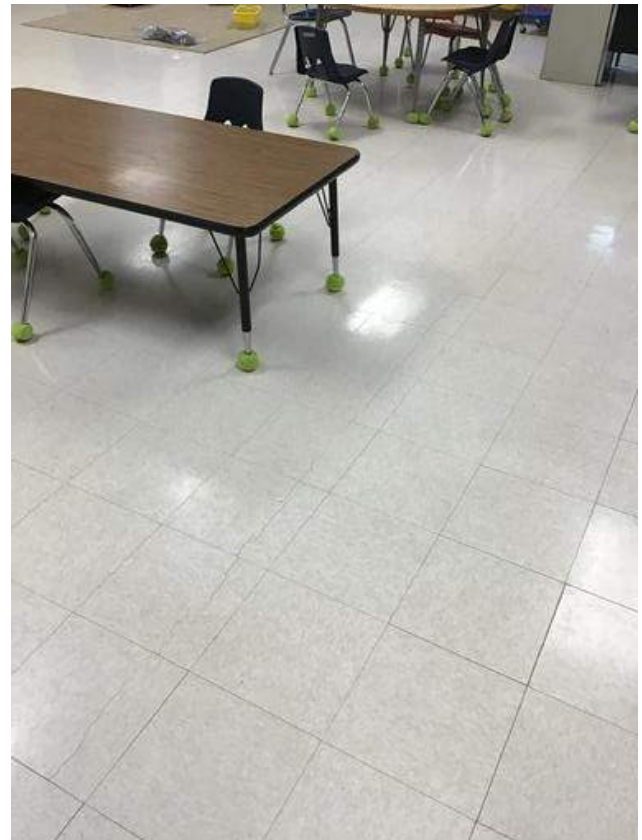
G75: General

Description: Cracks in floor

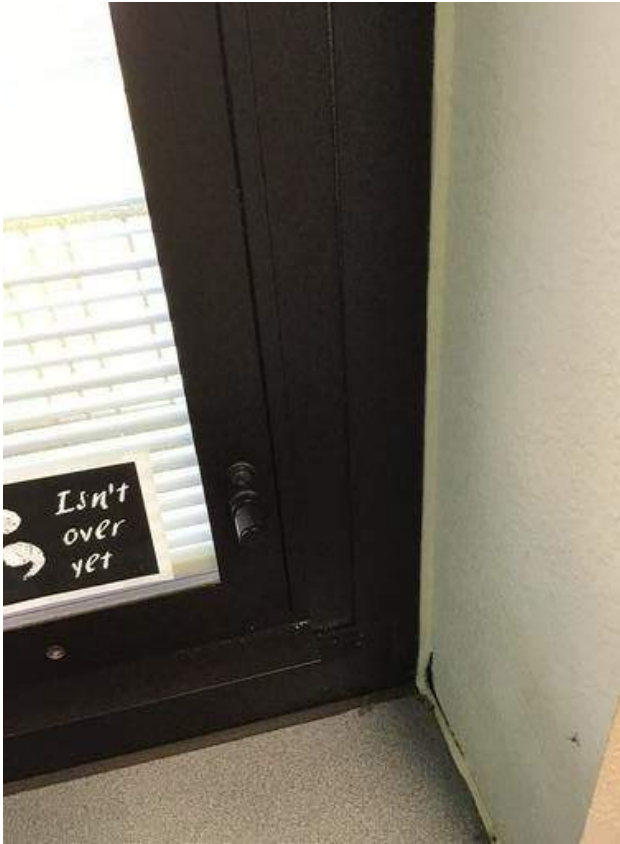
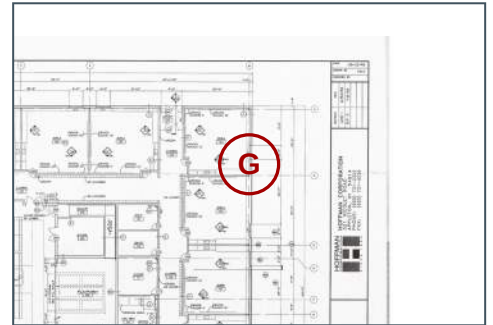
G76: General

Description: Window needs to be caulked

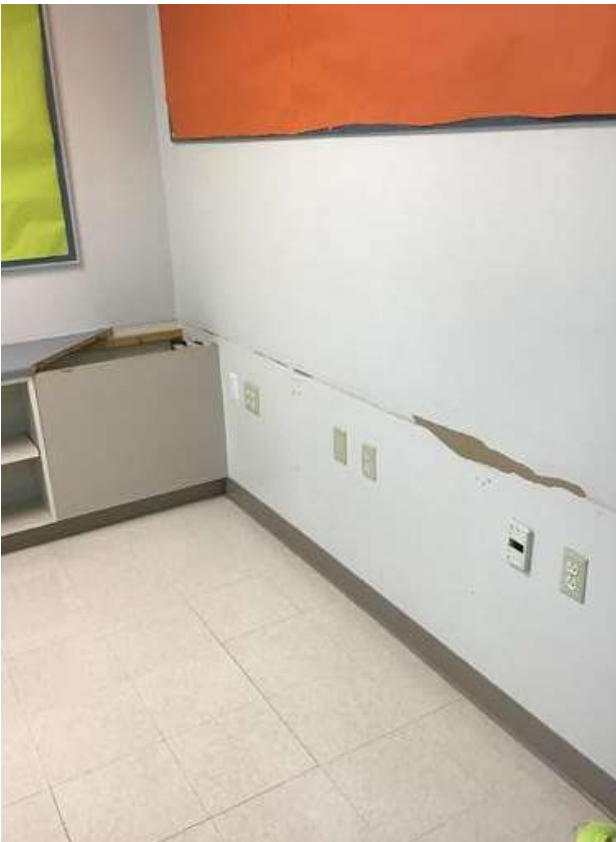
G77: General

Description: Drywall and paint needs to be refinished

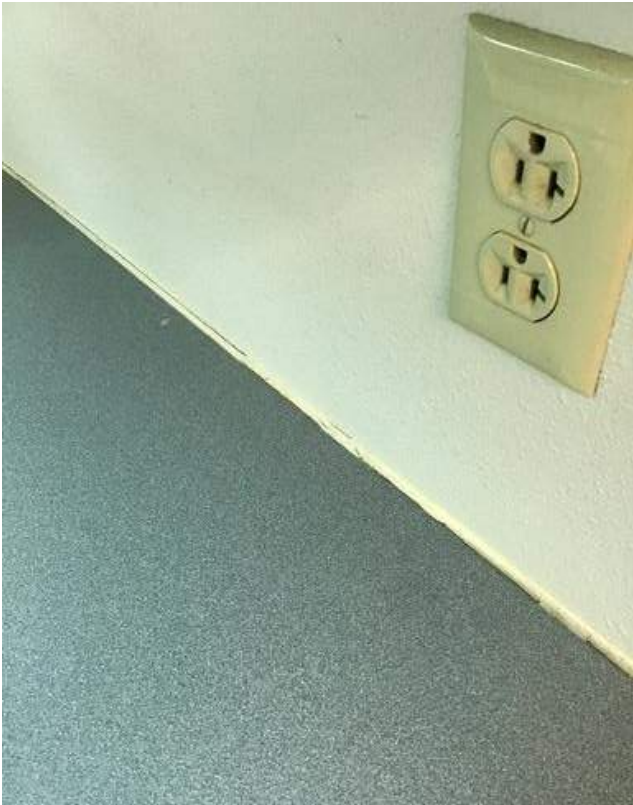
G78: General

Description: No base on the wall

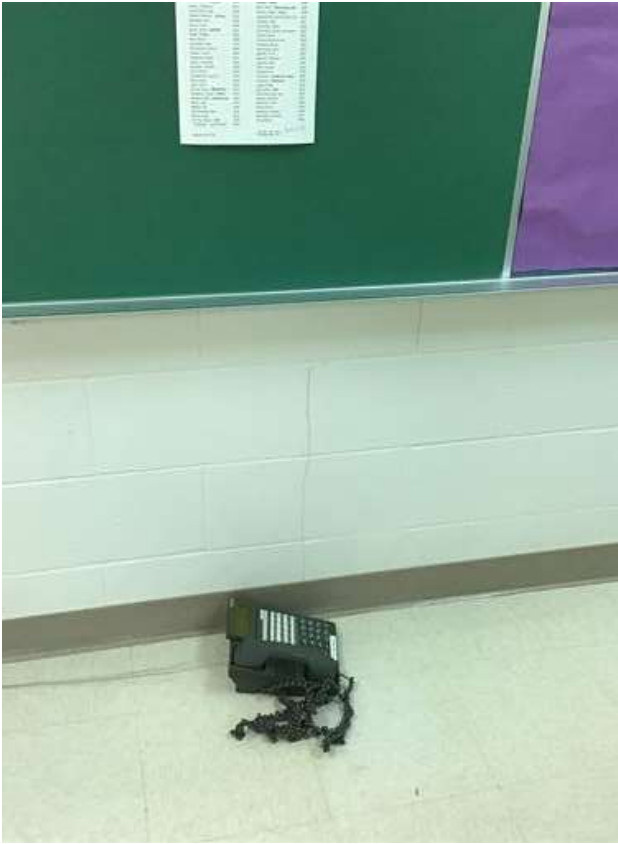
G79: General

Description: Crack in CMU wall

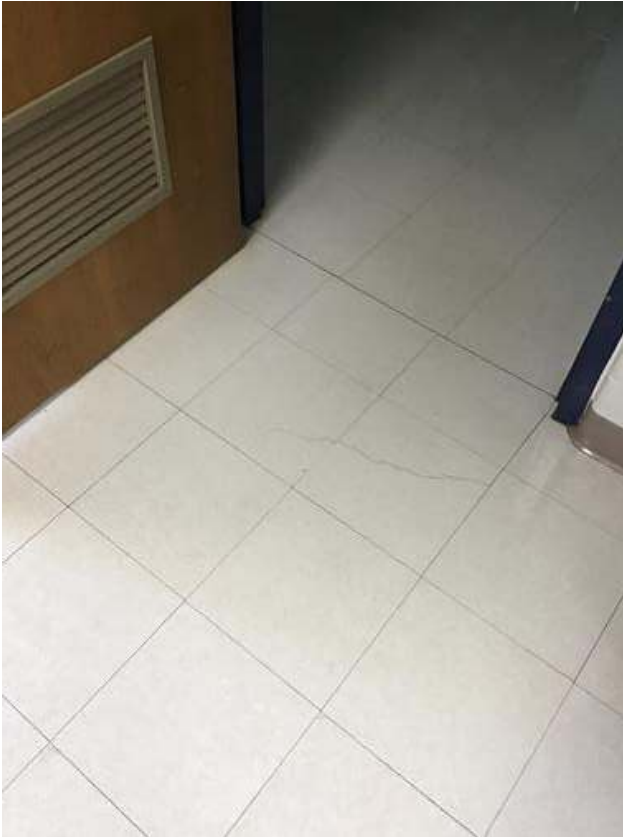
G80: General

Description: Cracks in the floor

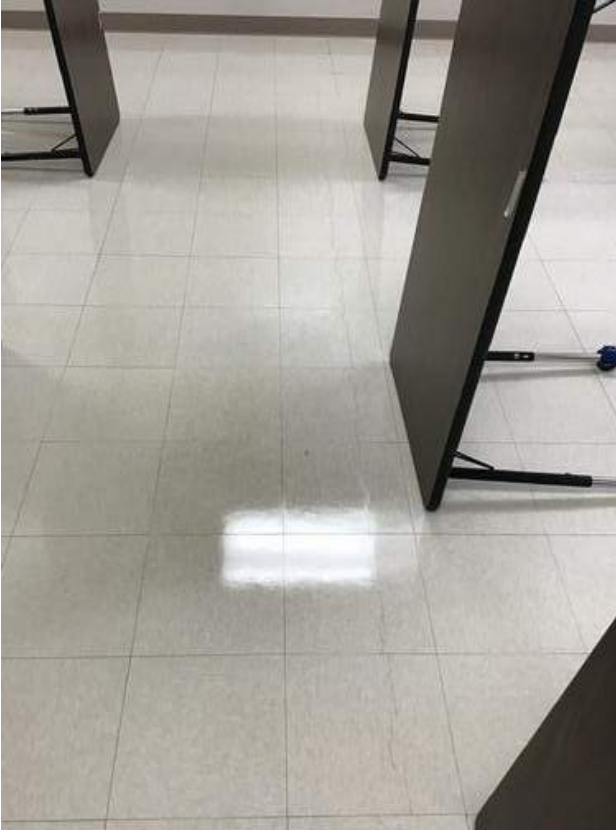
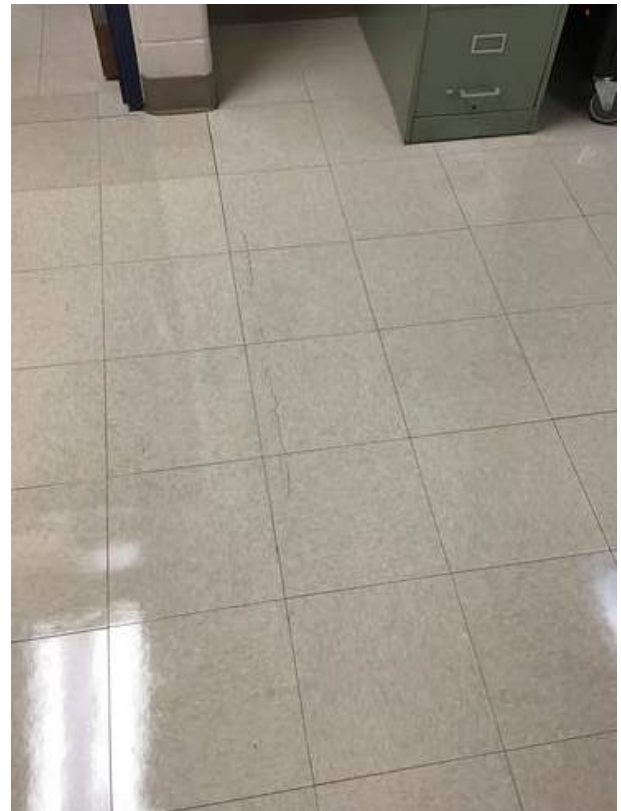
G81: General

Description: Cracks in the flooring

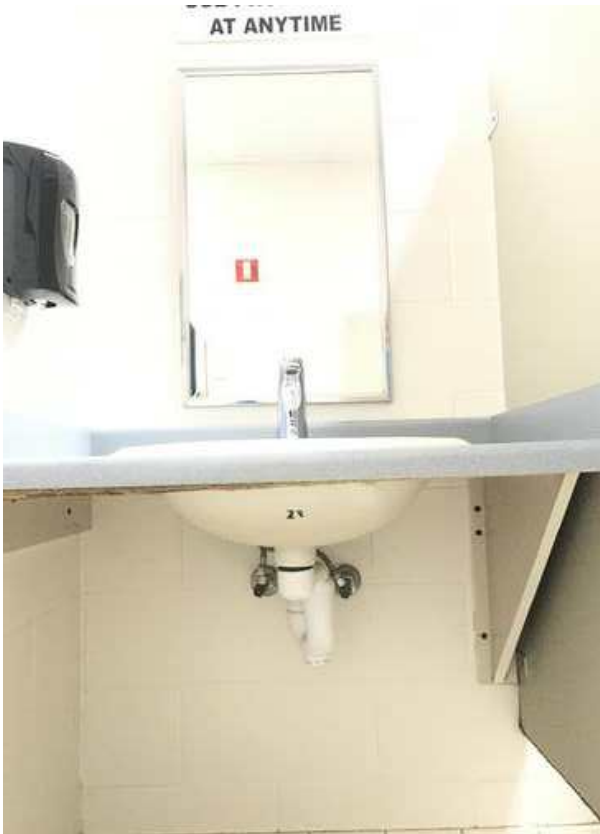
G82: General

Description: Laminate is pulling off counter top

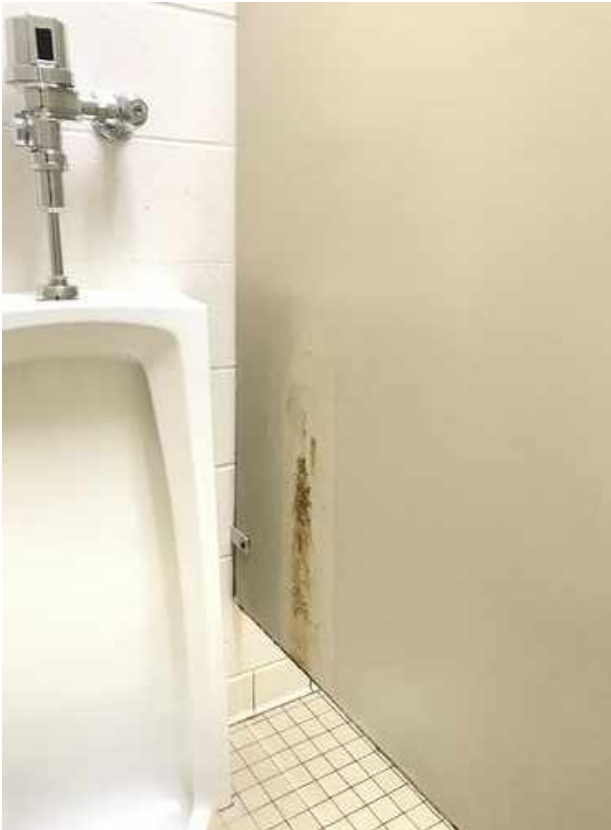
Description: Toilet partition is stained

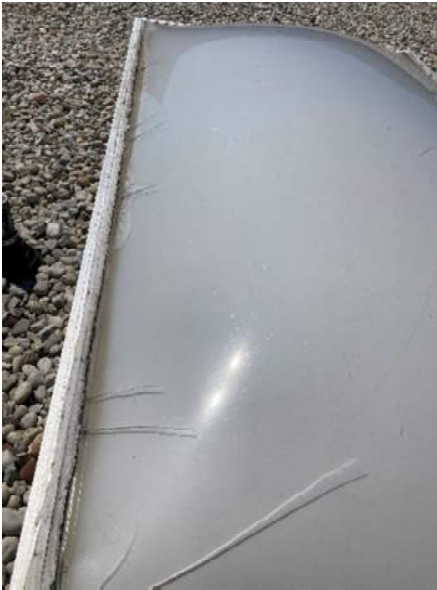
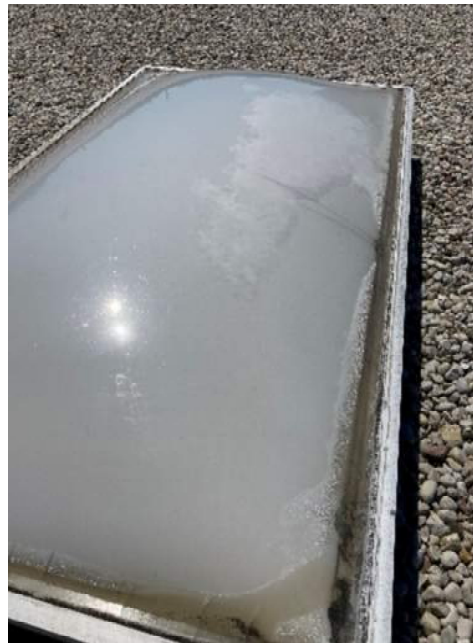
R1: Roof

Description: Two skylights are cracked and need to be replaced

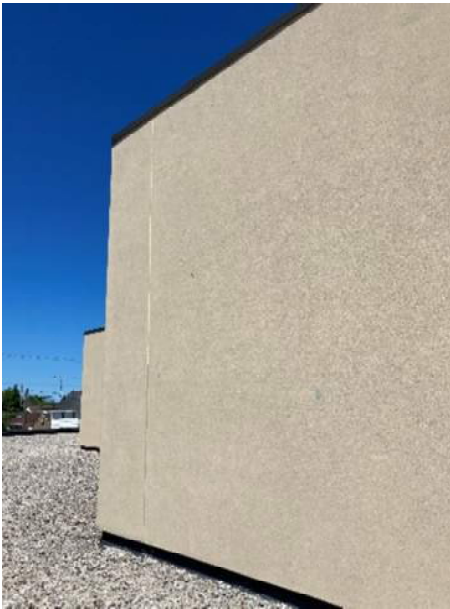
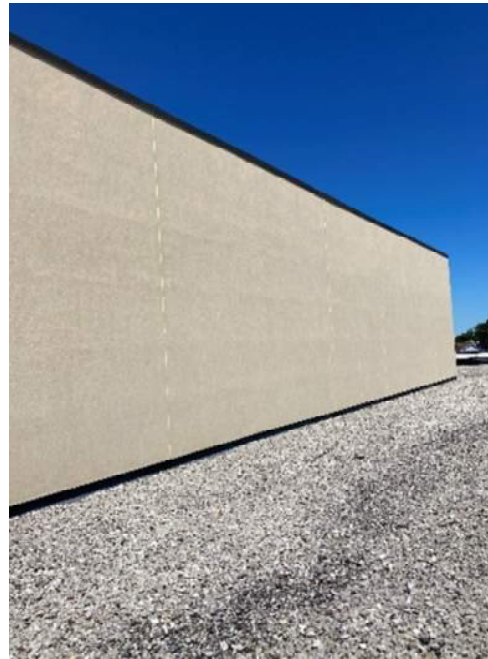
R2: Roof

Description: Caulking needed at wall panels

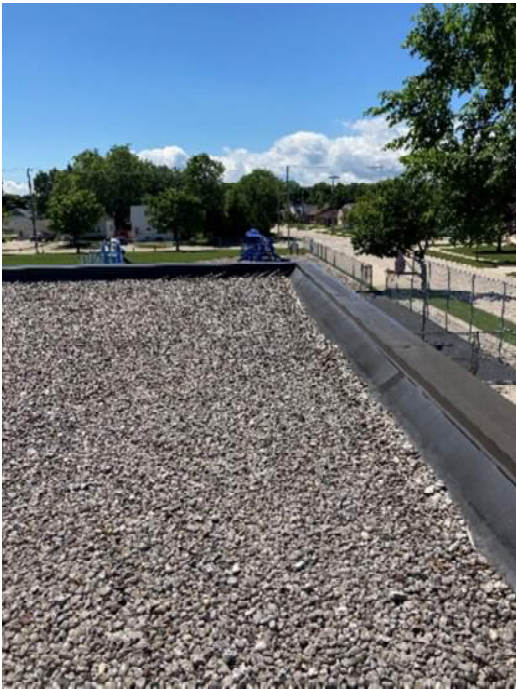
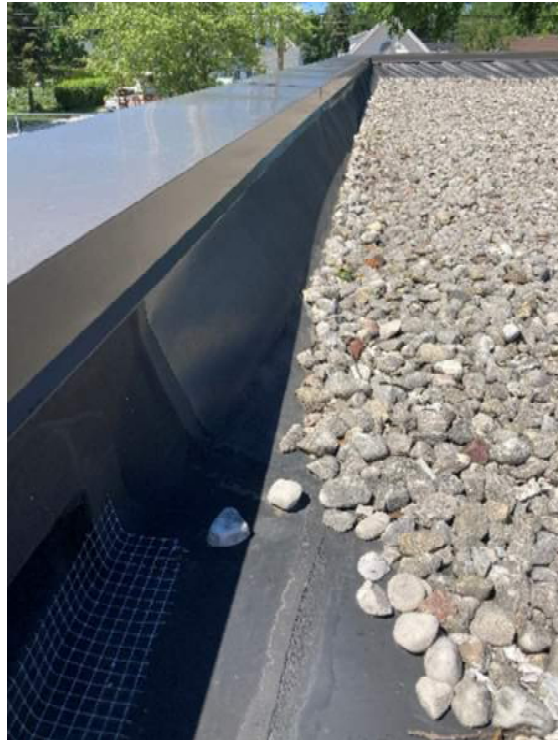
R3: Roof

Description: Pillowing at parapet walls

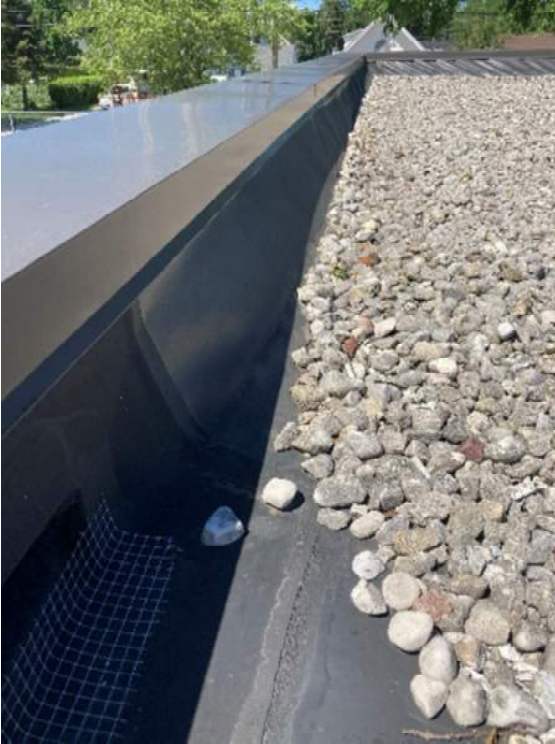
R4: Roof

Description: 5 years left on overall roof

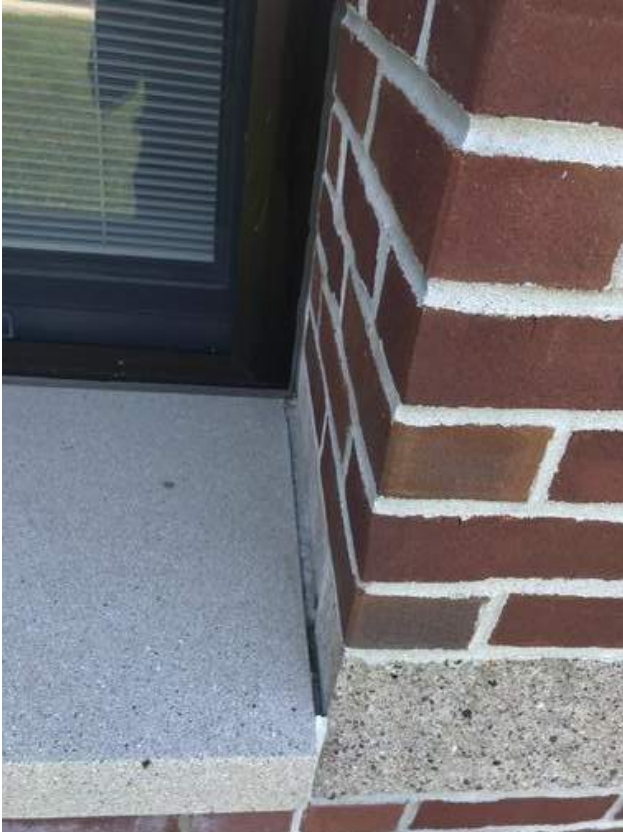
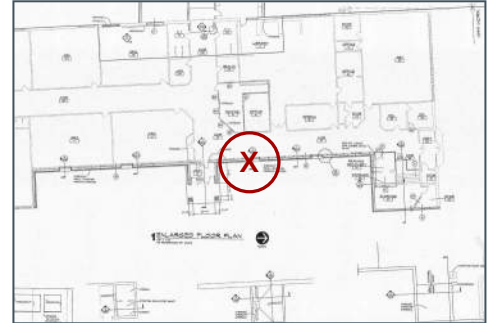
X1: Exterior

Description: Expanded gap between wall and sidewalk

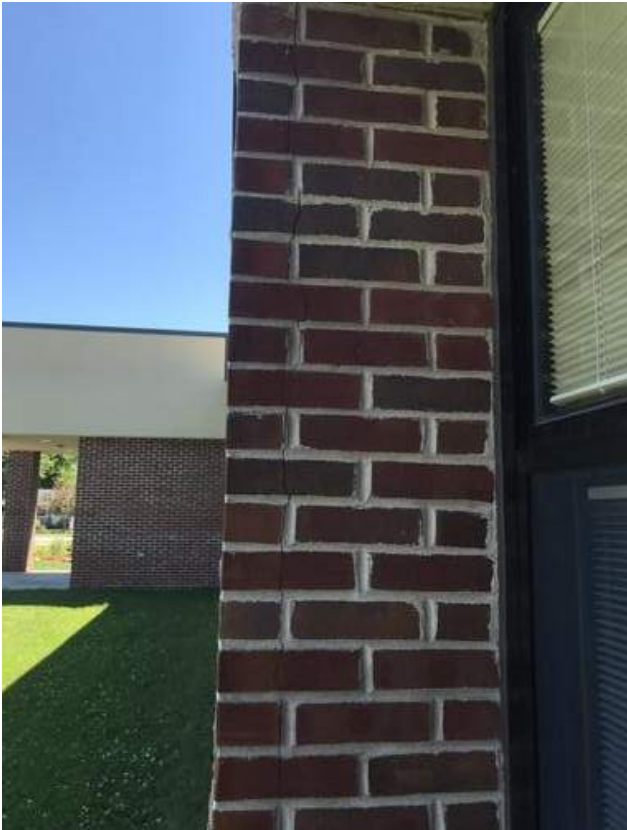
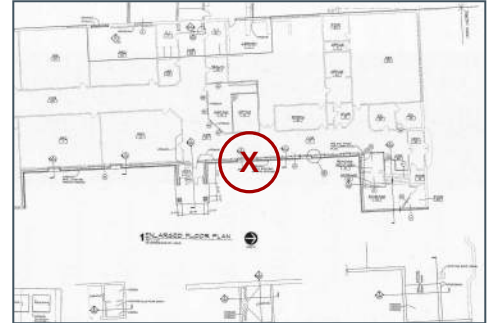
X2: Exterior

Description: Cracks in the wall

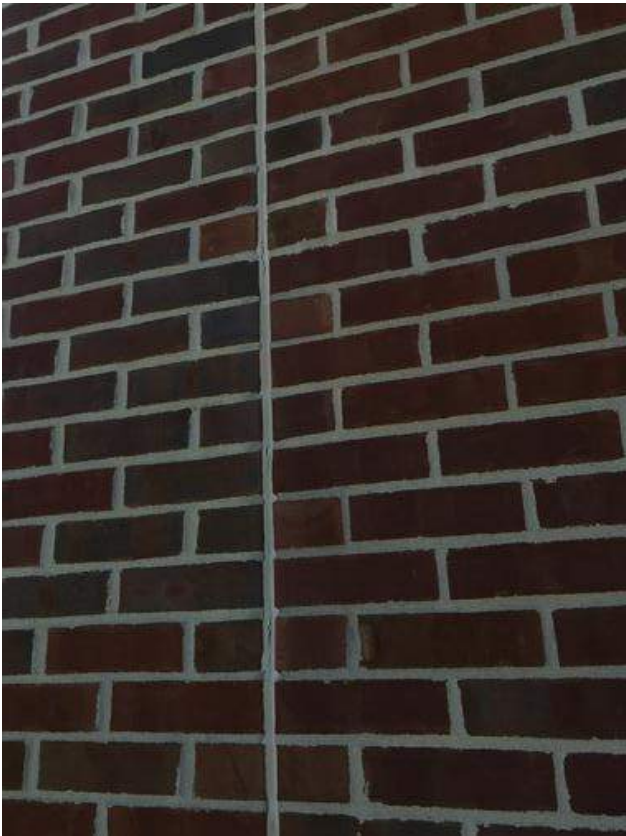
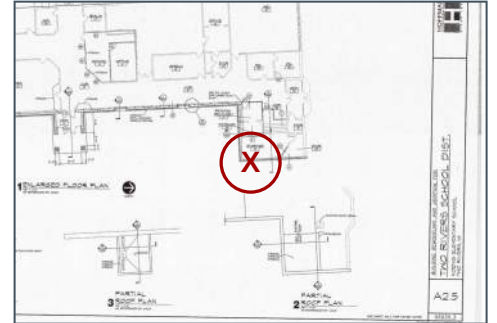
X3: Exterior

Description: Caulking at wall needed

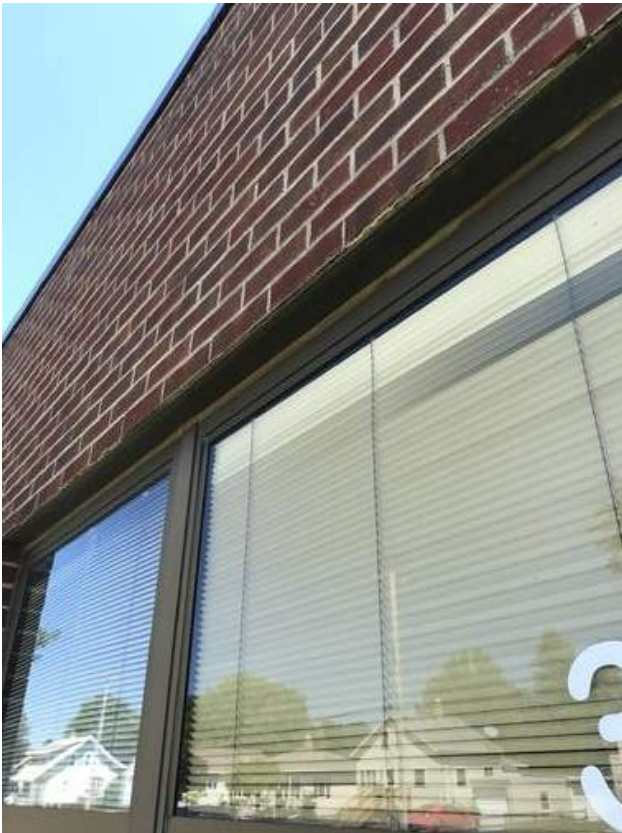
X4: Exterior

Description: Paint needed at all exterior lintels above windows

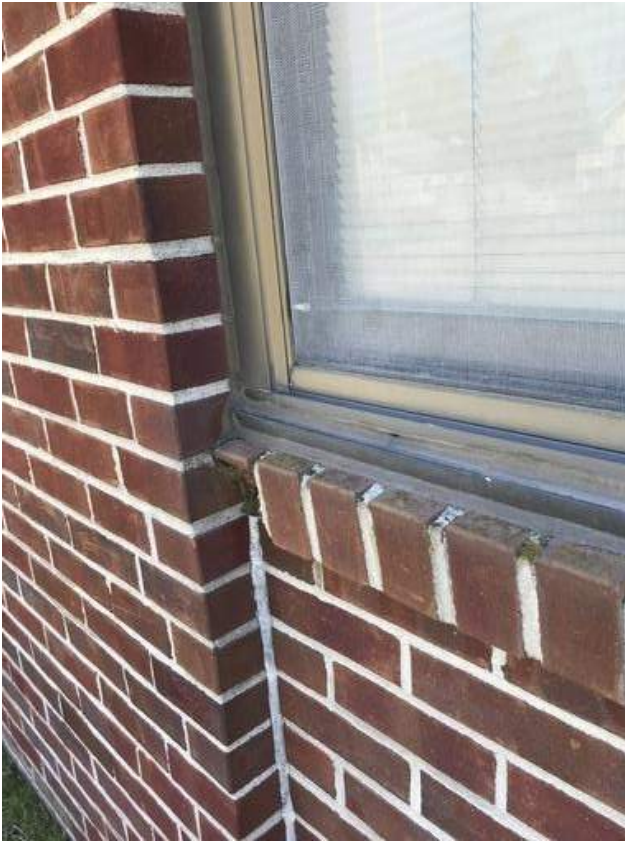
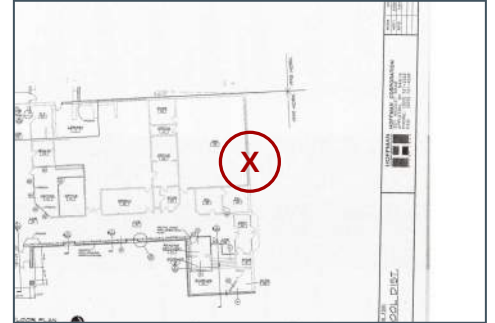
X5: Exterior

Description: Bricks missing from brick ledge

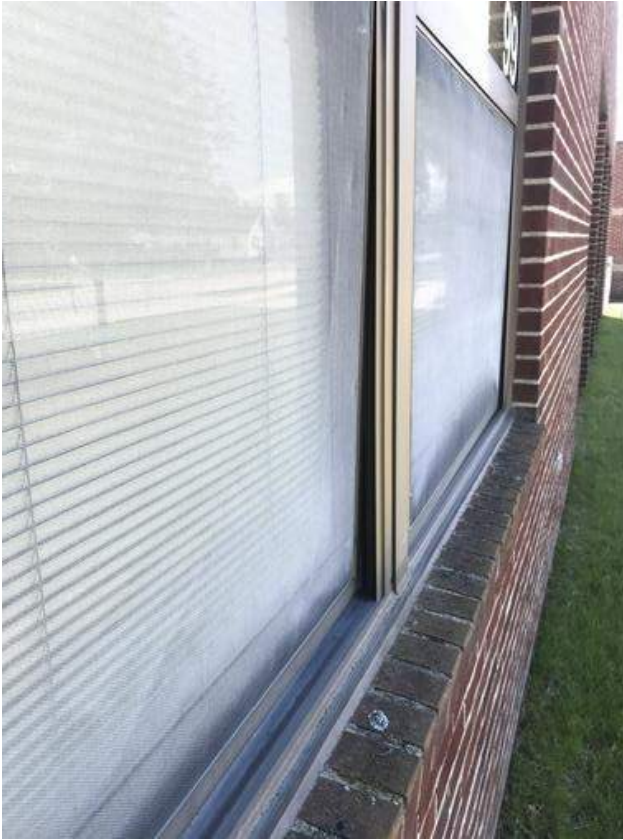
X6: Exterior

Description: Caulking required at all exterior windows

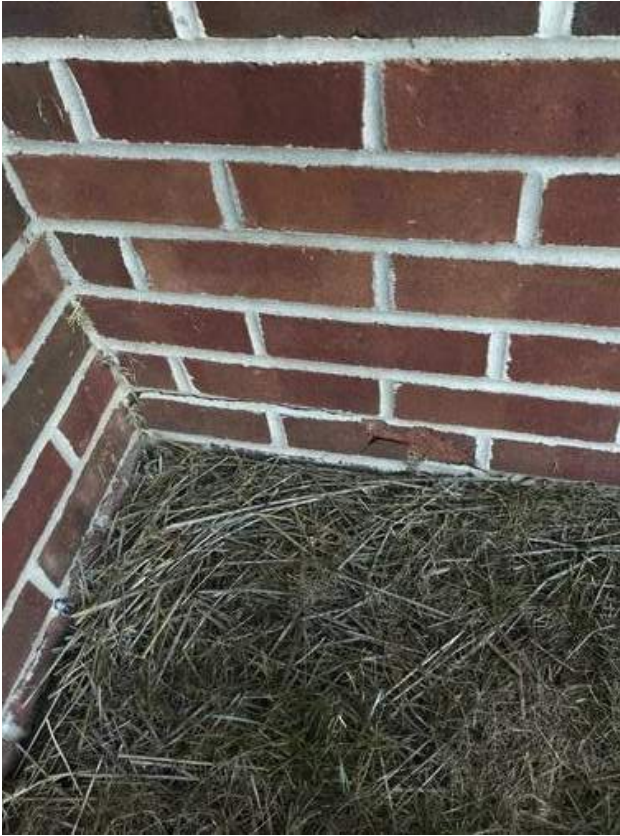
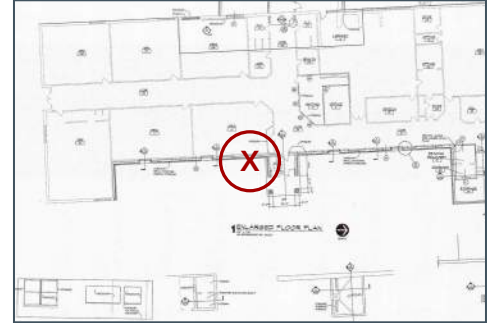
X7: Exterior

Description: Cracked mortar and damaged brick

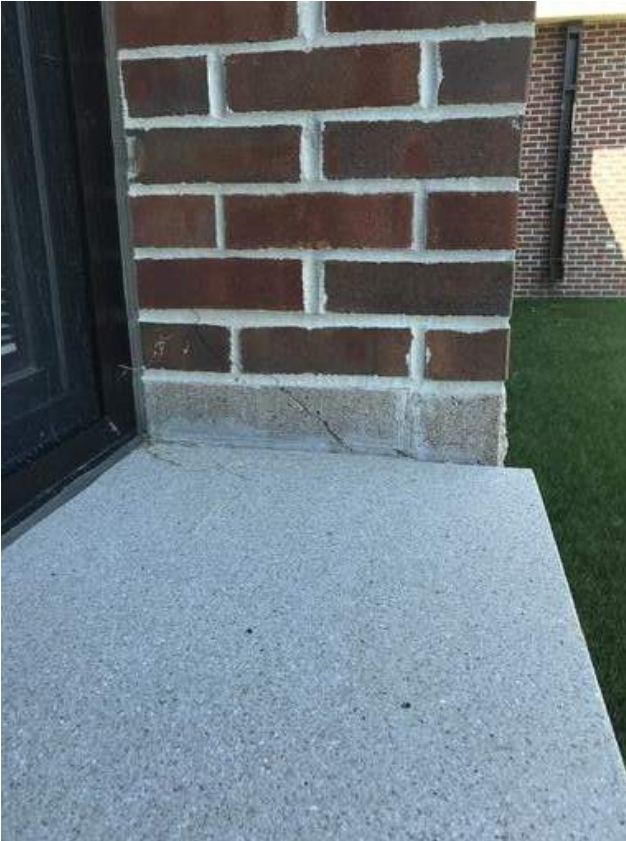
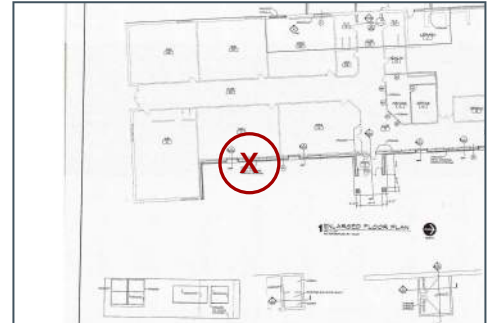
X8: Exterior

Description: Cracked brick

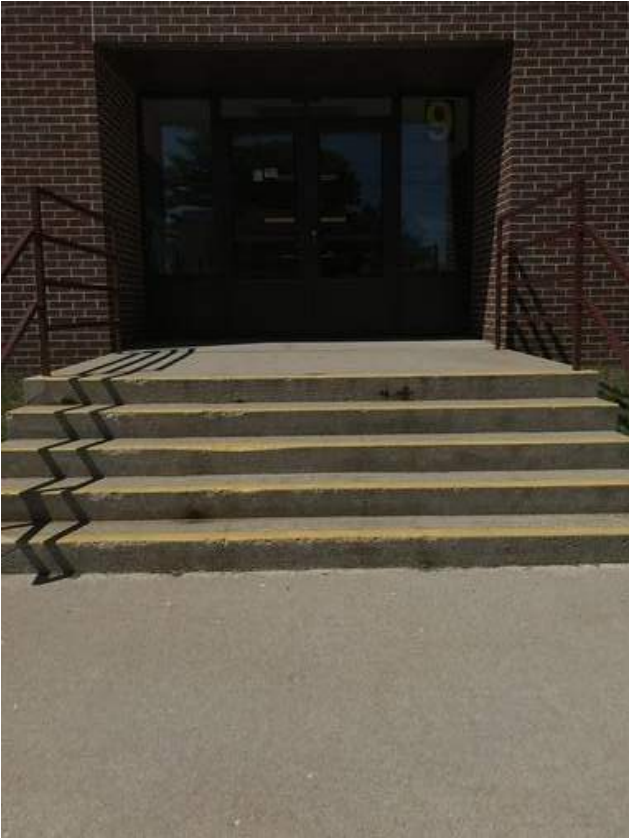
X9: Exterior

Description: Concrete chipped at nosing of steps

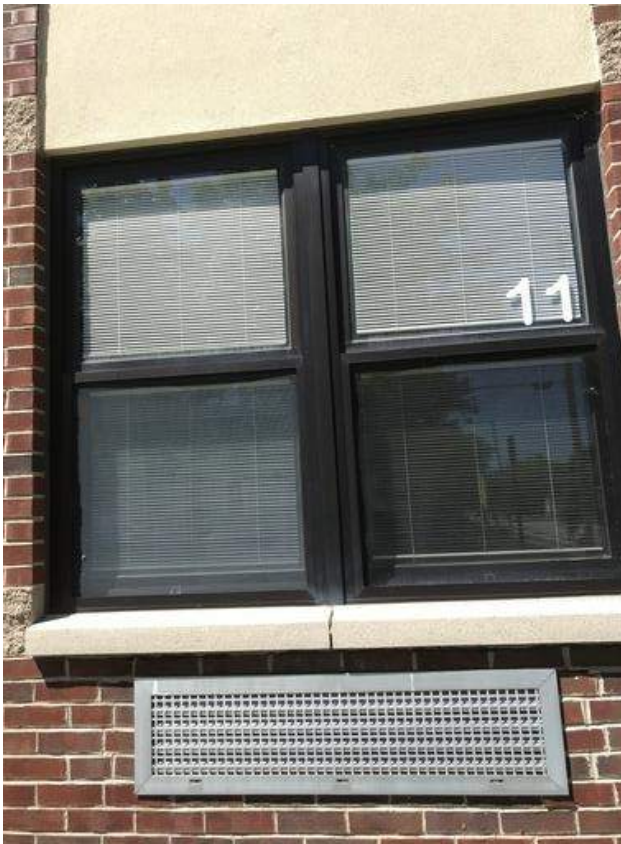
X10: Exterior

Description: Caulking required between window sills
