TWO RIVERS PUBLIC SCHOOLS

FACILITIES ASSESSMENT REPORT

08.19.21

Two Rivers School District Facilities Assessment July 2021

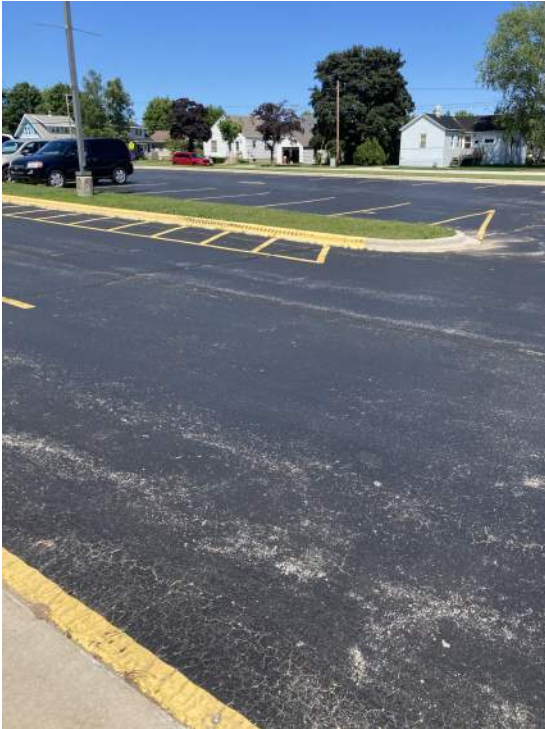
S1: Site Work

Description: Cracks in asphalt, five years left

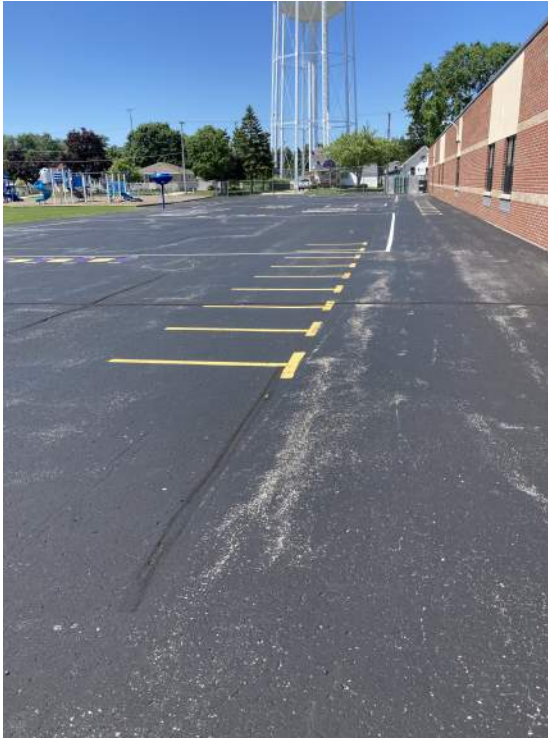
S2: Site Work

Description: Cracks in asphalt, five years left

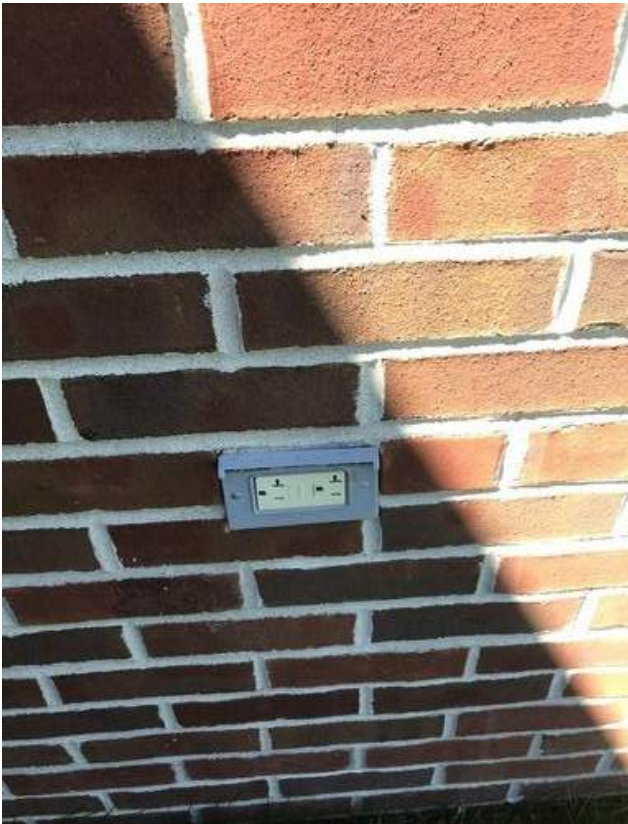
E2: Electrical

Description: Electrical receptacle needs cover

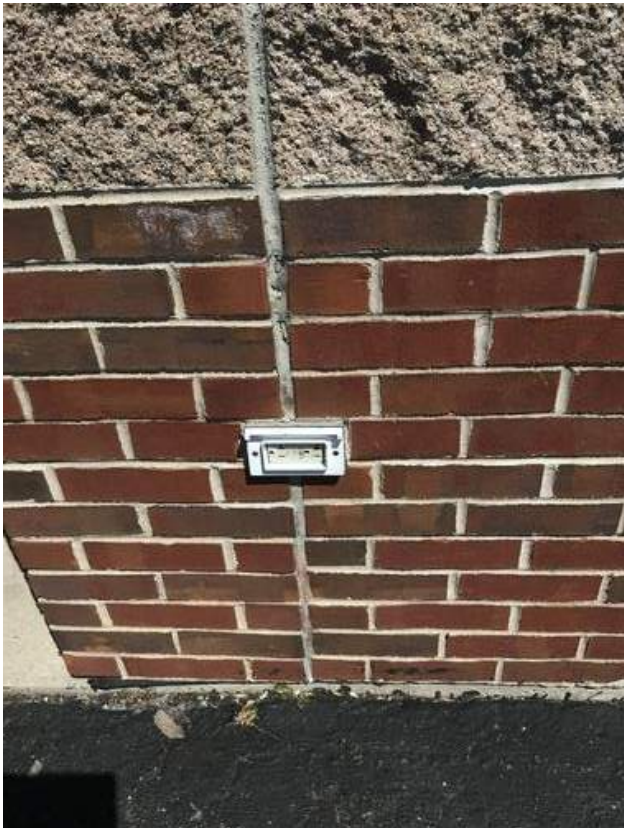
E3: Electrical

Description: Electrical receptacle needs cover

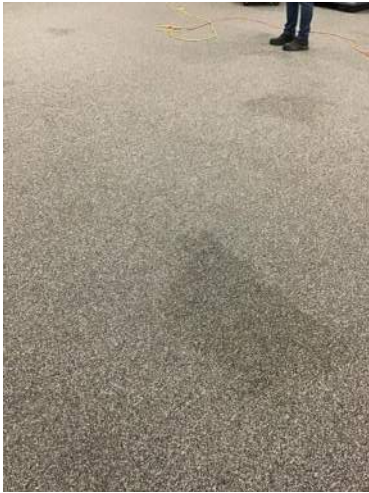
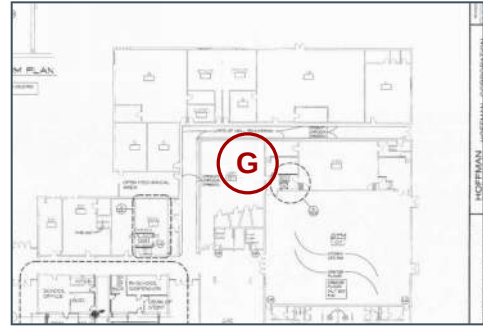
Sheet
A2.1

Description: Stained carpet

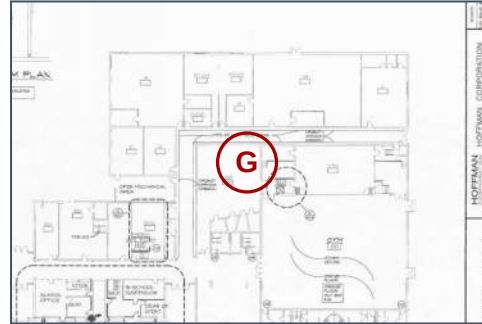
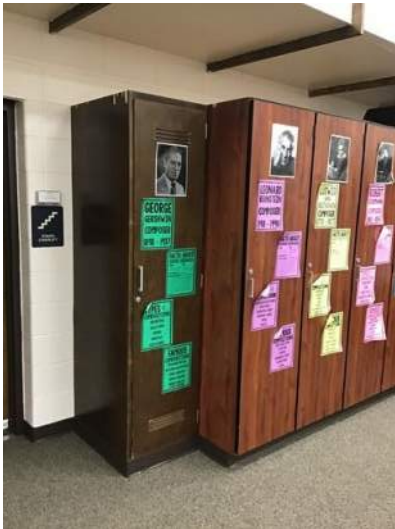
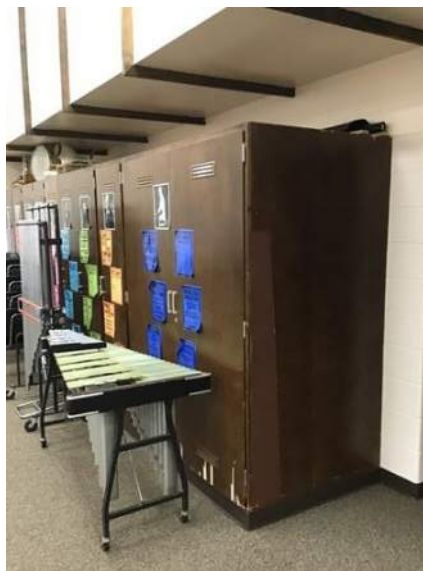
G2: General

Description: Cabinet Damages

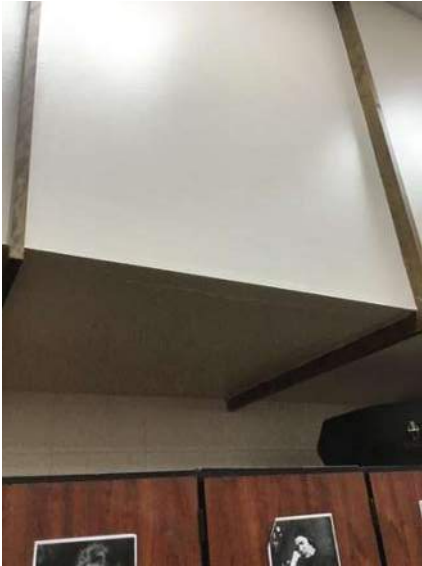
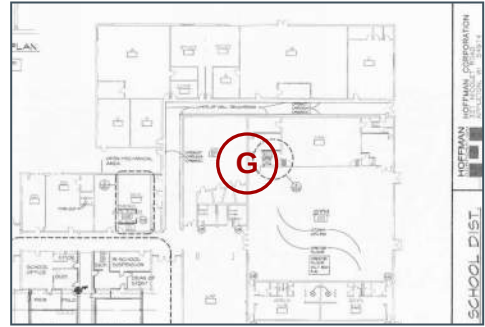
G3: General

Description: Paint is bubbling

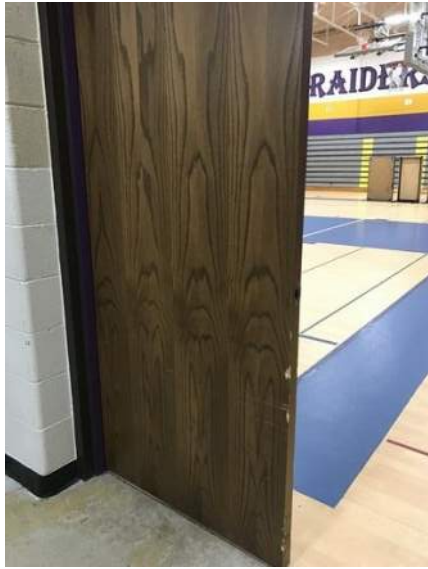
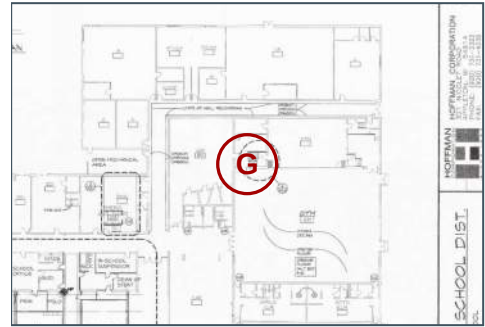
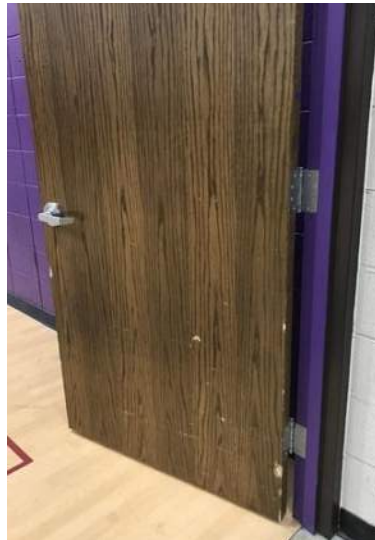
G4: General

Description: Scratched doors

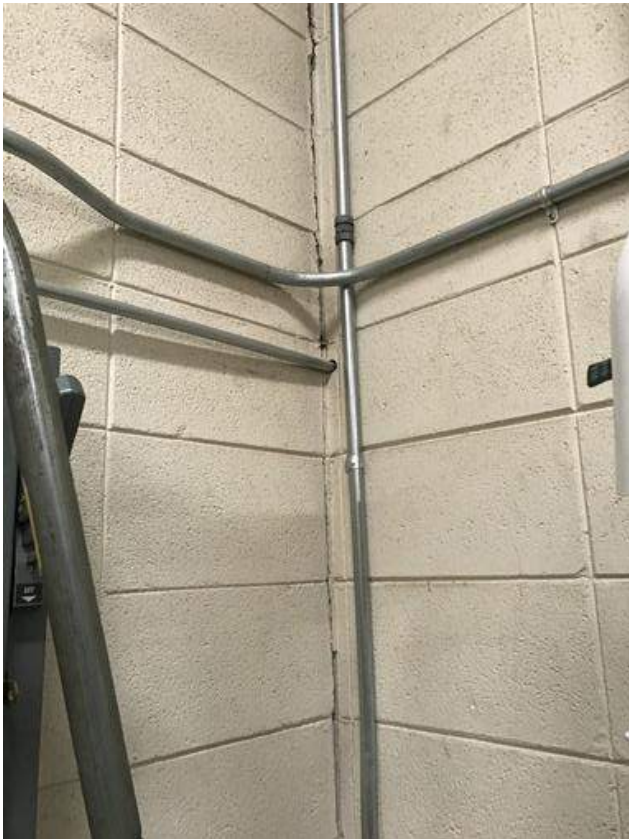
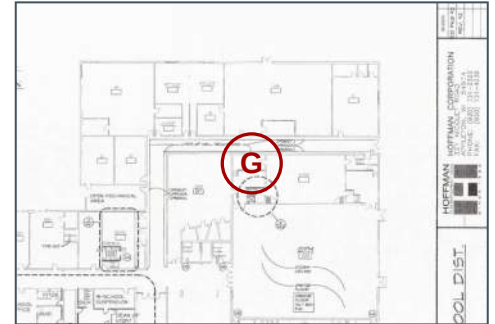
G5: General

Description: Crack in CMU wall

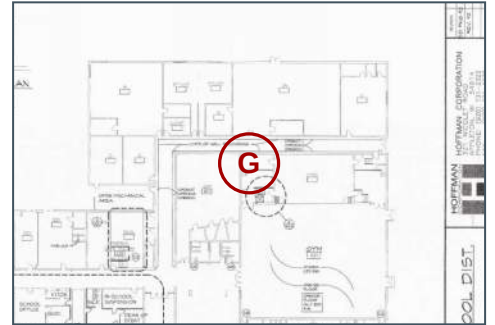
G6: General

Description: Holes in CMU wall

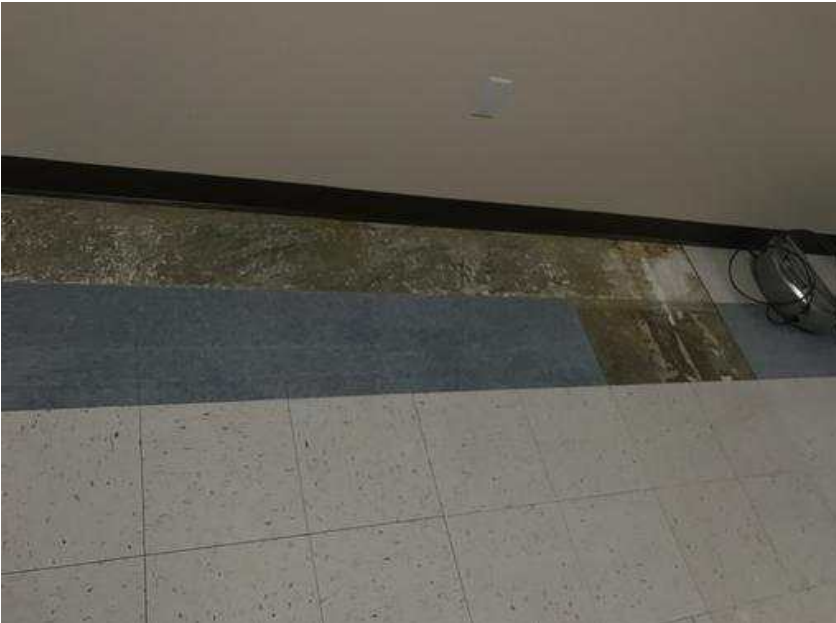
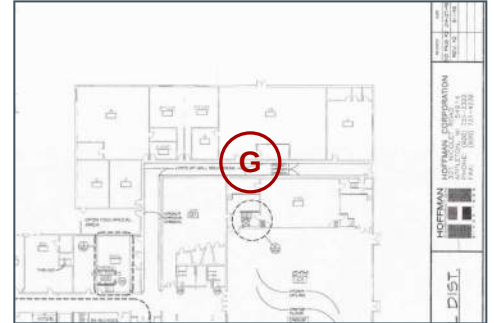
G7: General

Description: Missing VCT tile

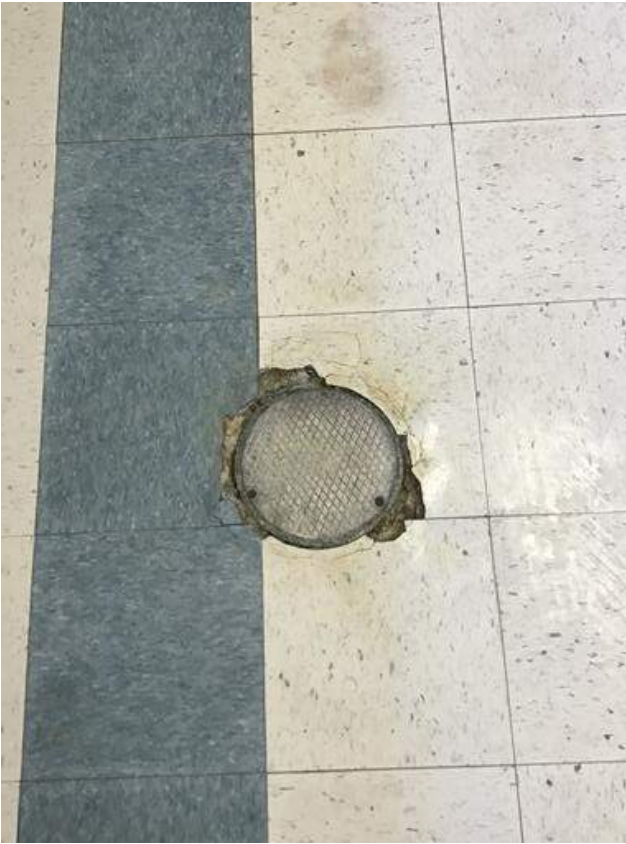
G8: General

Description: Cracked VCT around floor cover

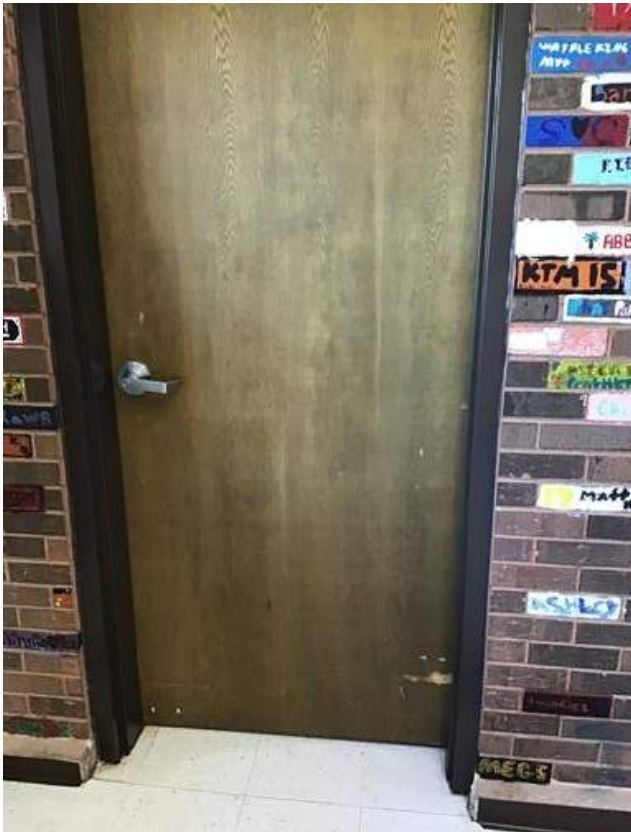
G9: General

Description: Scratched door

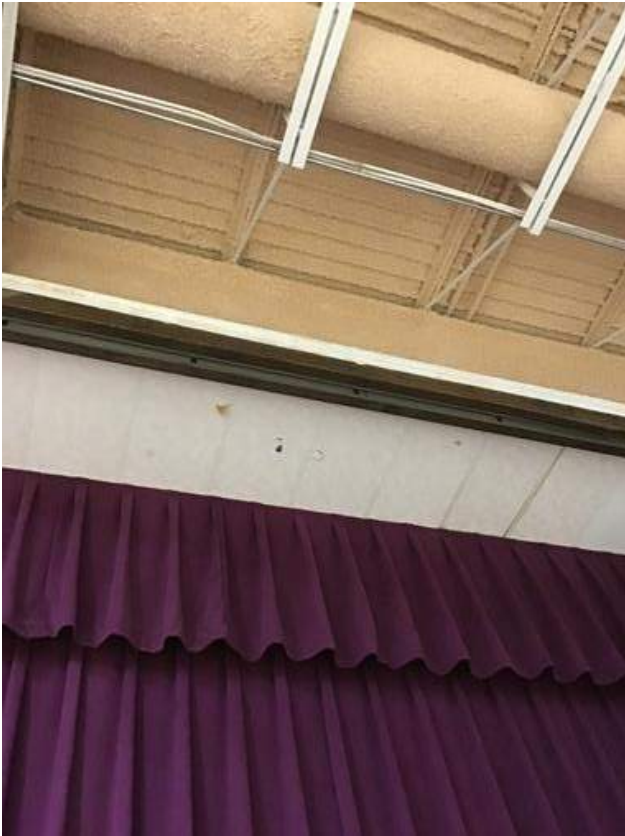
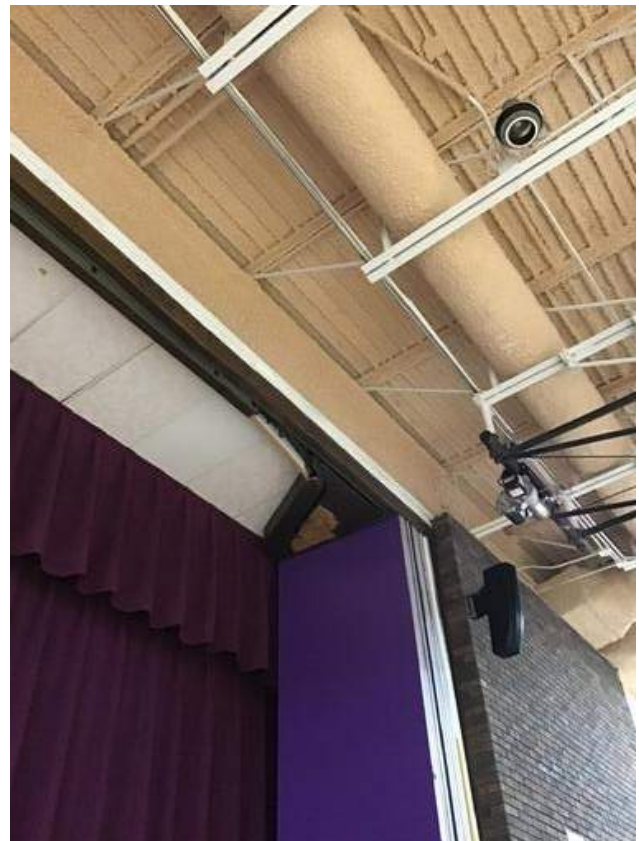
G11: General

Description: Damaged ceiling above stage

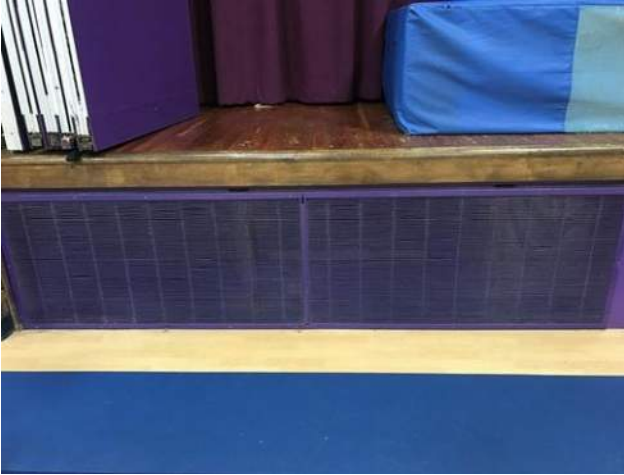
G12: General

Description: Bent Vent

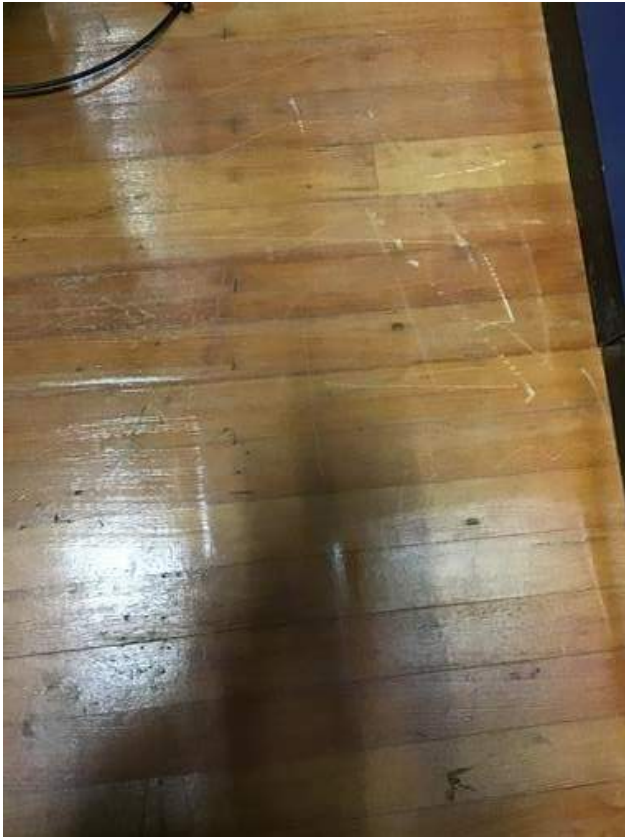
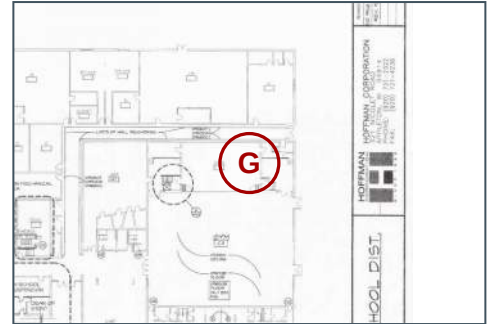
G13: General

Description: Scratch of floor finish of stage

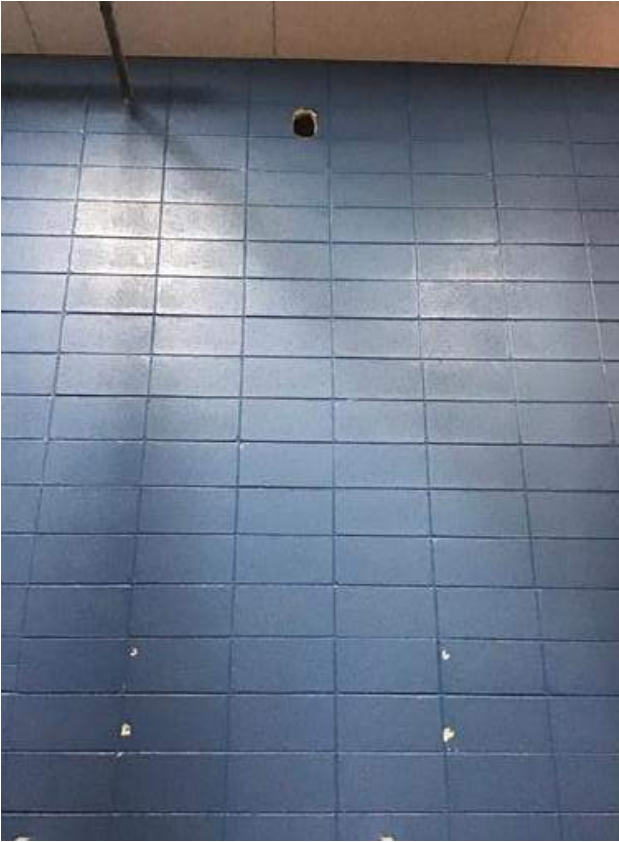
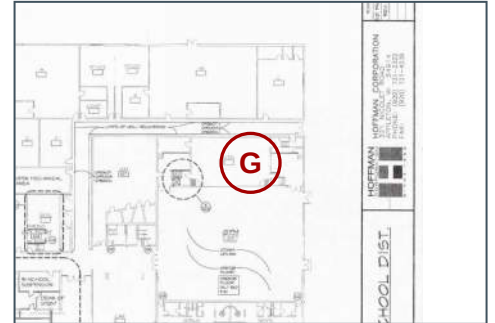
G14: General

Description: Hole in CMU wall

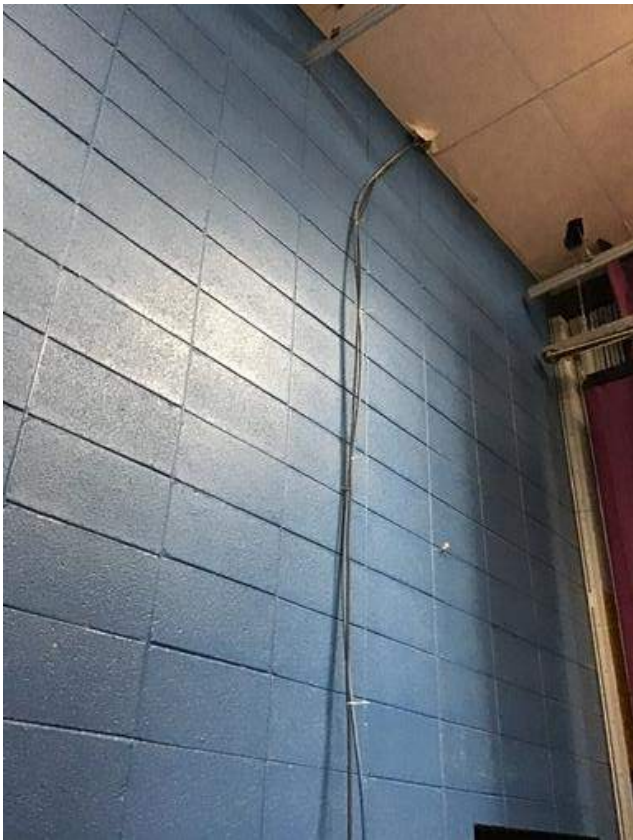
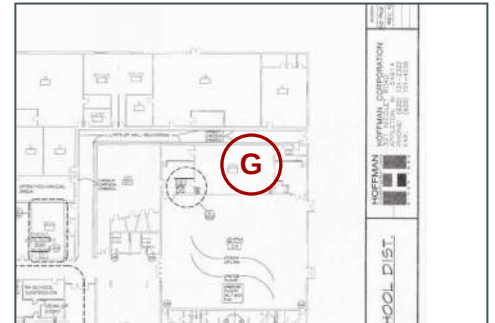
G15: General

Description: Damaged ACT

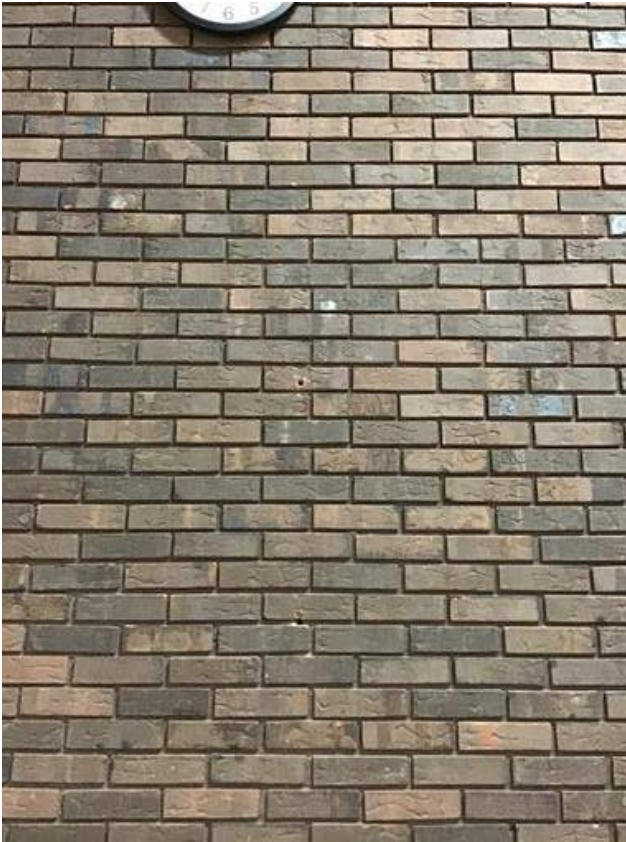
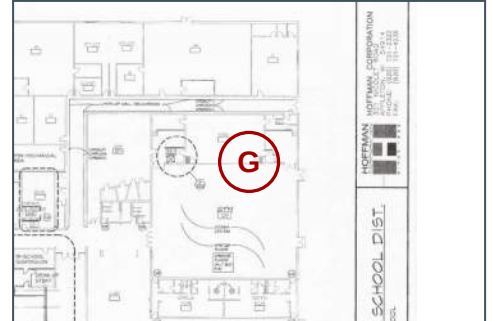
G16: General

Description: Holes in brick wall

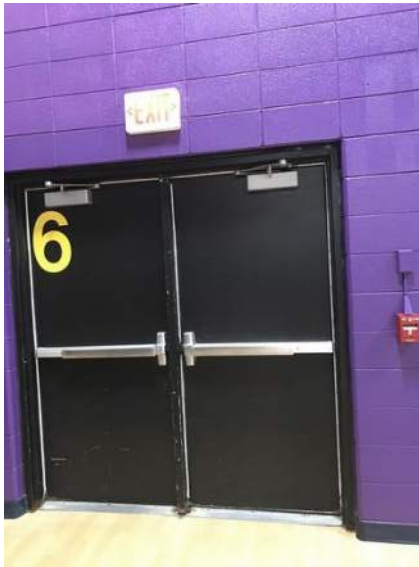
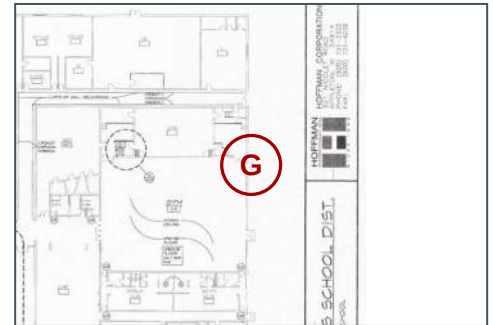
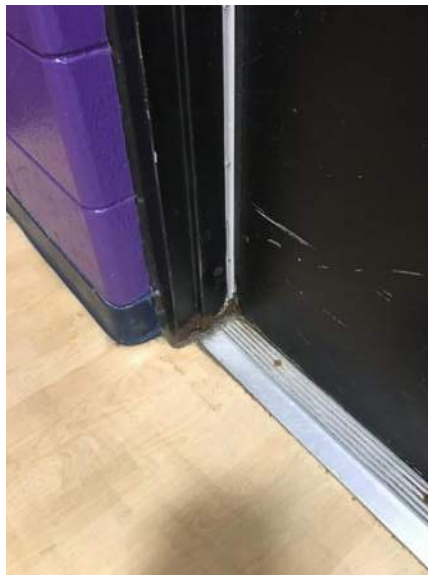
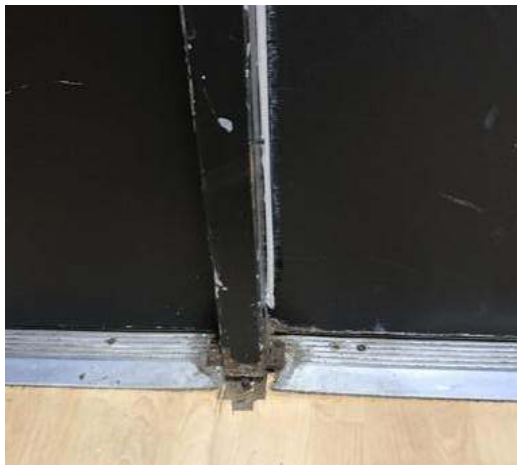
G17: General

Description: Scratched doors and rusted door frames at base

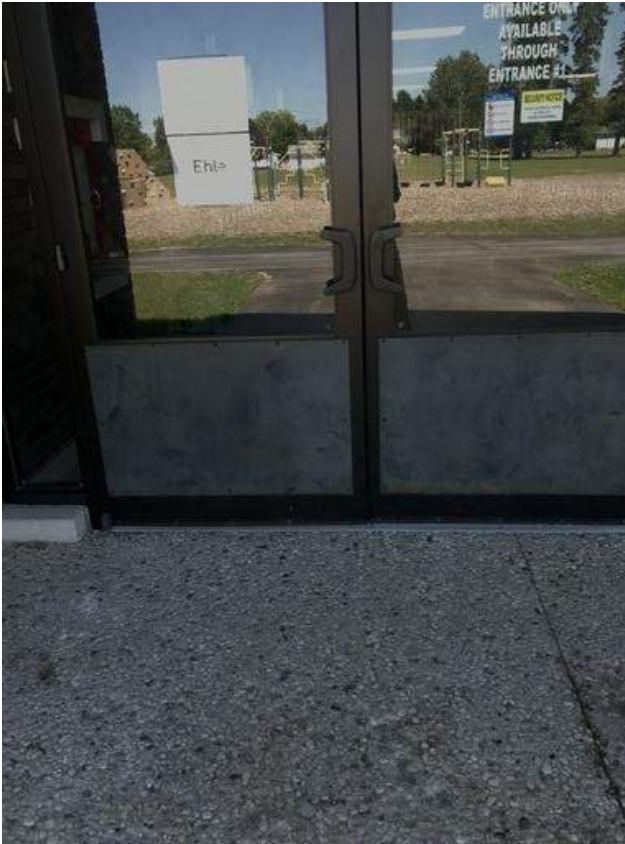
G24: General

Description: Scratched exterior door

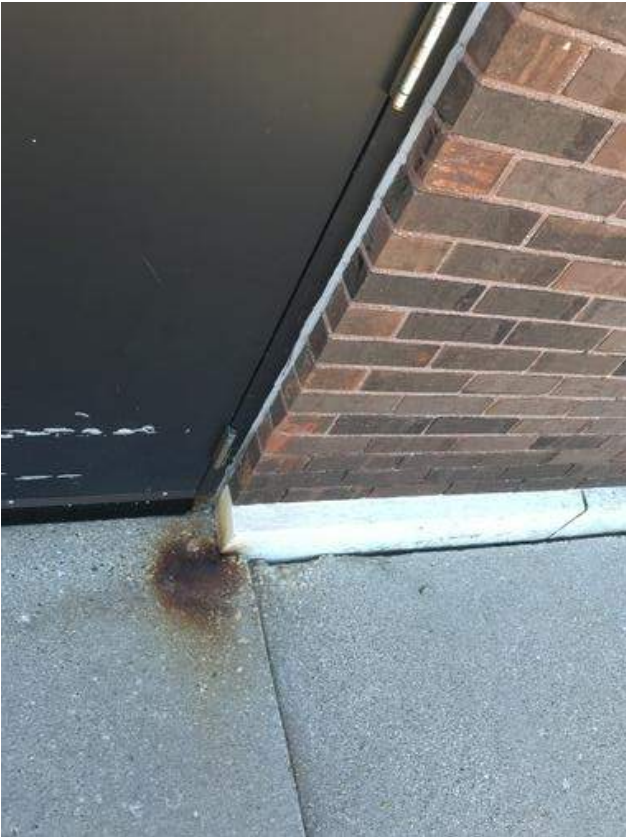
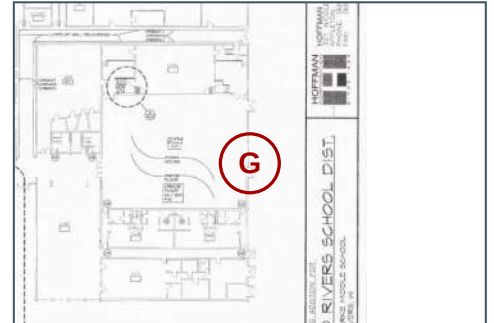
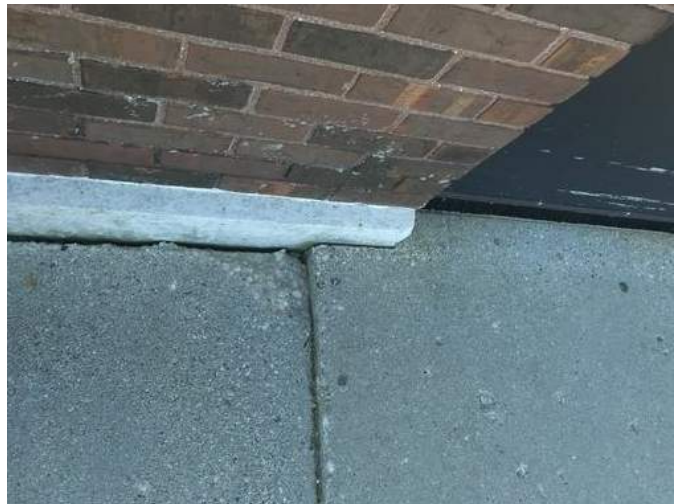
G25: General

Description: Scratched doors and rusted door frames at base

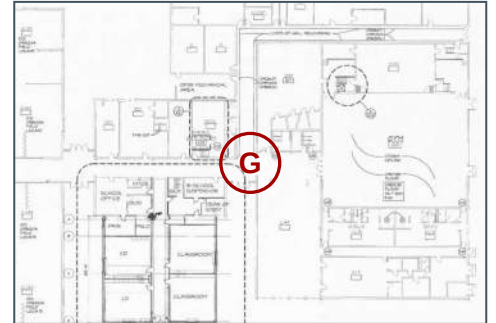
G29: General

Description: Cracks in flooring

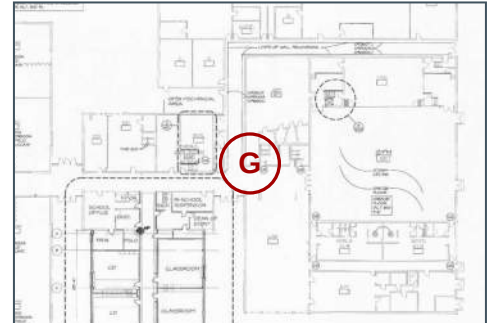
G30: General

Description: Crack in flooring

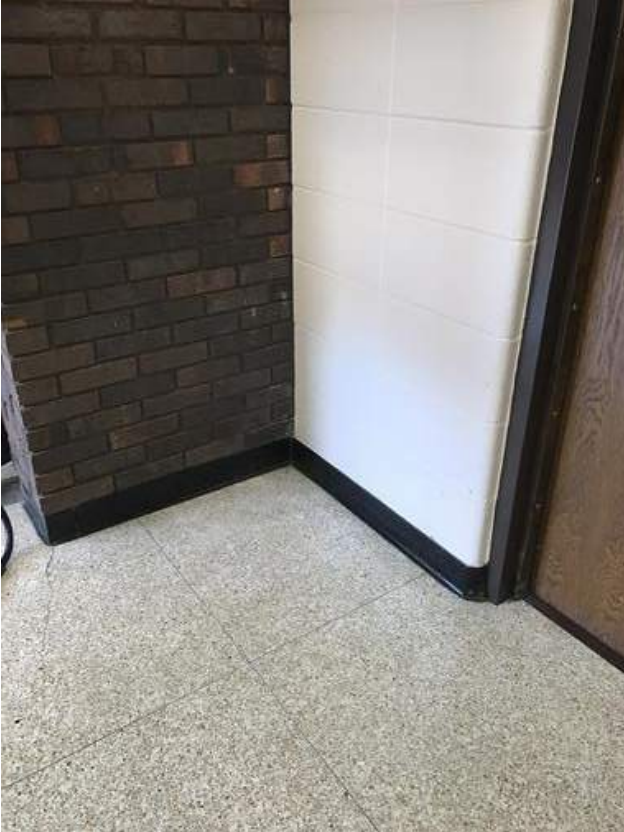
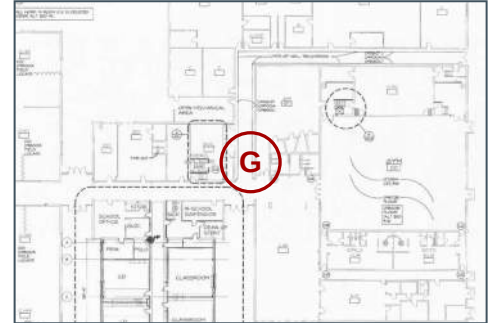
G31: General

Description: Cracks in VCT flooring

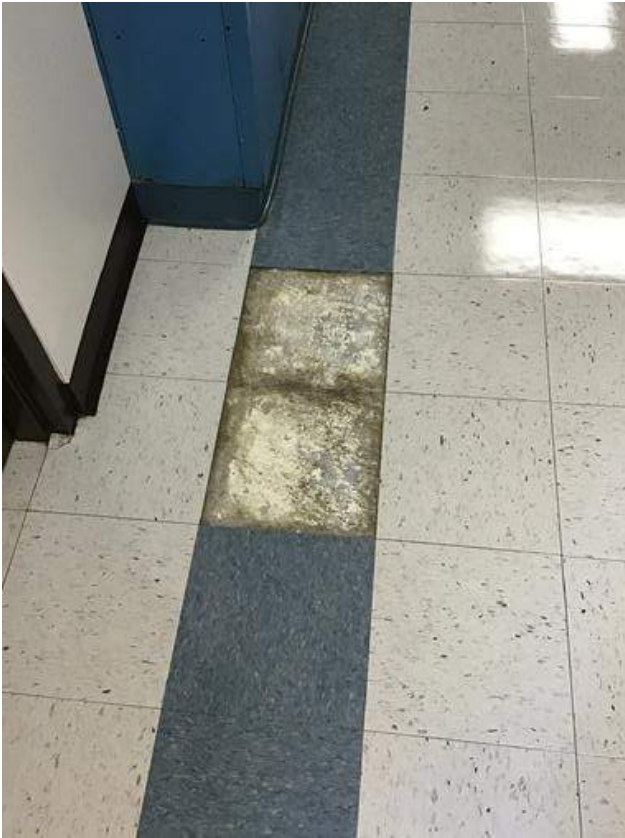
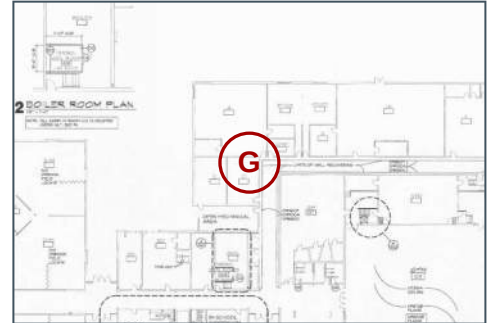
G34: General

Description: Scratched door, cracked and missing VCT

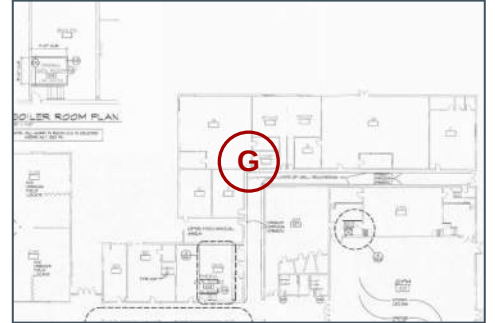
G35: General

Description: Damaged ACT ceiling

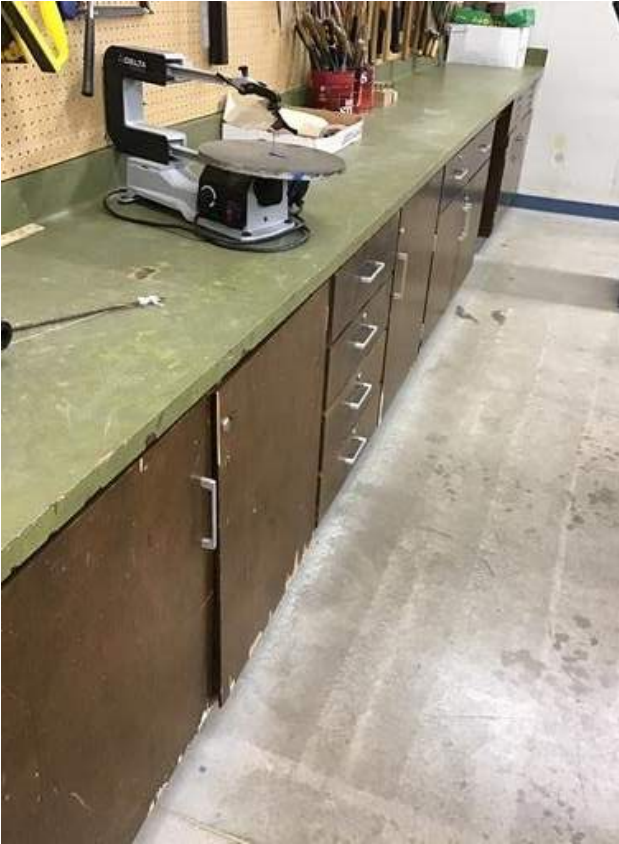
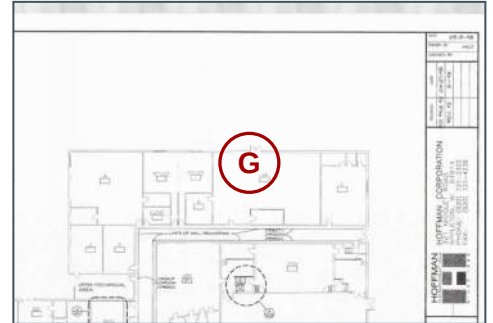
G38: General

Description: Wall damages and scratches

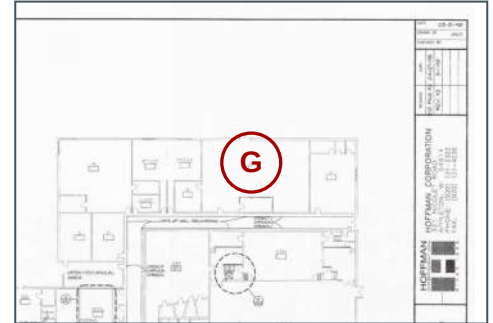
G39: General

Description: Cracks in CMU wall

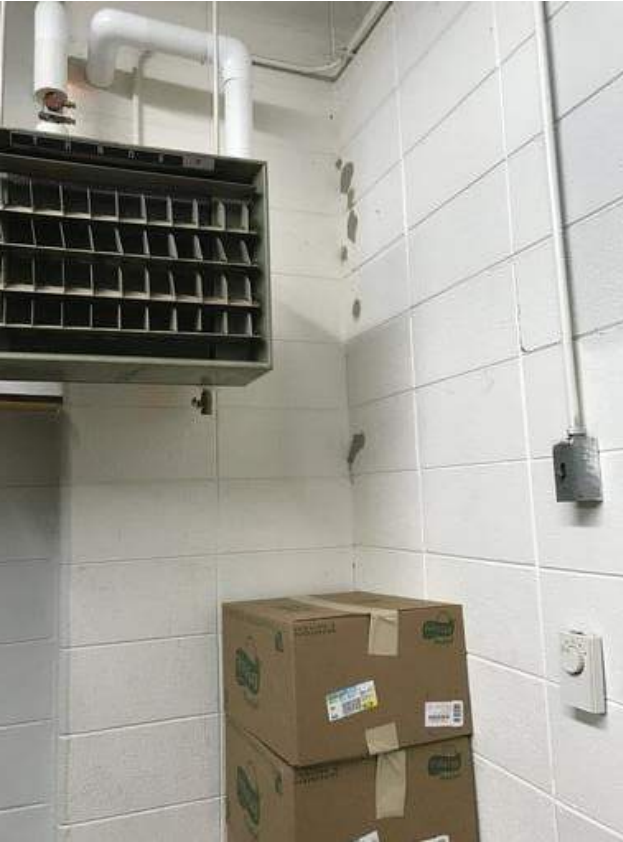
G40: General

Description: Chips in CMU wall

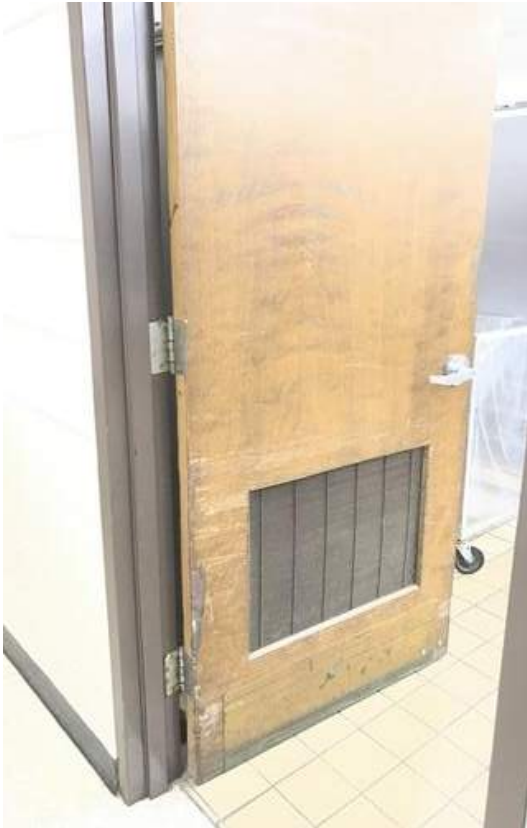
G41: General

Description: Damaged wood door

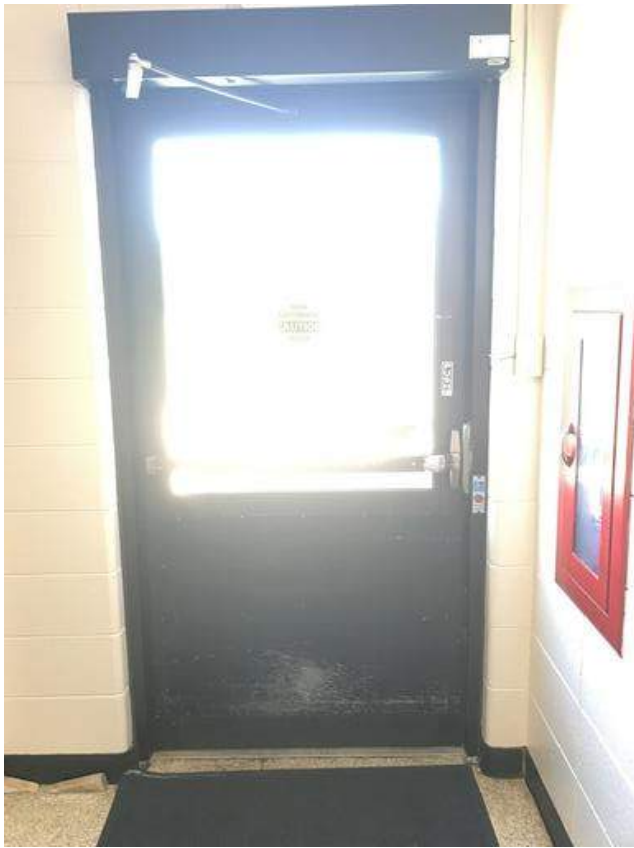
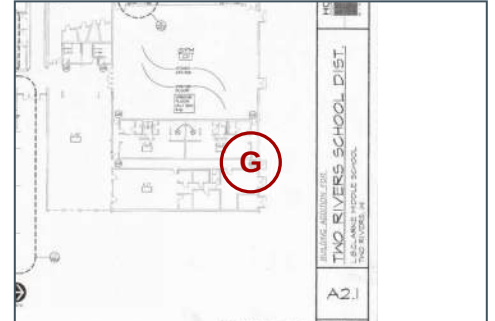
G43: General

Description: Scratched door

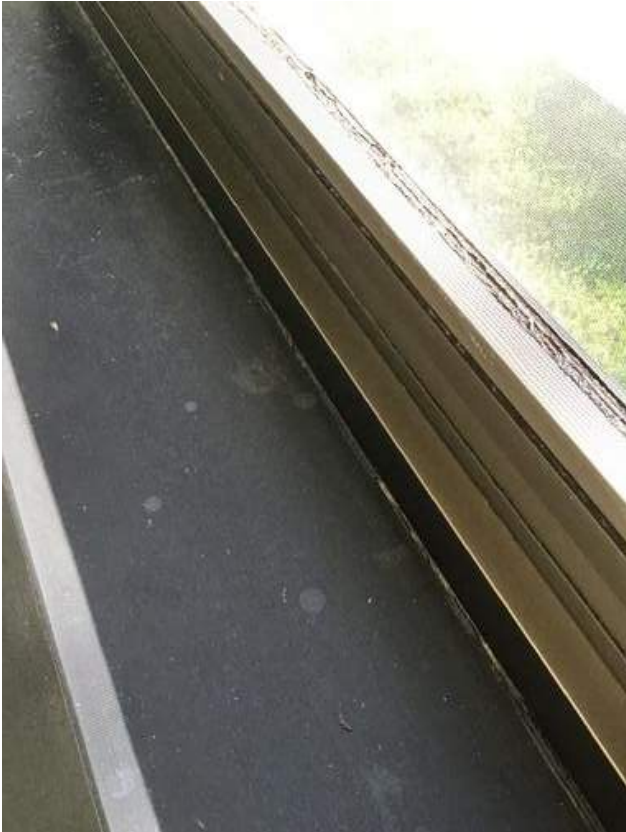
G44: General

Description: Caulk needed at window

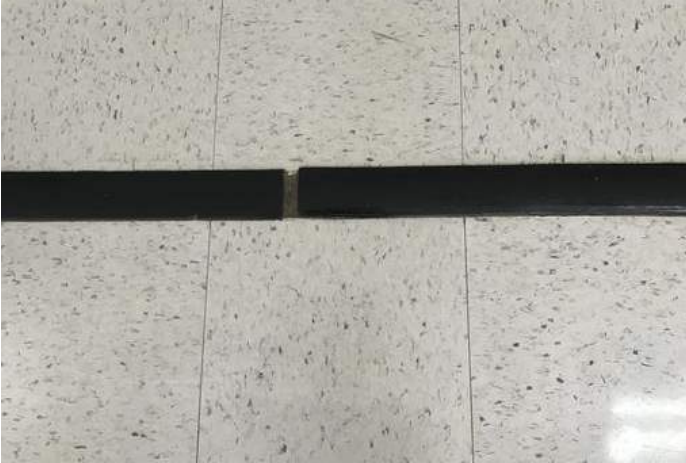
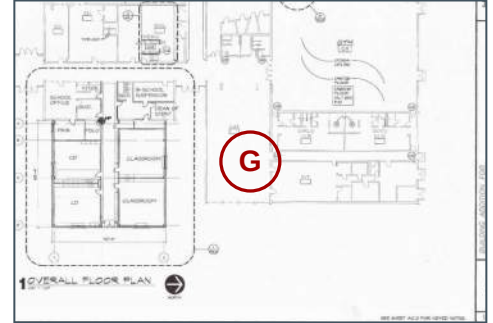
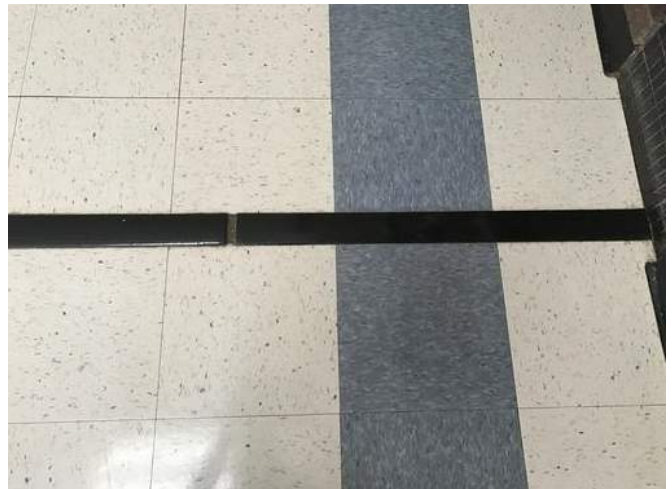
G45: General

Description: Gap between rubber transition

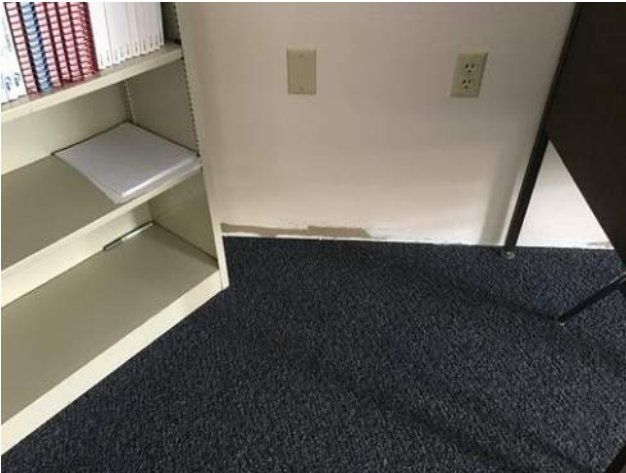
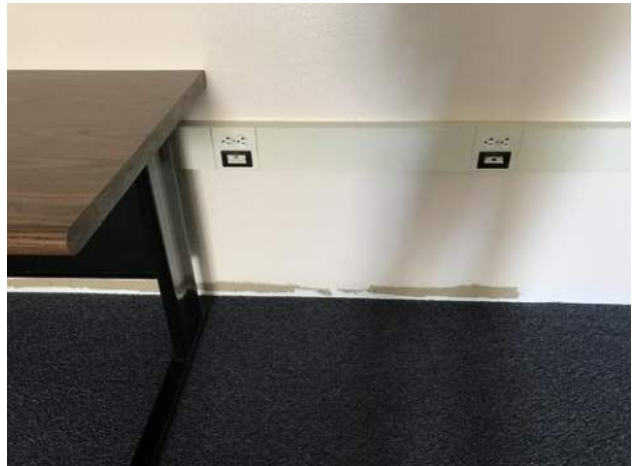
G46: General

Description: Missing wall base

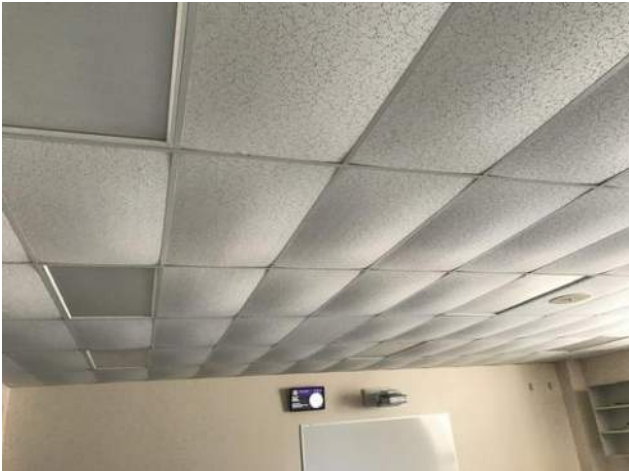
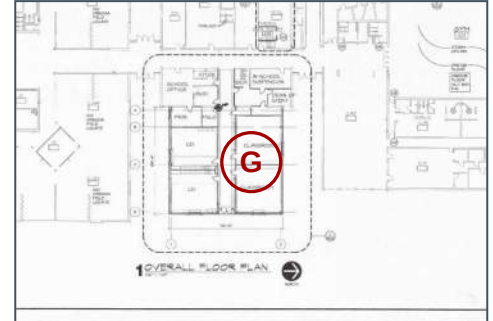
G47: General

Description: Warped ACT

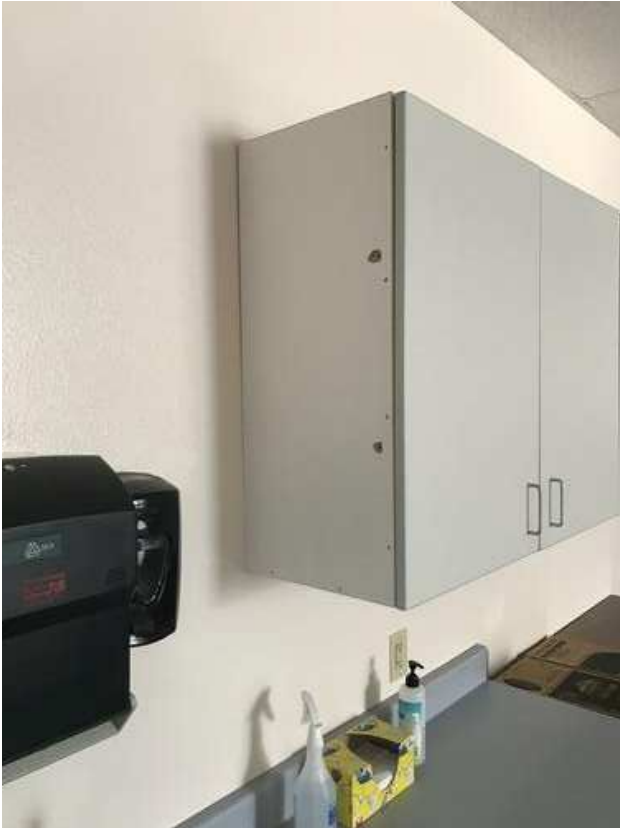
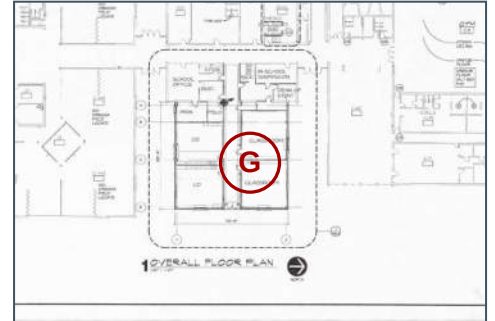
G48: General

Description: Scuffs in casework

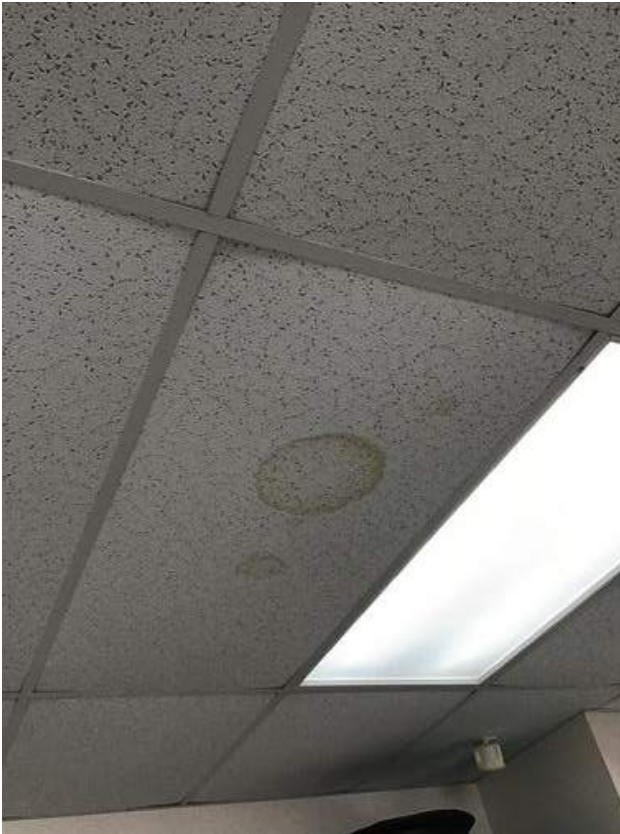
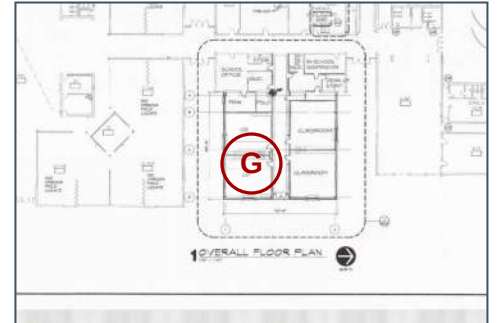
G54: General

Description: Stained ACT

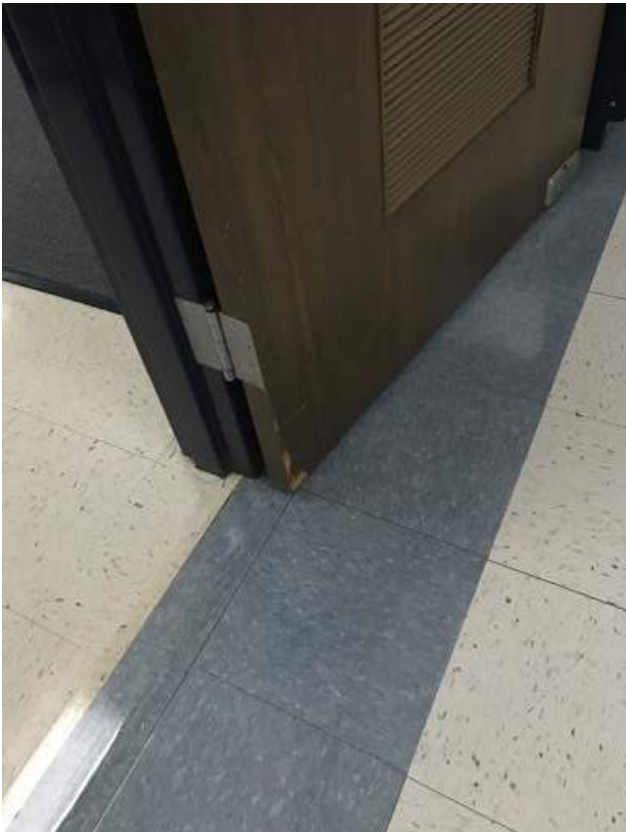
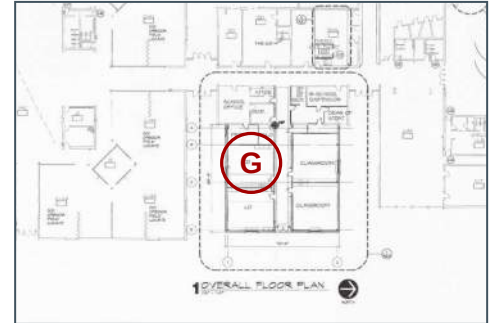
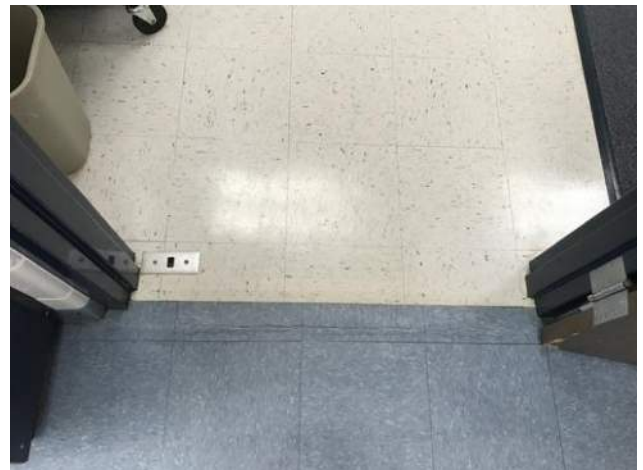
G55: General

Description: Cracks at the door entry way and door damages

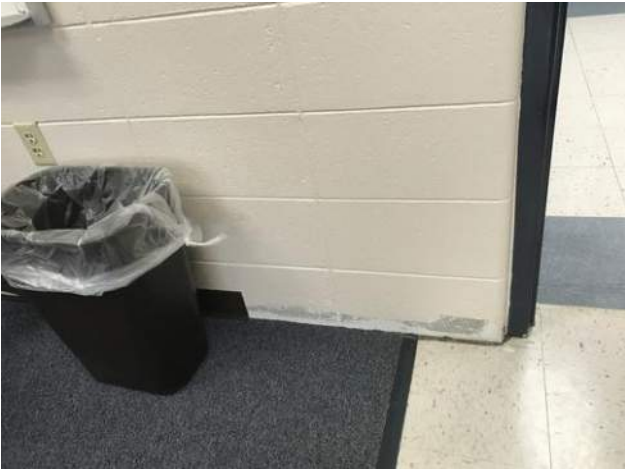
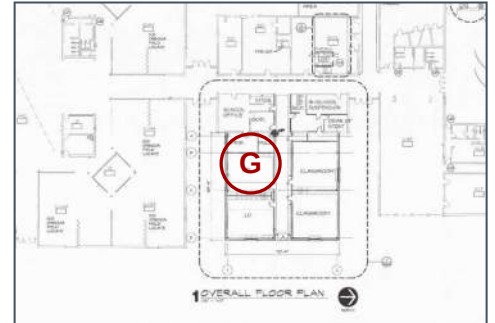
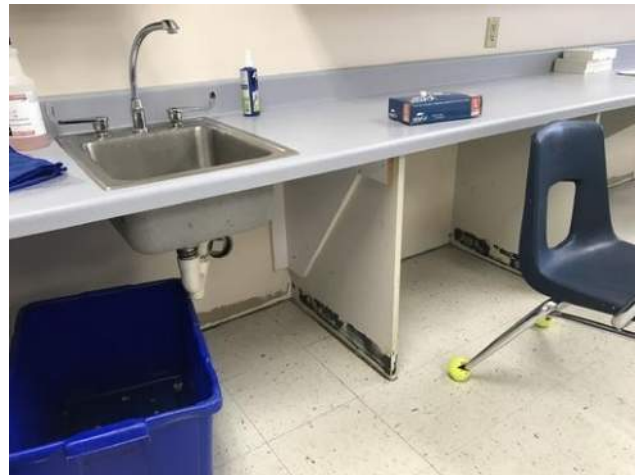
Description: Missing rubber base
