TWO RIVERS PUBLIC SCHOOLS

FACILITIES ASSESSMENT REPORT

08.19.21

Two Rivers School District Facilities Assessment July 2021

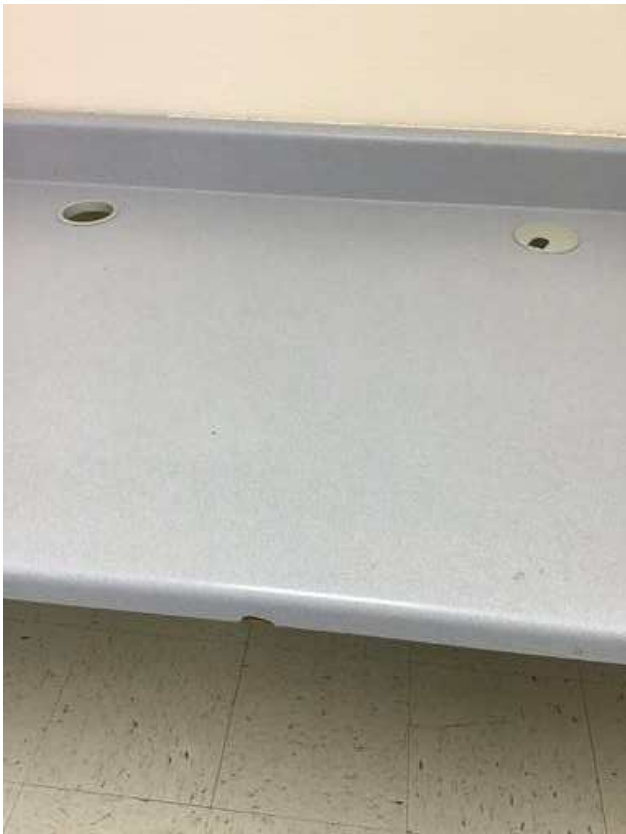
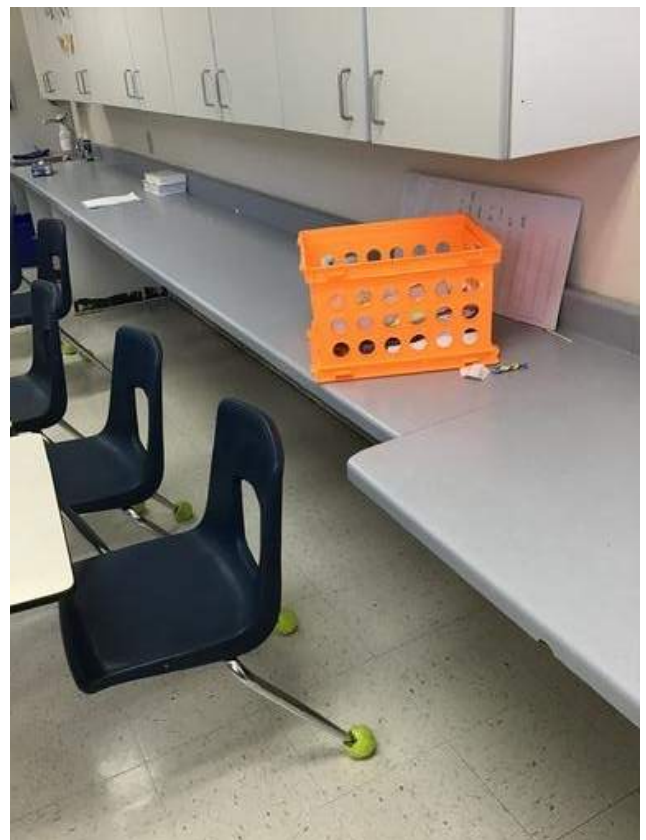
G57: General

Description: Chipped P-Lam

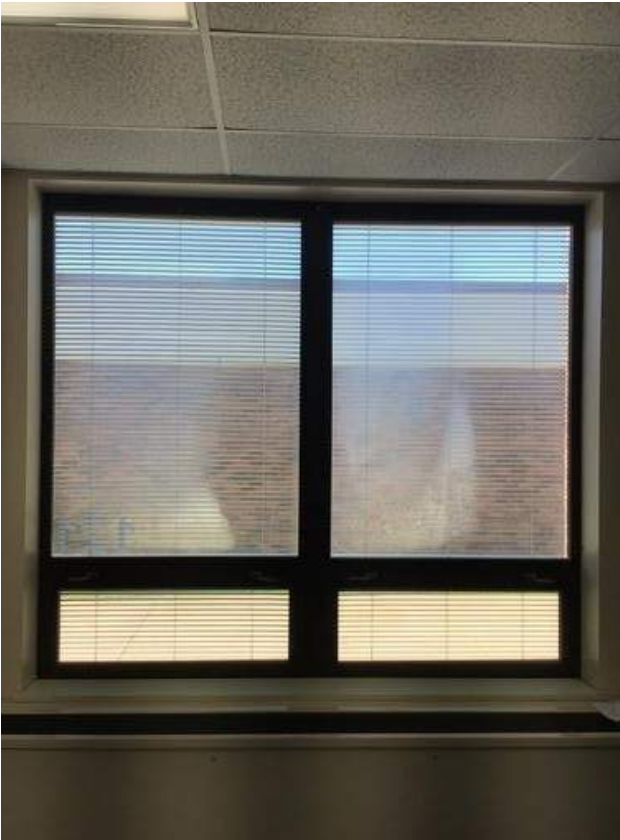
G58: General

Description: Window needs caulking

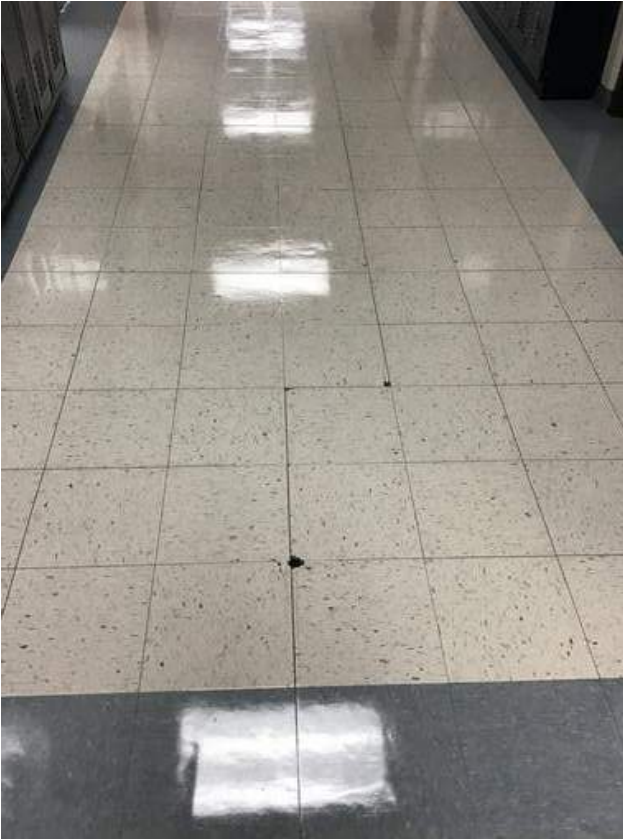
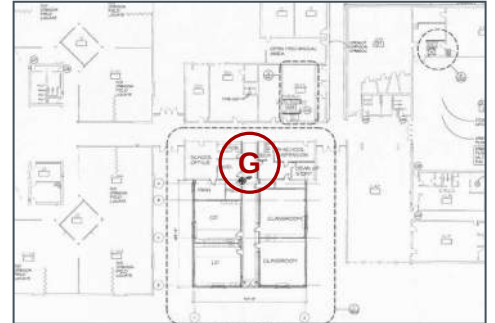
G59: General

Description: Cracks in VCT tile

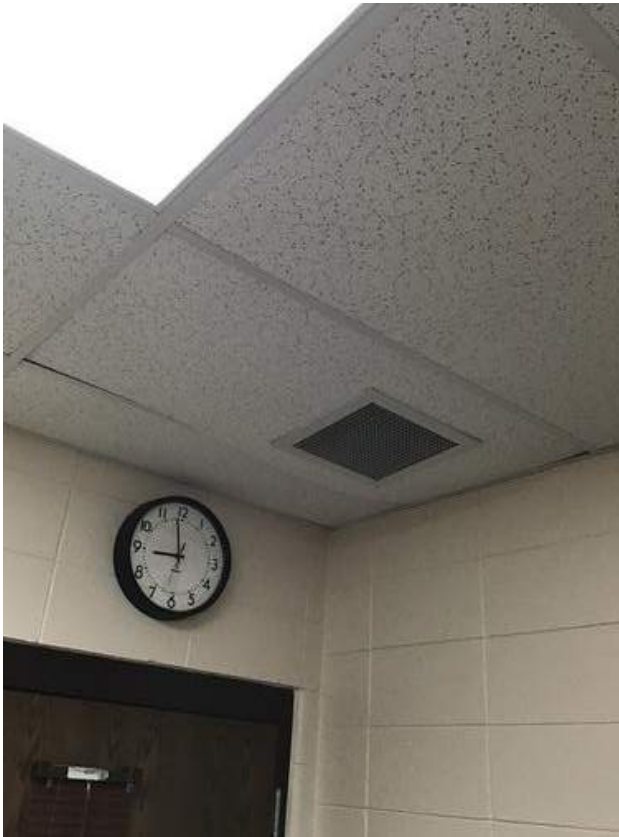
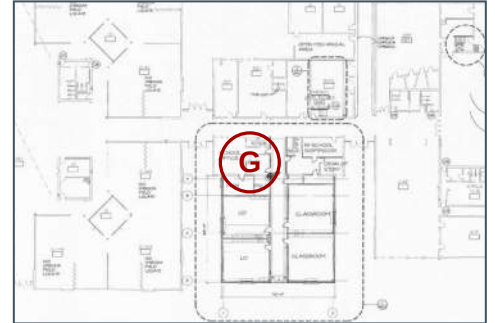
G60: General

Description: Warped ACT tile

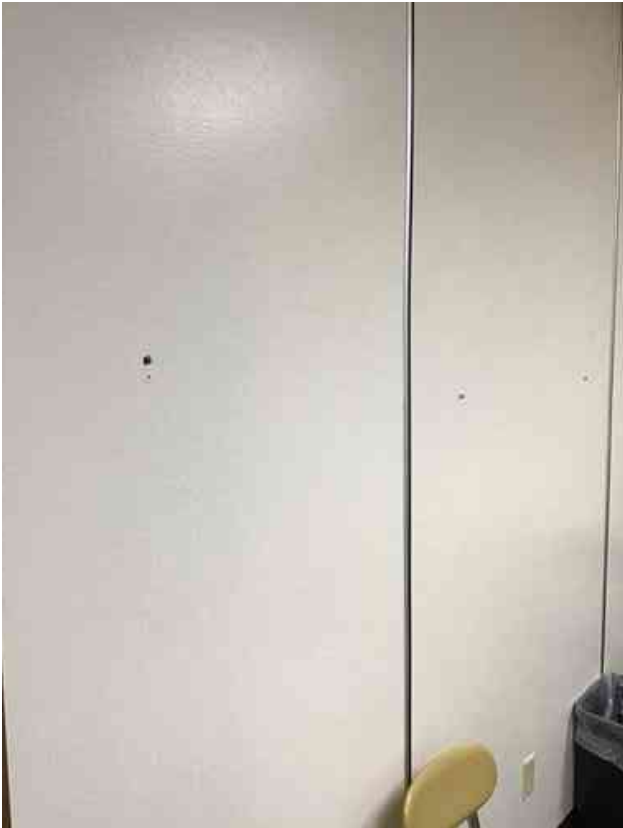
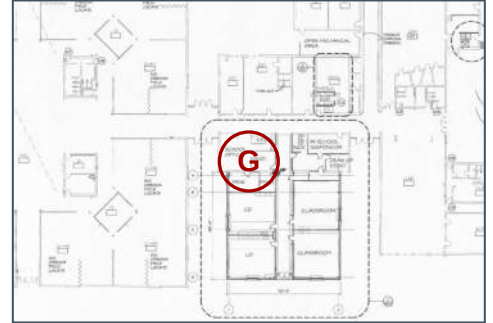
G61: General

Description: Holes in wall

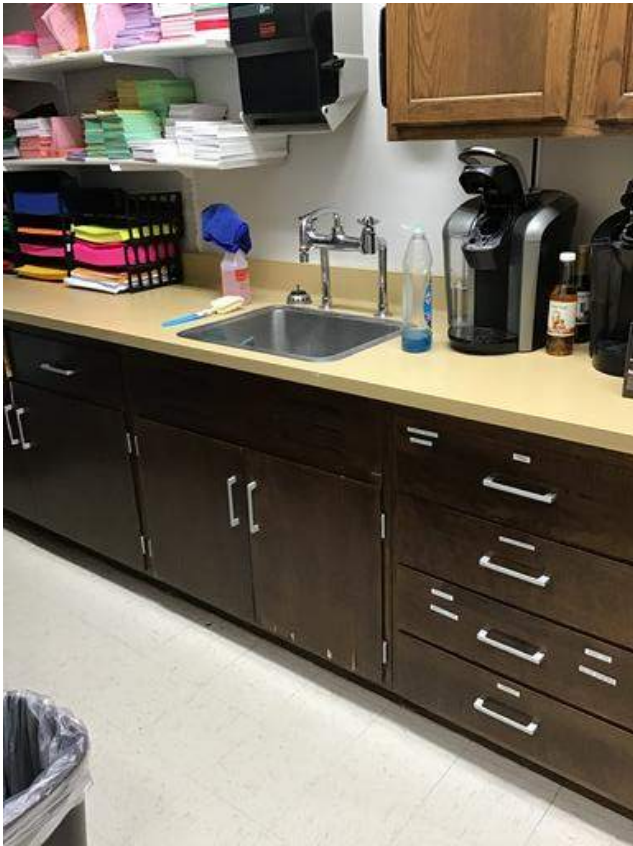
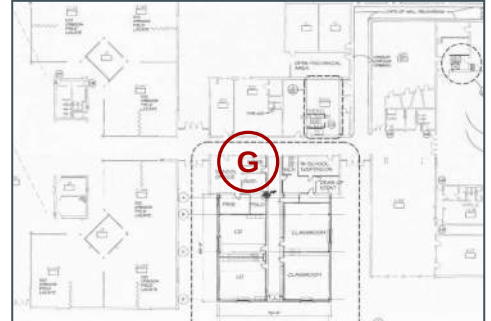
G62: General

Description: Scratched cabinetry

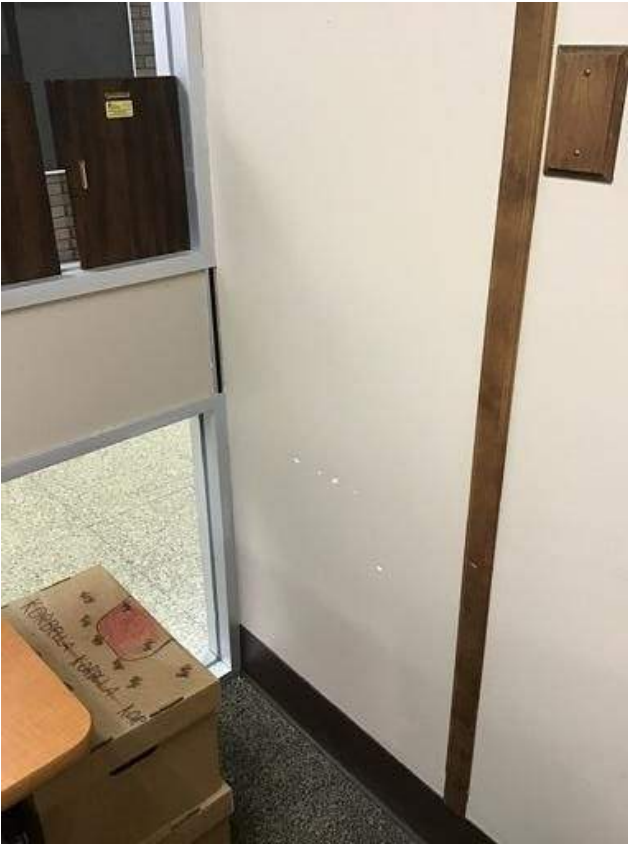
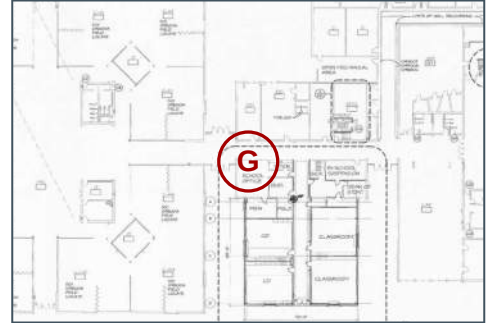
G63: General

Description: Wall scratches

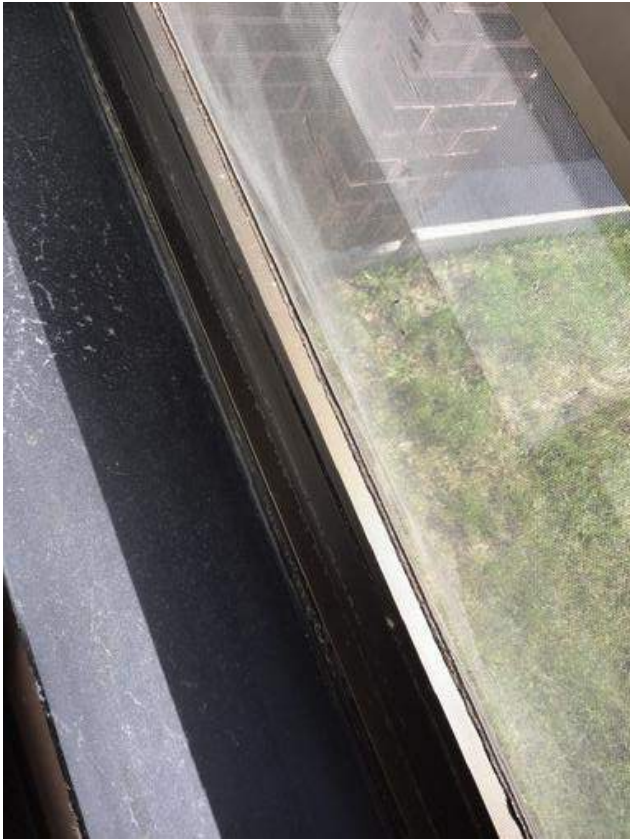
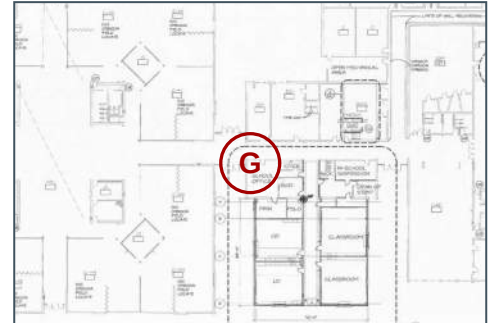
G64: General

Description: Windows need to be caulked

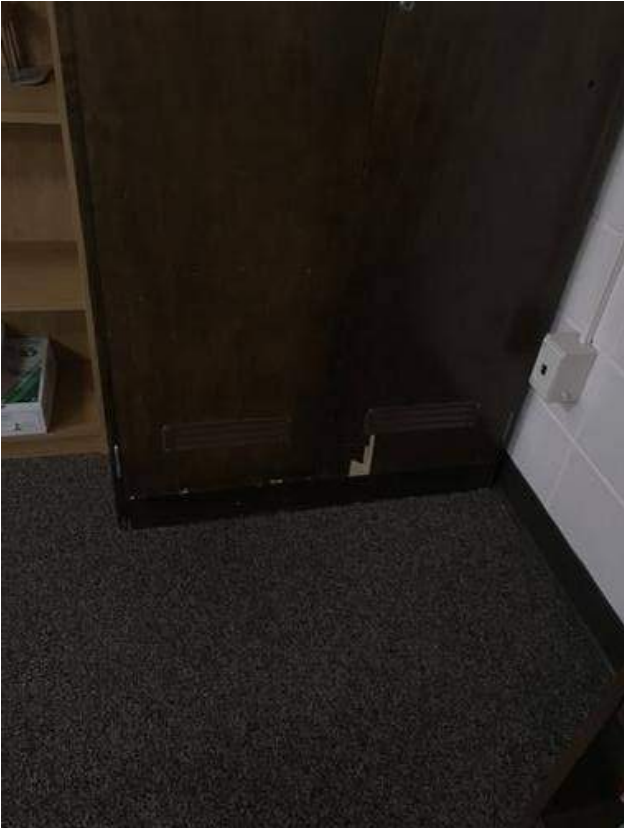
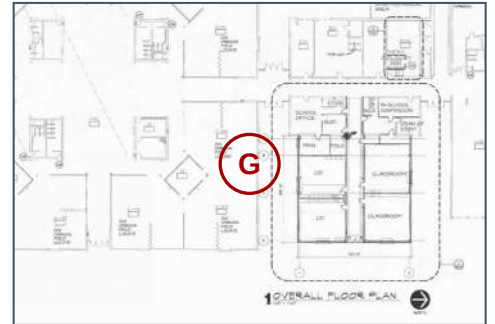
G65: General

Description: Scratched door

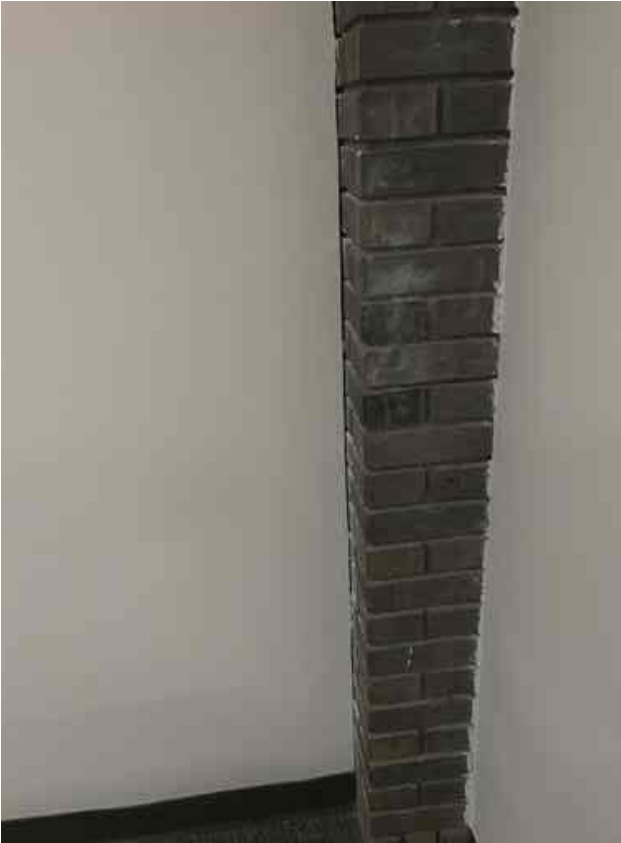
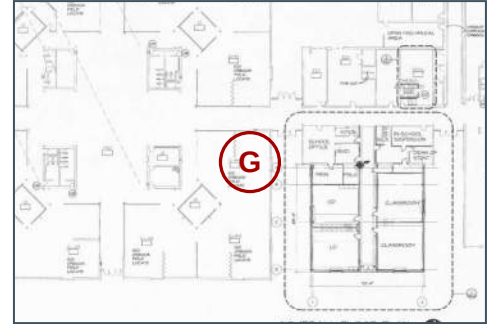
G66: General

Description: Space between wall and brick, needs caulking

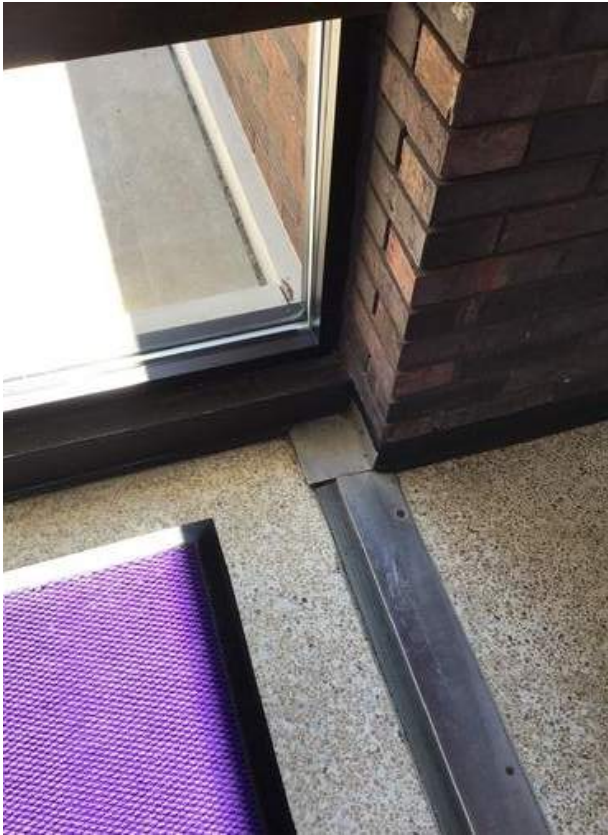
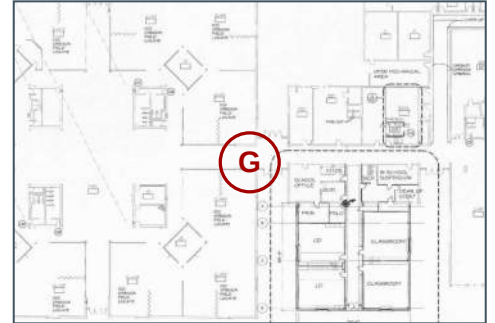
G67: General

Description: Upgrade floor transition

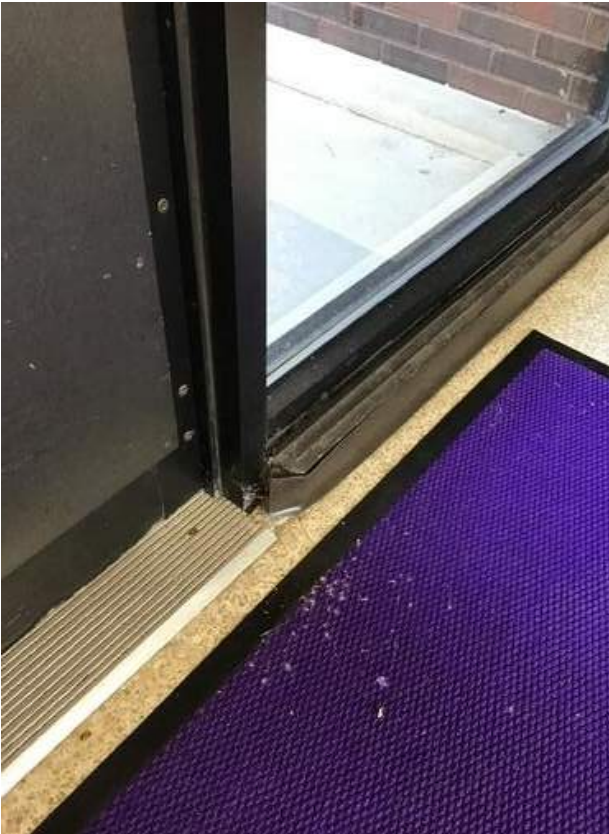
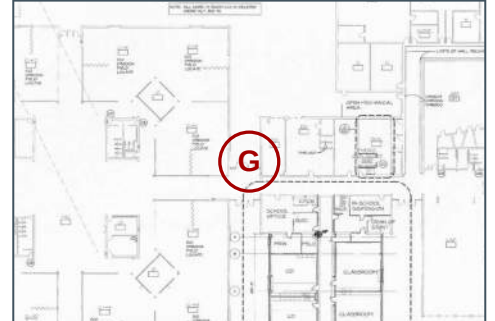
G68: General

Description: Damaged window frame

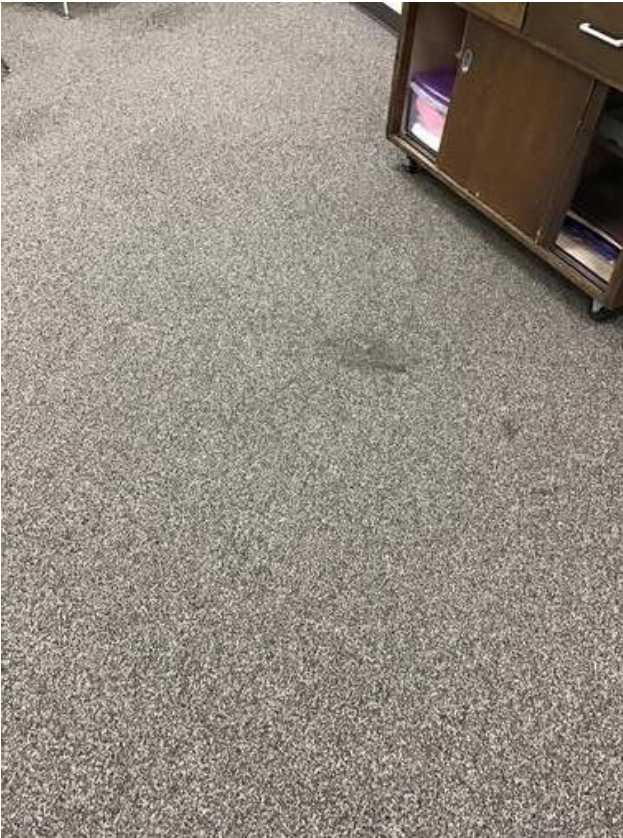
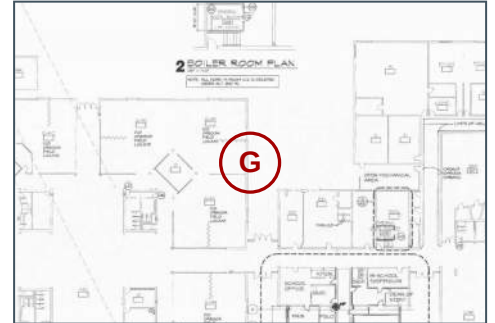
G69: General

Description: Stained flooring

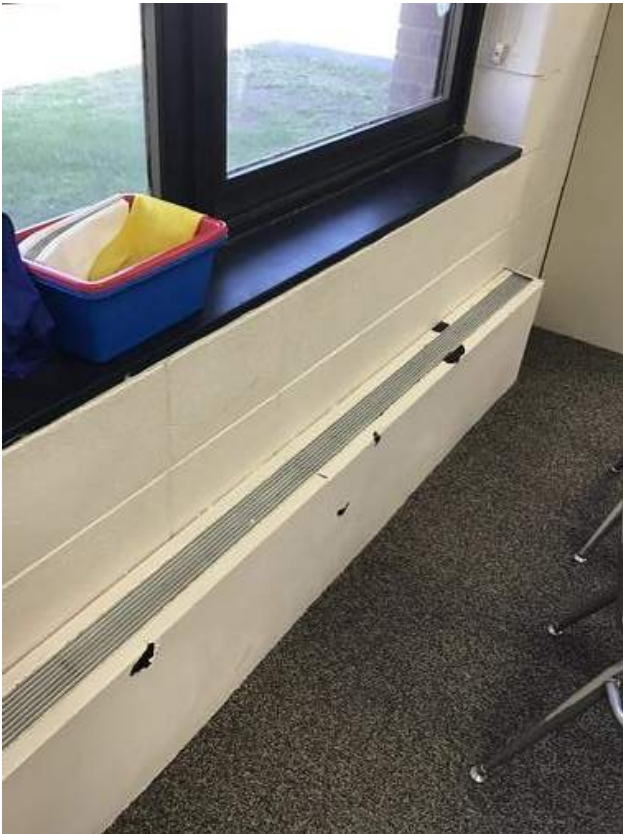
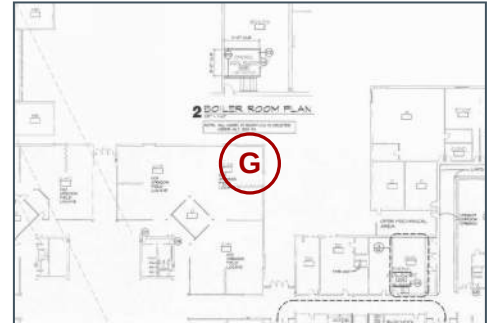
G70: General

Description: Chipped paint on heater

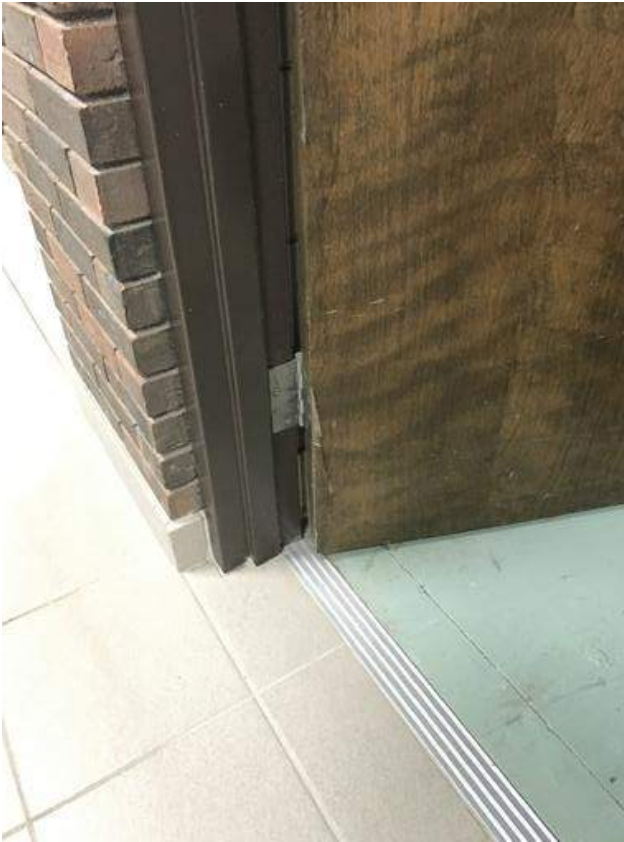
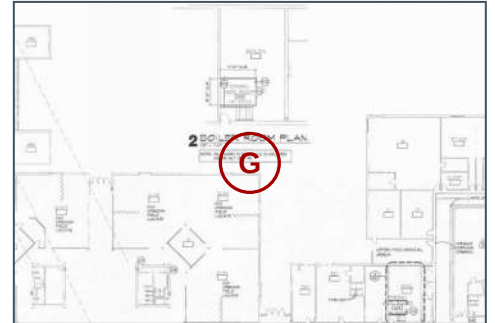
G71: General

Description: Scratched door

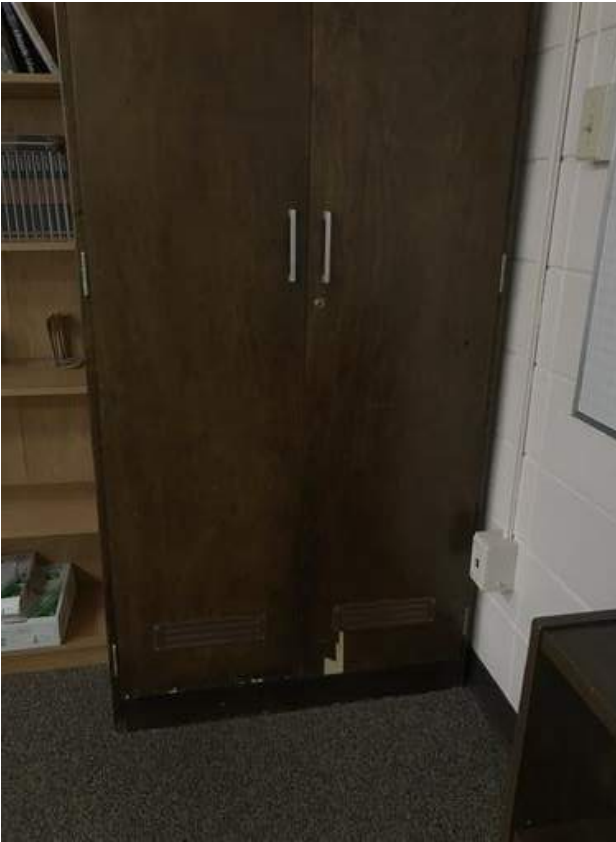
G72: General

Description: Scratched closet

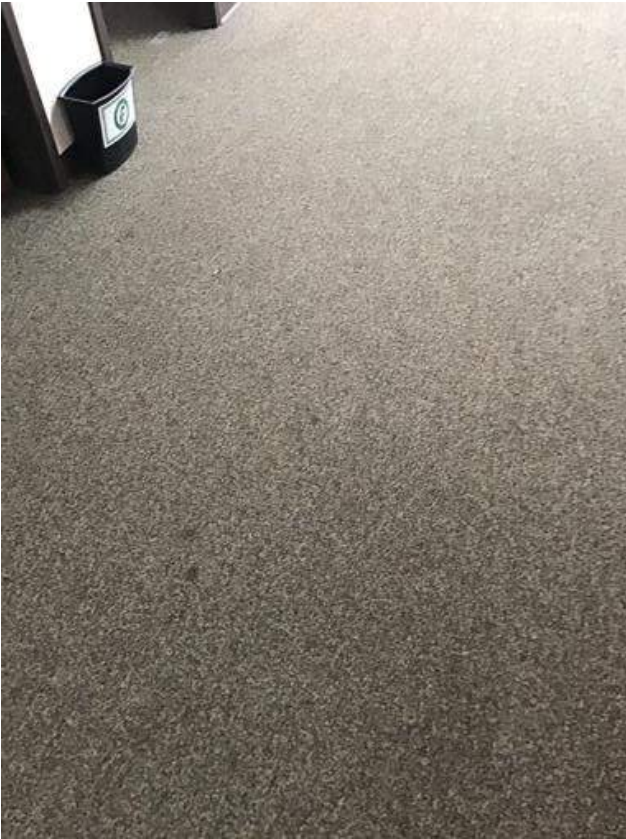
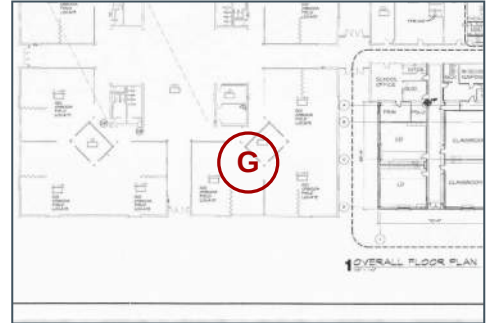
G73: General

Description: Stained floor carpet

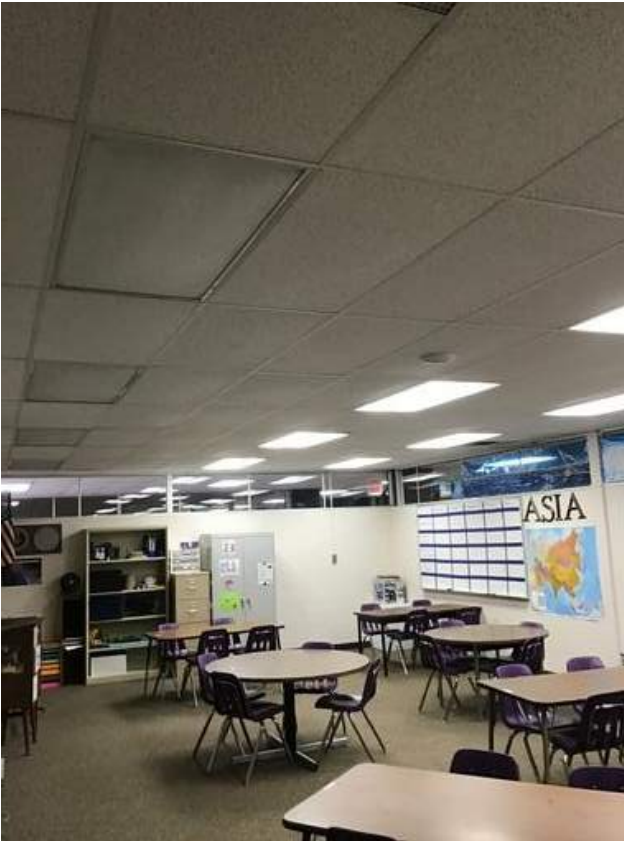
G74: General

Description: Lights do not work

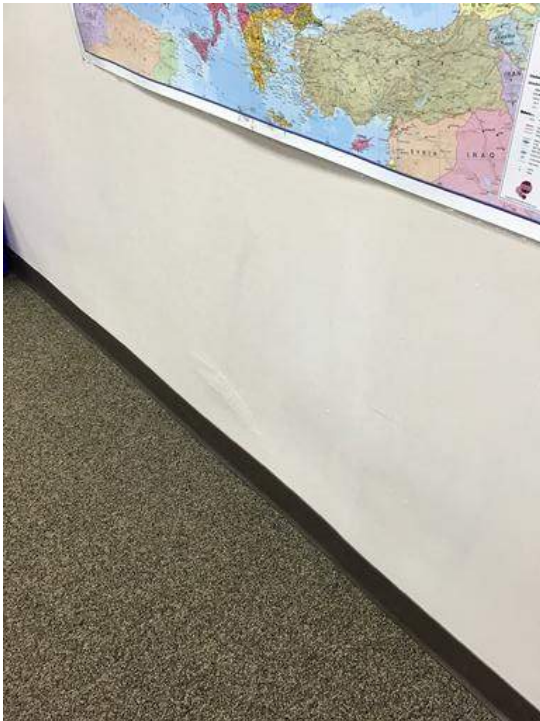
Description: Wall paint is bubbled

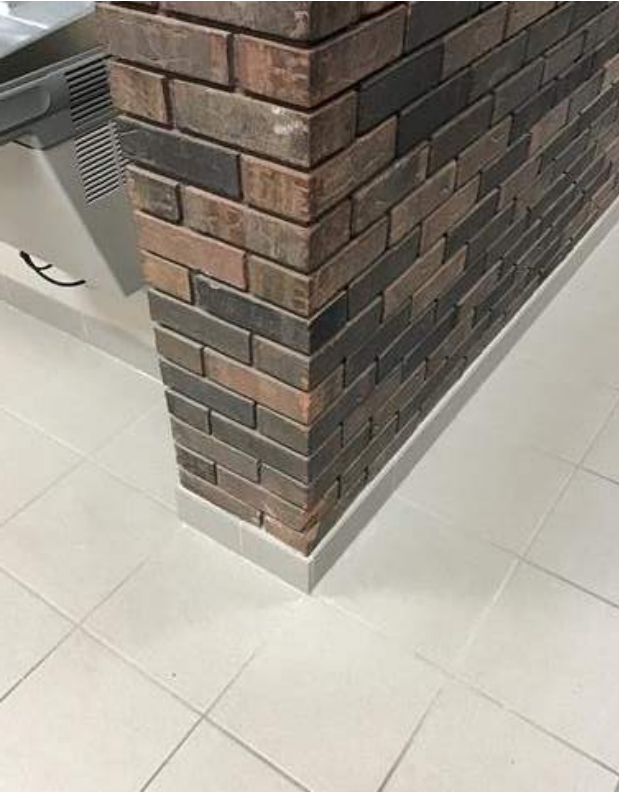
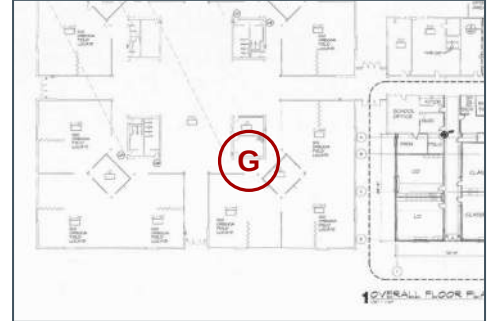
G76: General

Description: Corner bricks are chipped

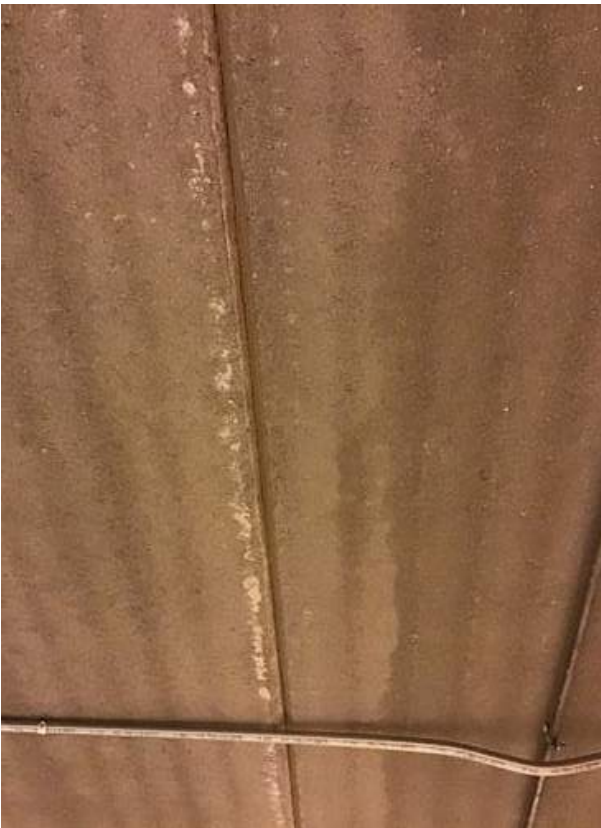
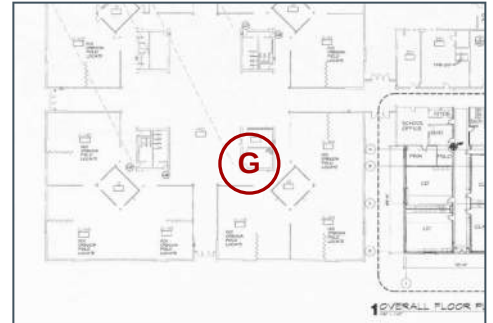
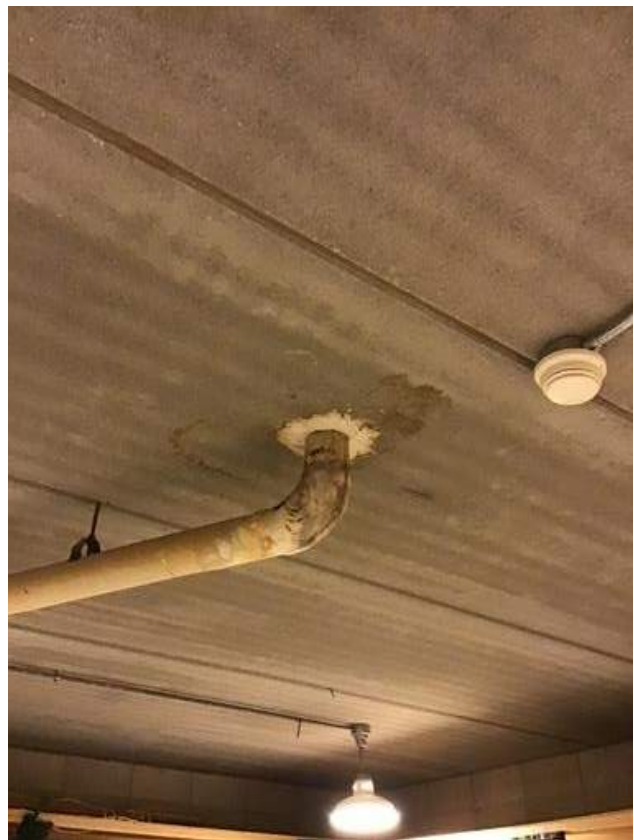
G77: General

Description: Stained ceiling due to potential leaks

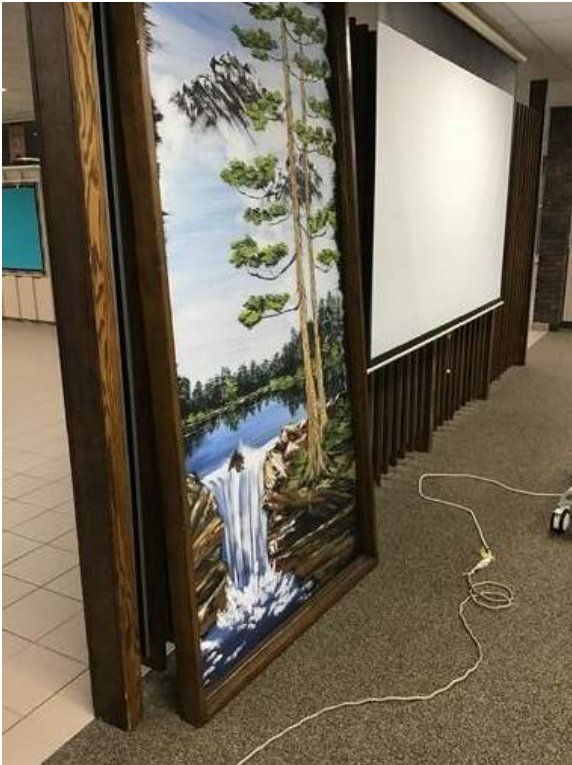
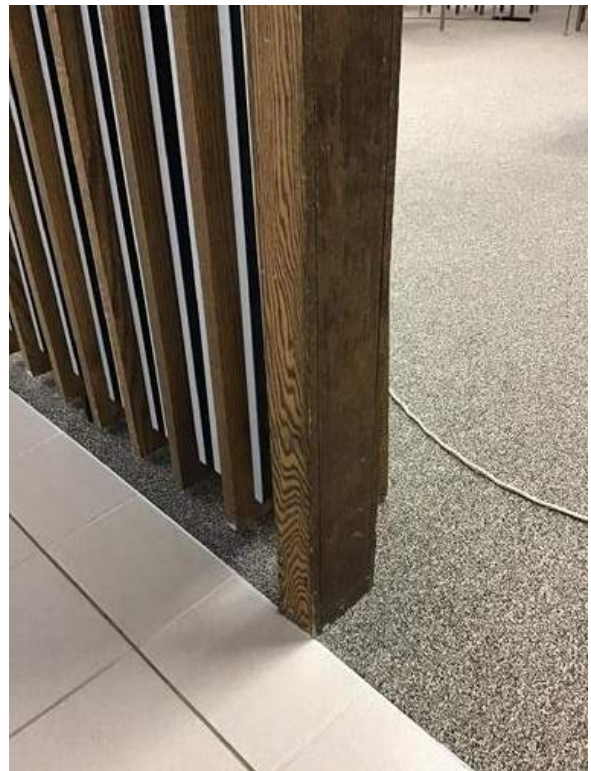
G78: General

Description: Wood panels scratched

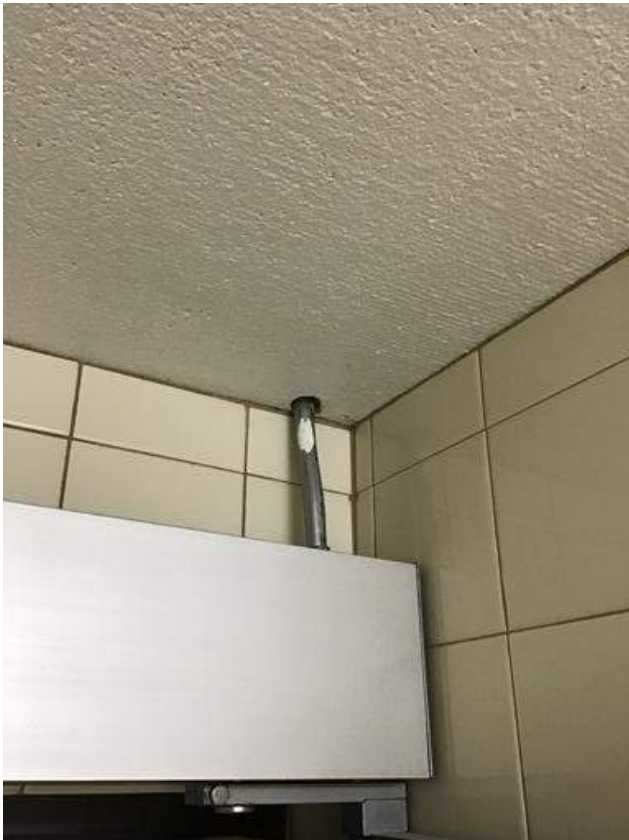
G79: General

Description: Caulk needed around panels

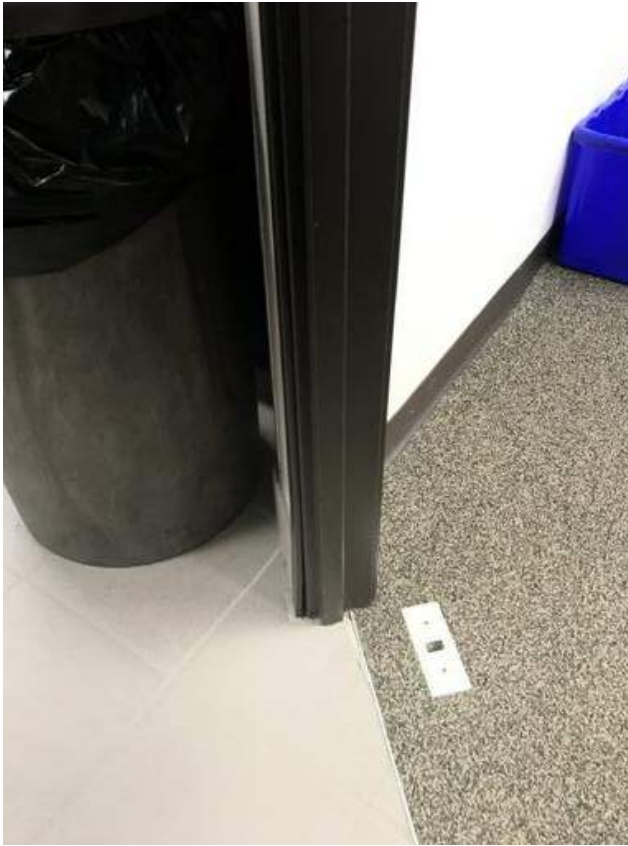
G80: General

Description: Damaged door frame at bottom

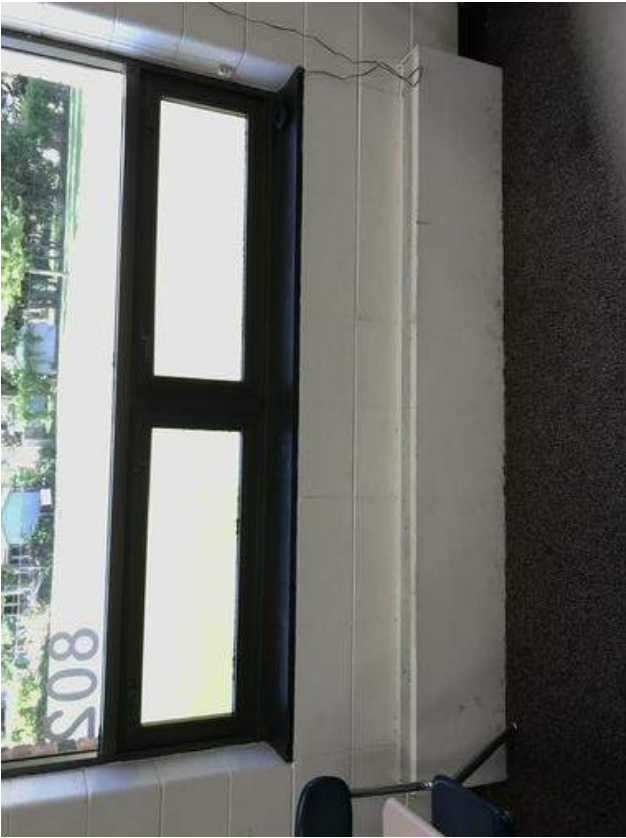
G81: General

Description: Window caulking needed

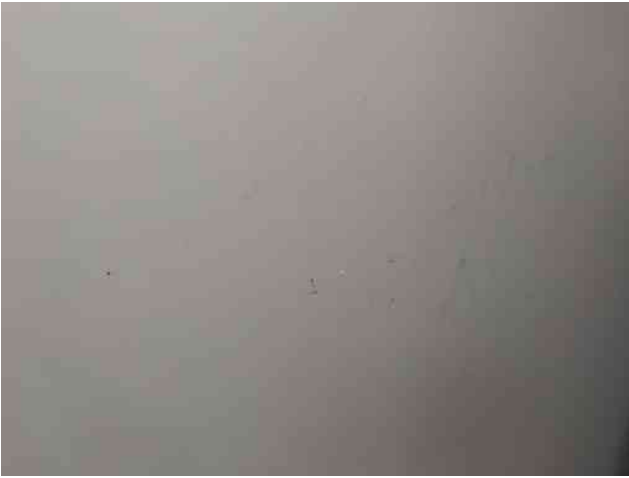
G82: General

Description: Scratches on wall

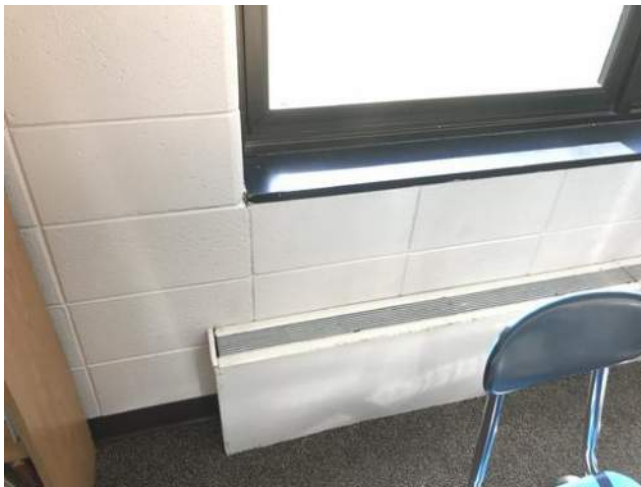
G83: General

Description: Caulking needed at window

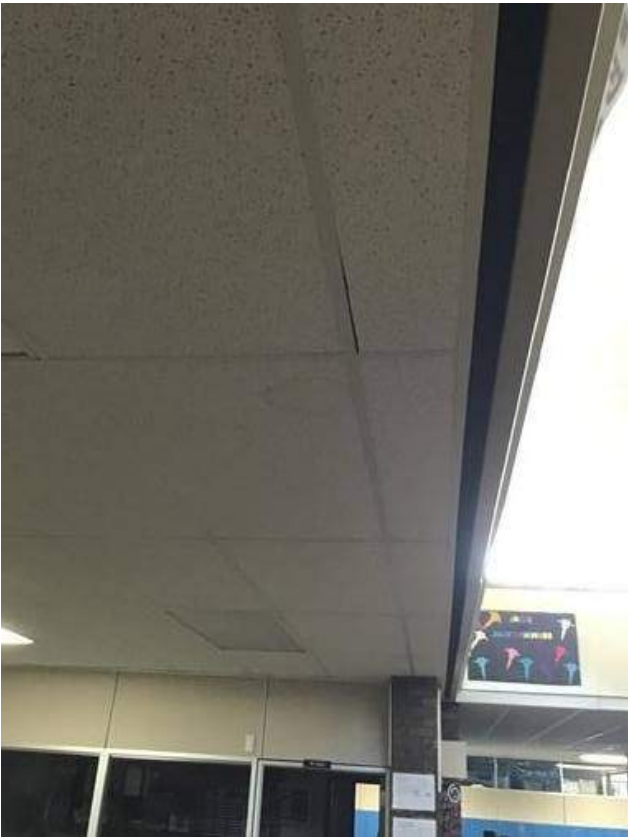
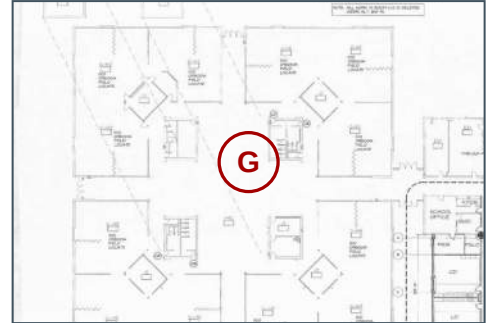
G84: General

Description: Stained ACT

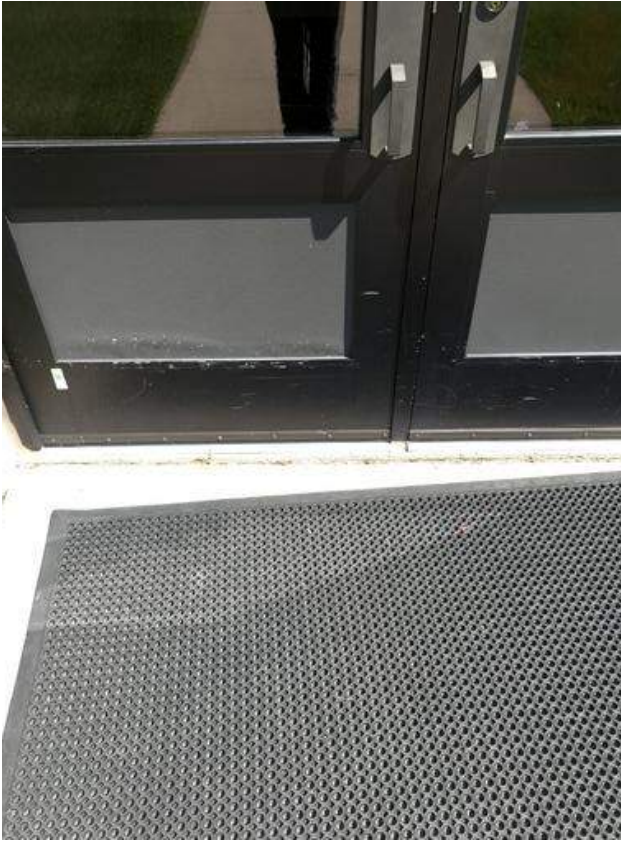
G85: General

Description: Scratched door frames and doors

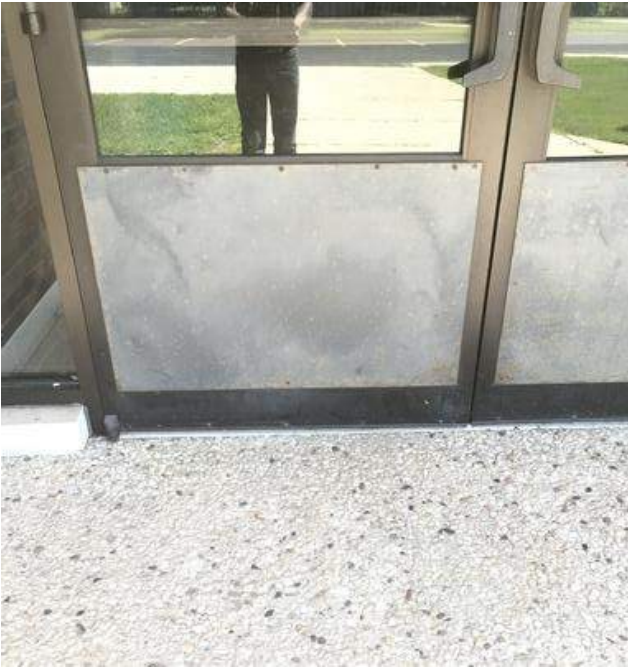
G86: General

Description: Rusting at door panels

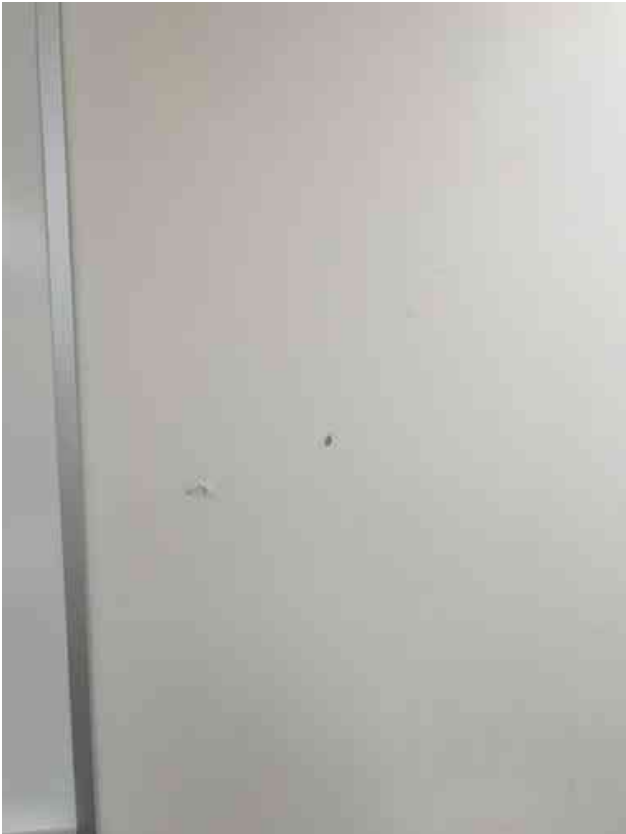
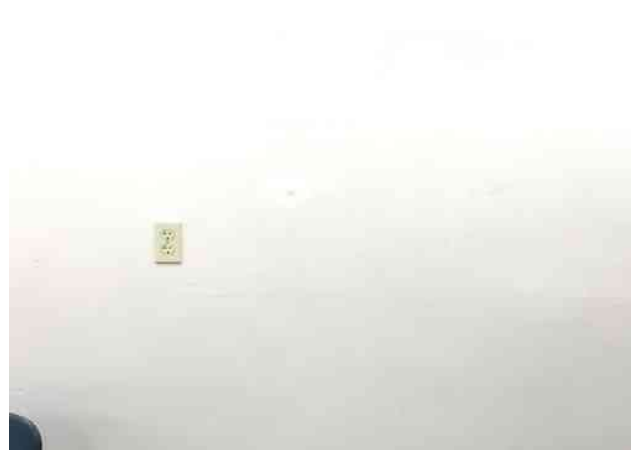
G87: General

Description: Wall damages/scratches and mismatching paint

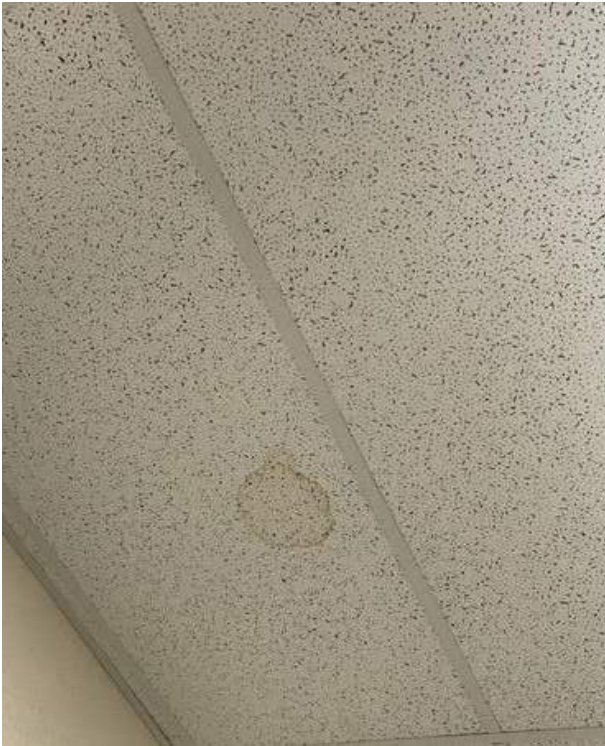
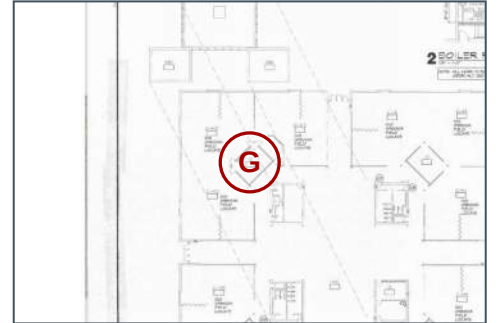
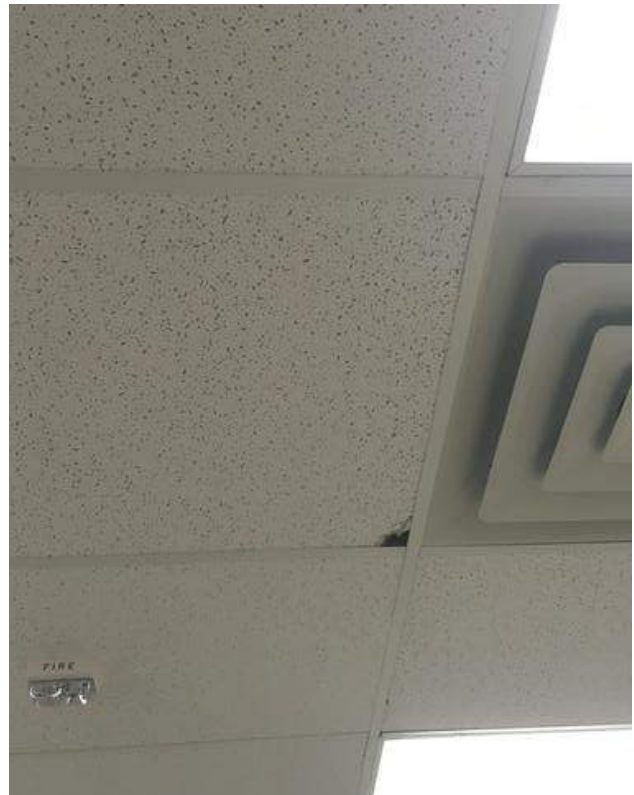
G88: General

Description: Damaged and stained ACT

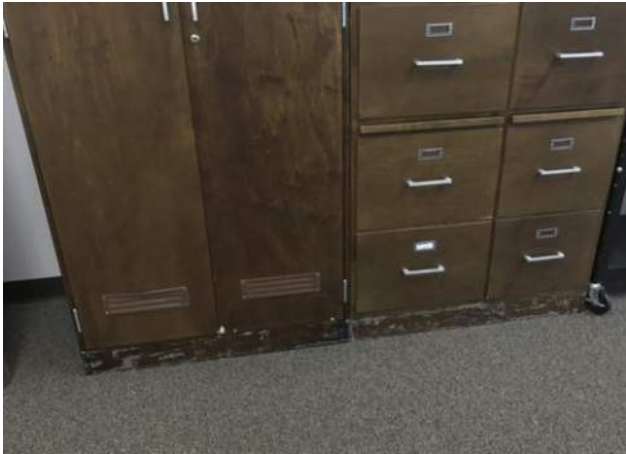
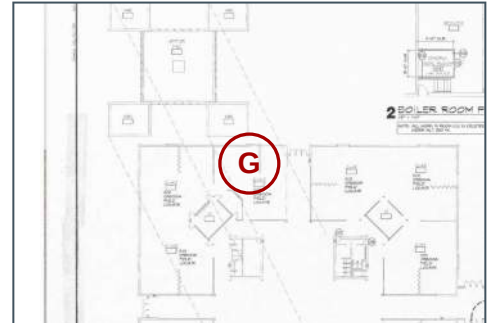
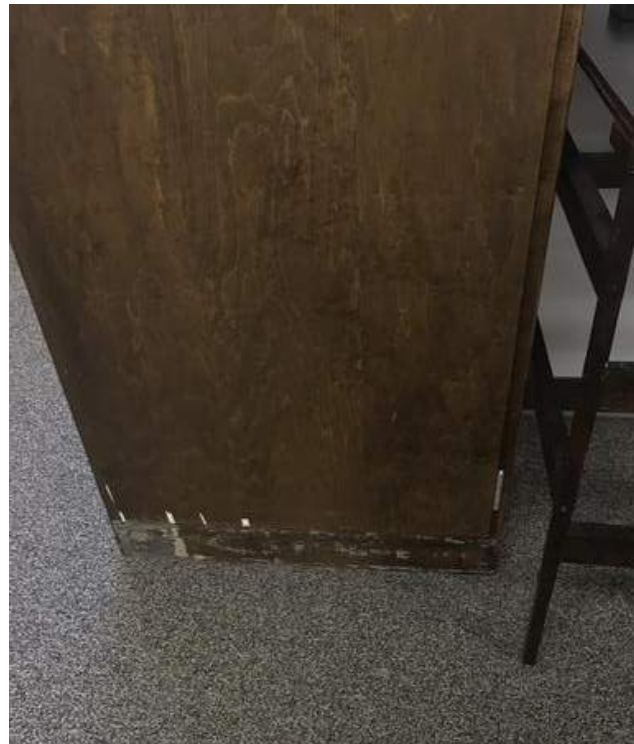
G89: General

Description: Scratched cabinetry

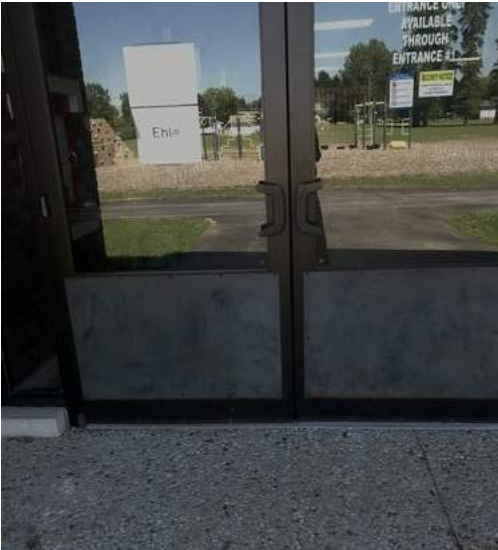
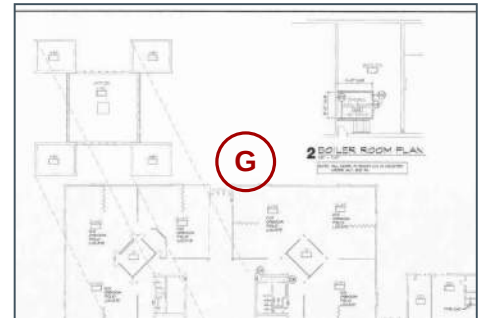
G90: General

Description: Rusted door panels
