TWO RIVERS PUBLIC SCHOOLS

FACILITIES ASSESSMENT REPORT

08.19.21

Two Rivers School District Facilities Assessment July 2021

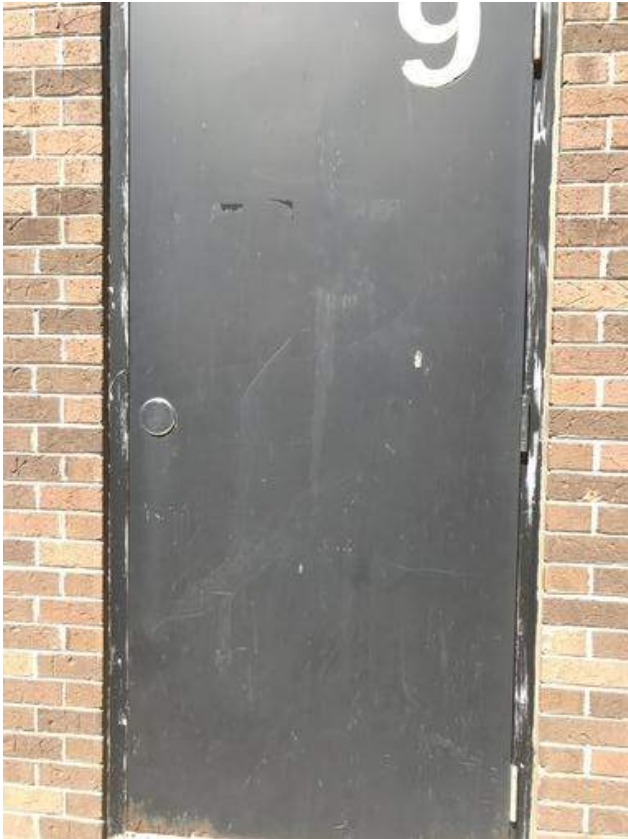
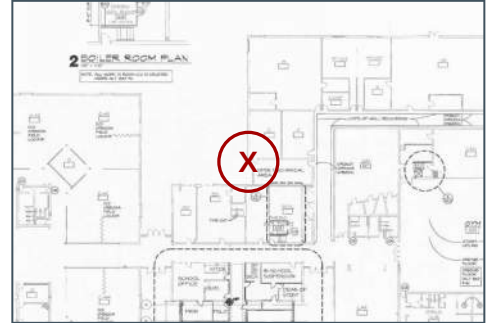
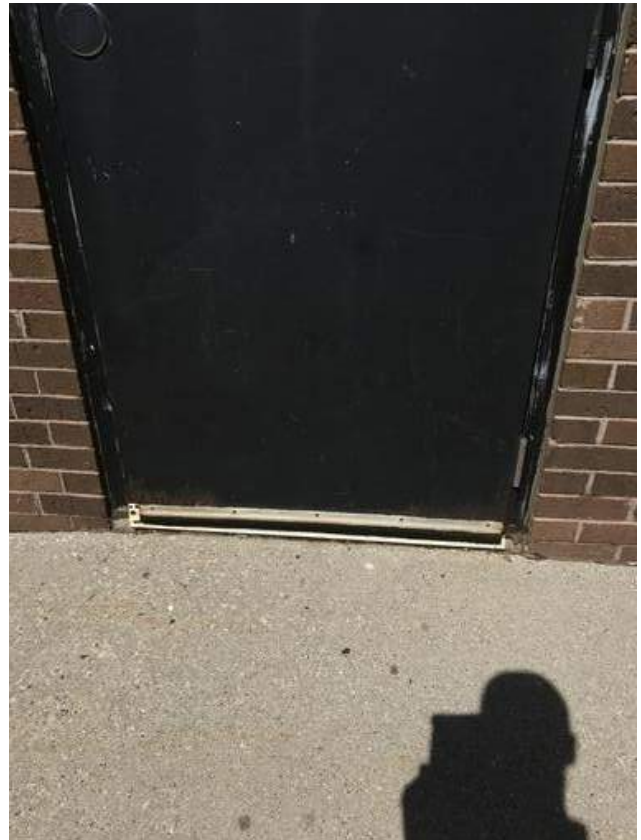
X1: Exterior

Description: Scratched and rusted door

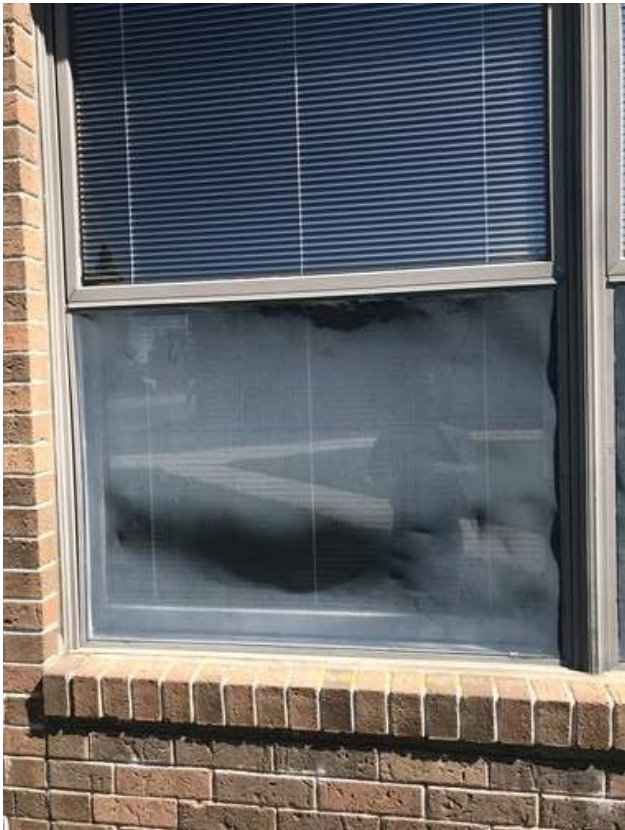
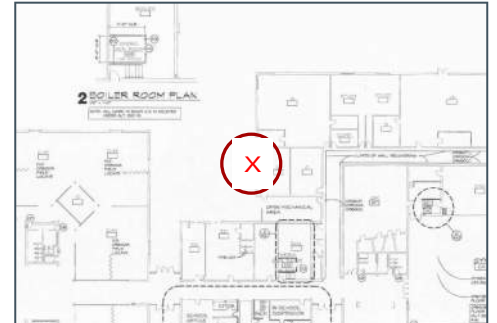
X4: Exterior

Description: Damaged window screens

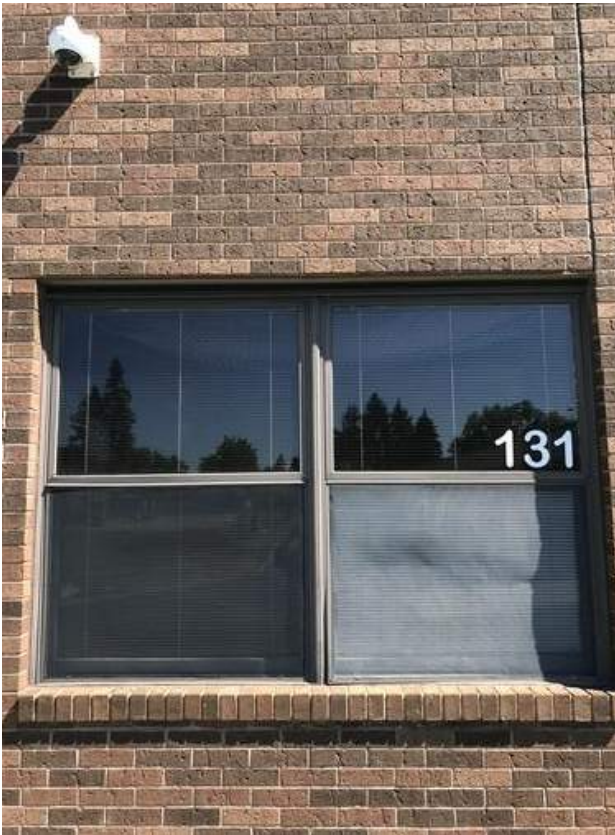
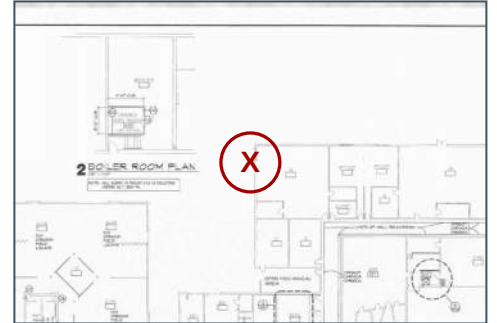
X5: Exterior

Description: Caulking required at all exterior windows

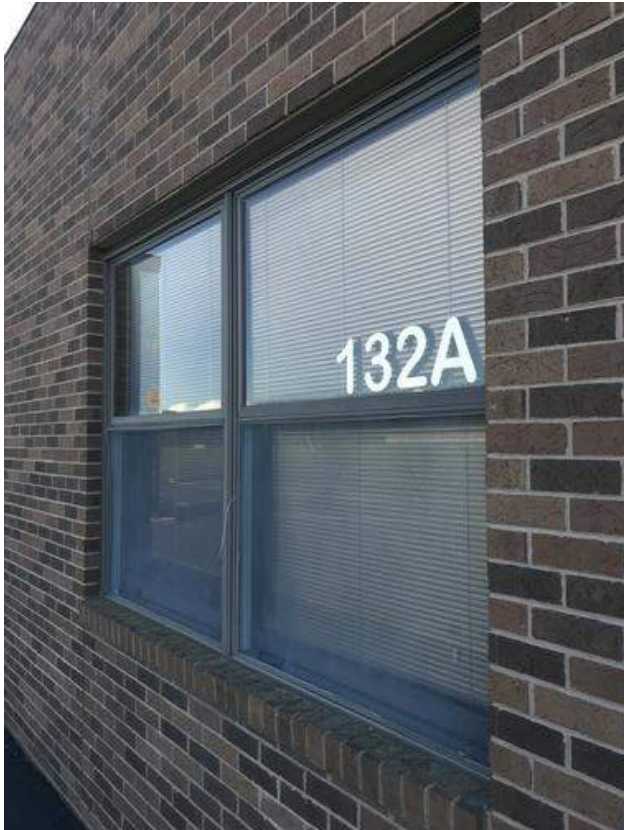
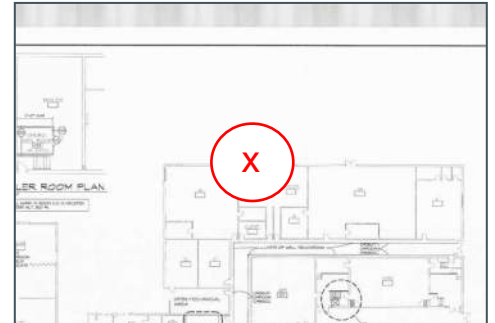
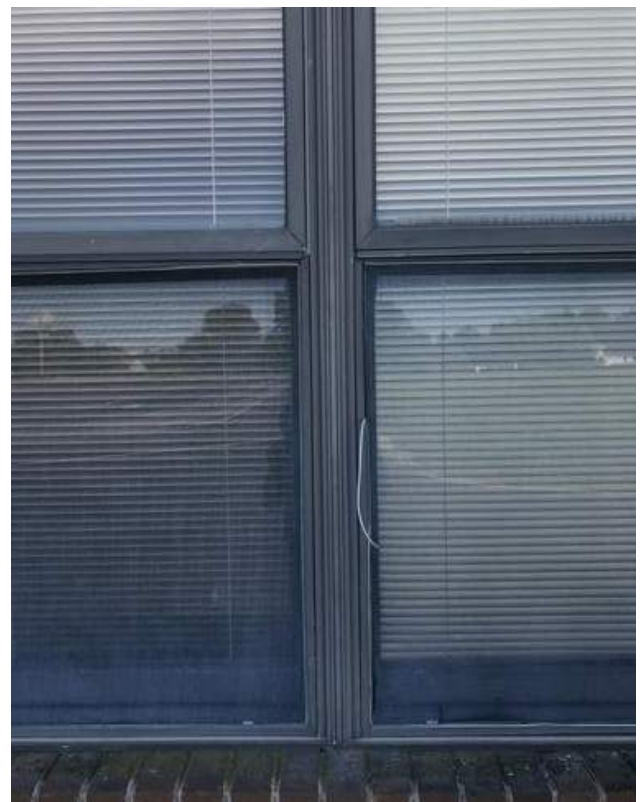
X6: Exterior

Description: Damaged window screens

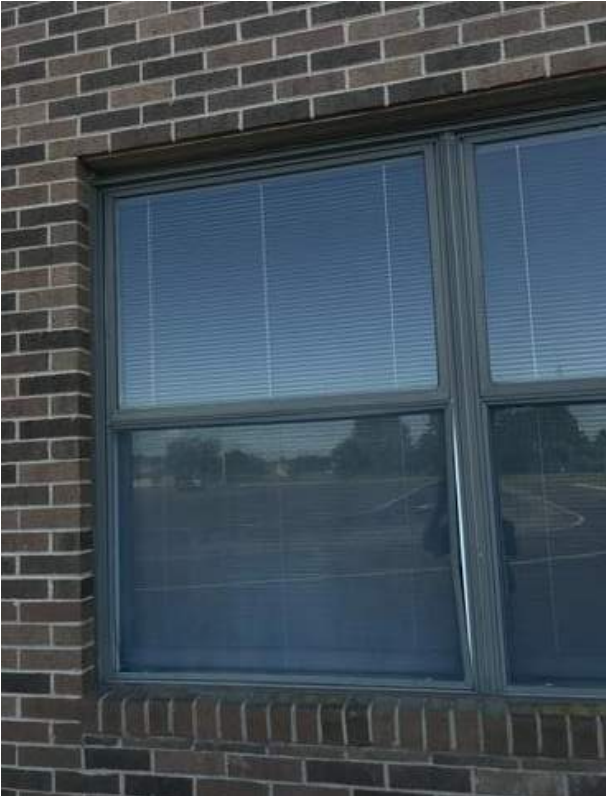
X7: Exterior

Description: Damaged window frames

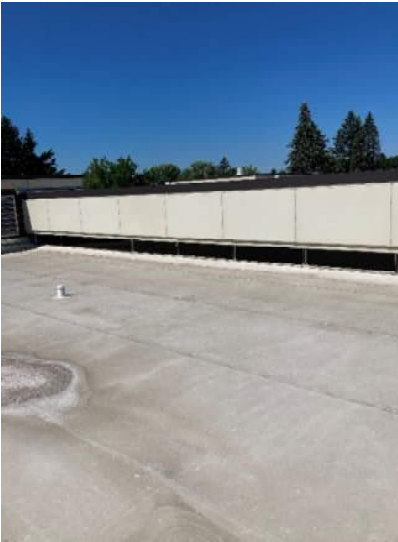
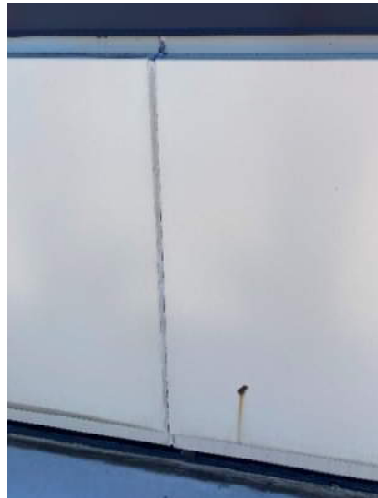
R3: Roof

Description: Caulk needed at solid stone

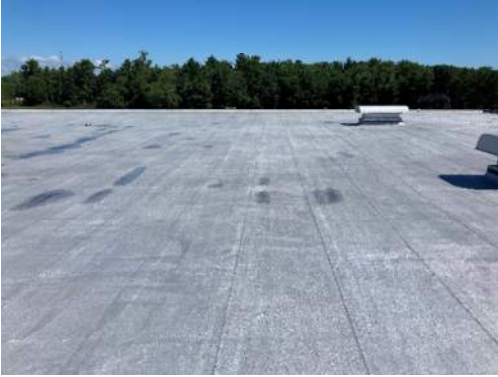
Description: Modified roof 5-8 years left

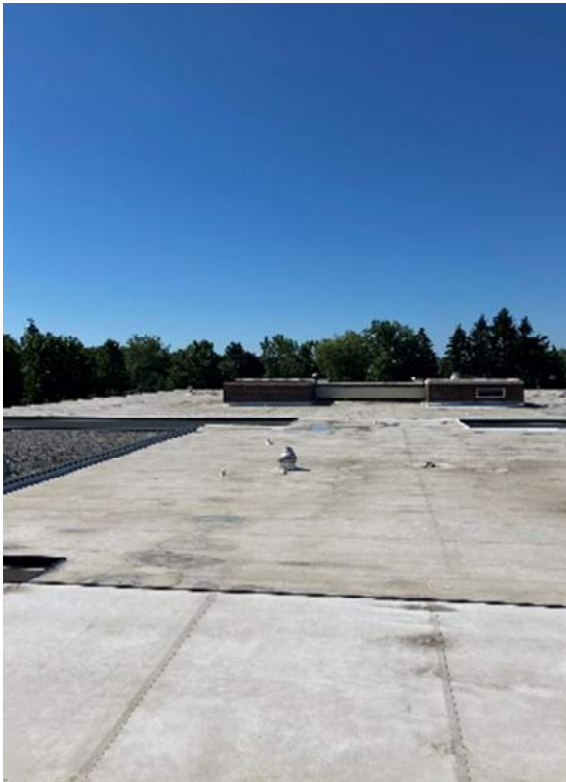
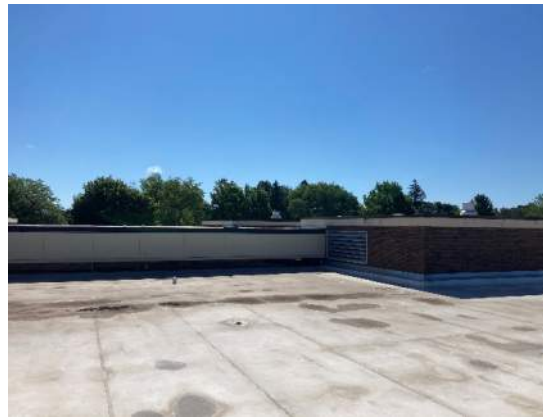
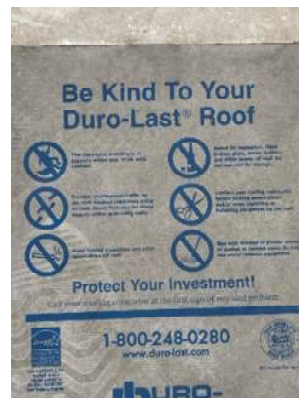
R5: Roof

Description: Duro-Last roof 5 years left

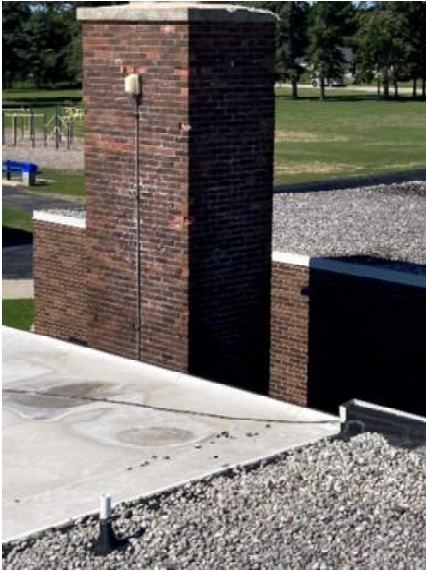
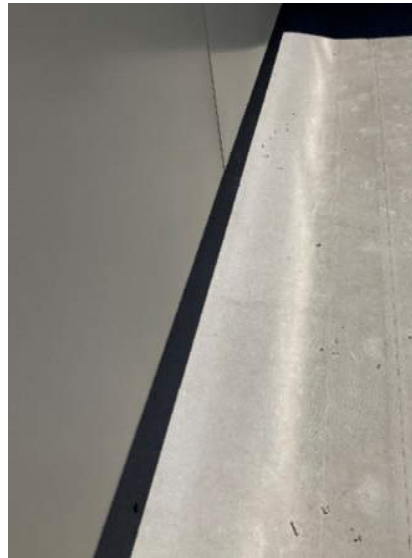
R6: Roof

Description: Ballast roof 5 years left

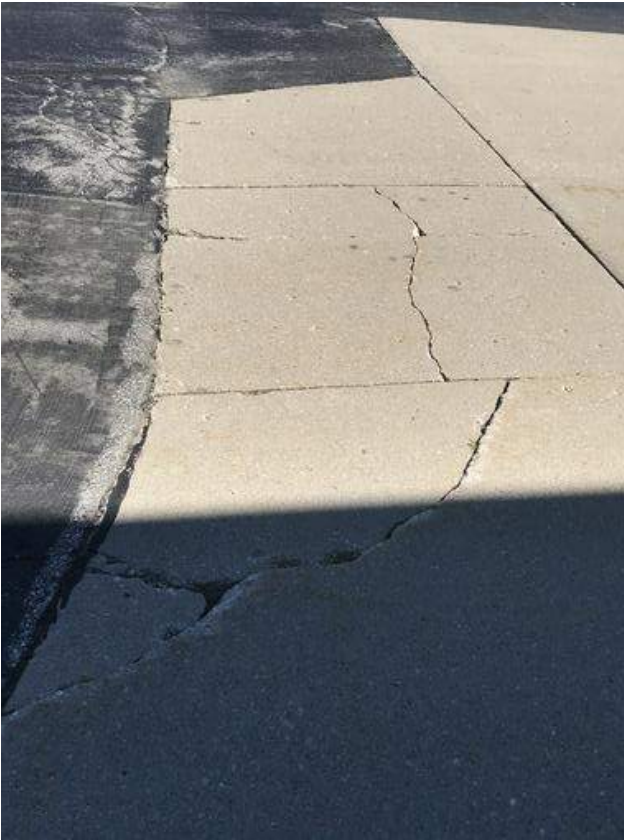
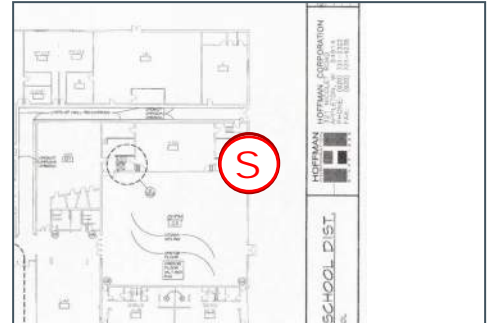
S1: Site Work

Description: Cracked concrete sidewalk

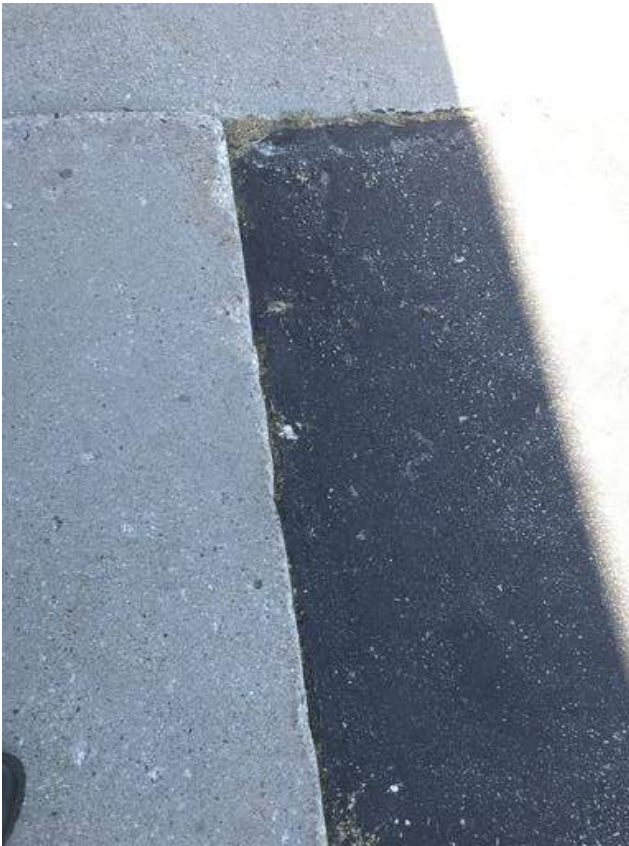
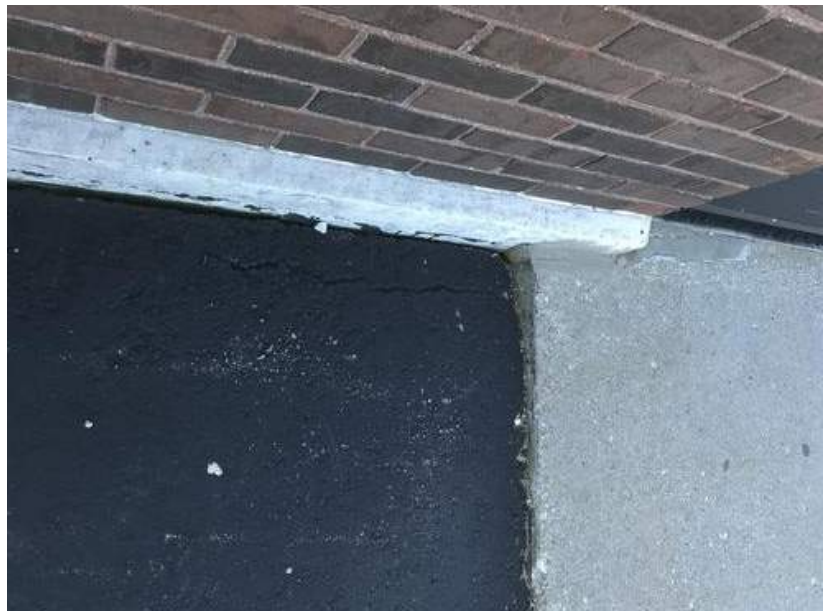
S2: Site Work

Description: Asphalt is settling below concrete stoop

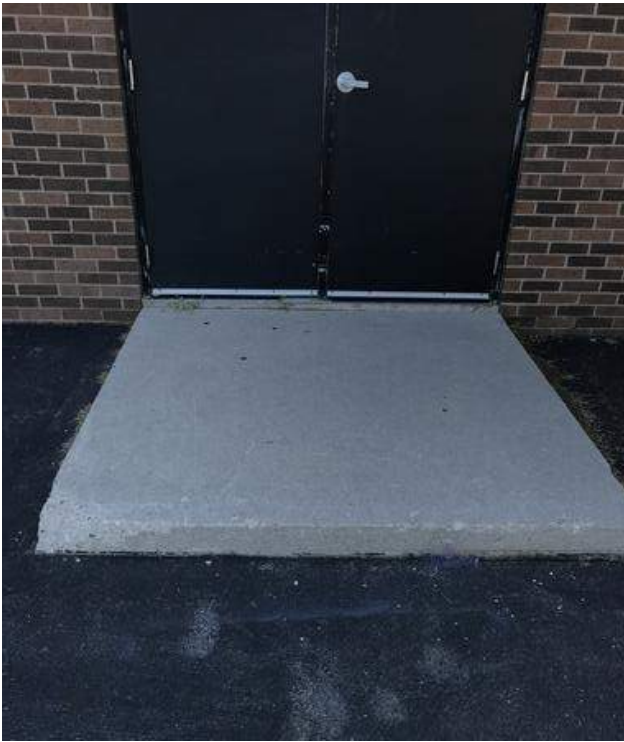
S3: Site Work

Description: Asphalt is settling below concrete

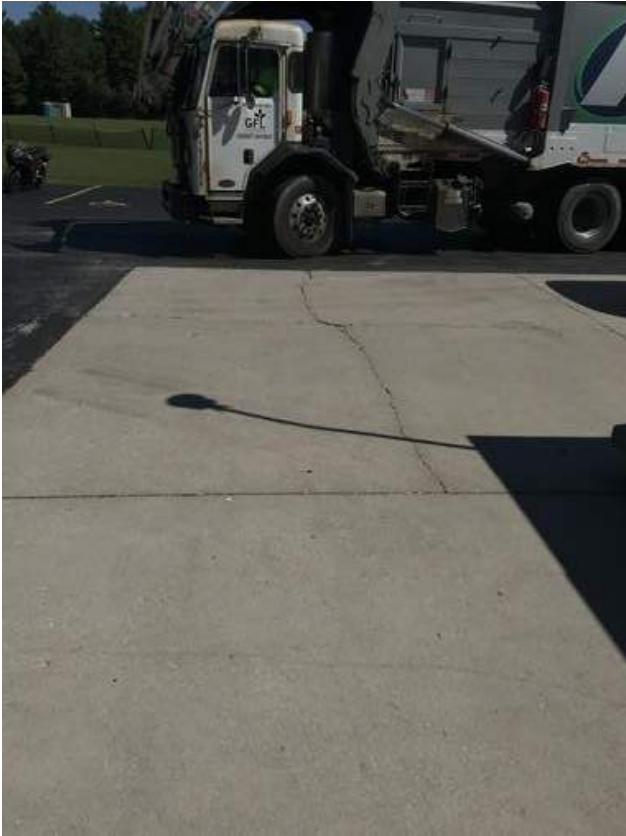
S4: Site Work

Description: Cracked concrete

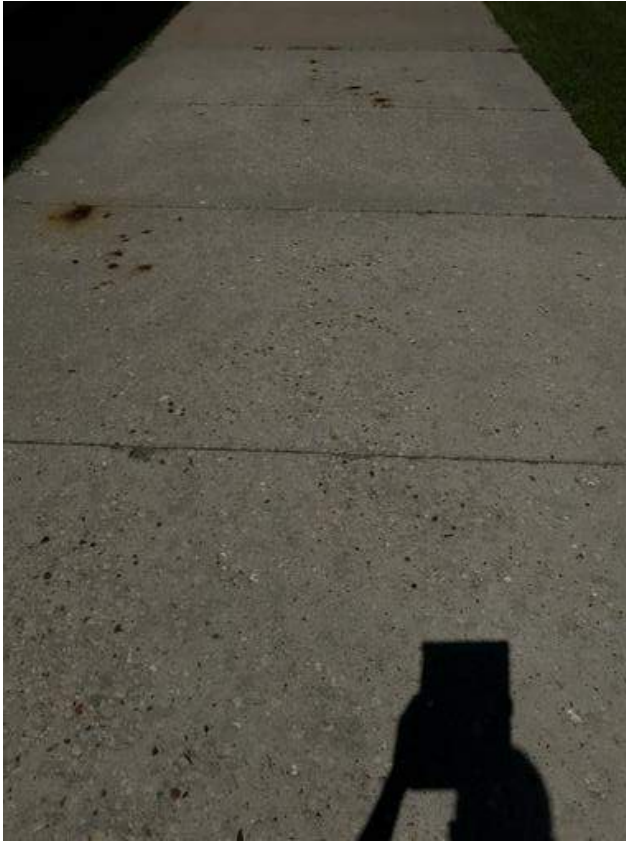
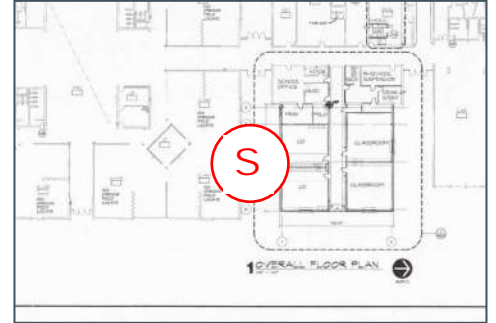
S5: Site Work

Description: Stained concrete sidewalk

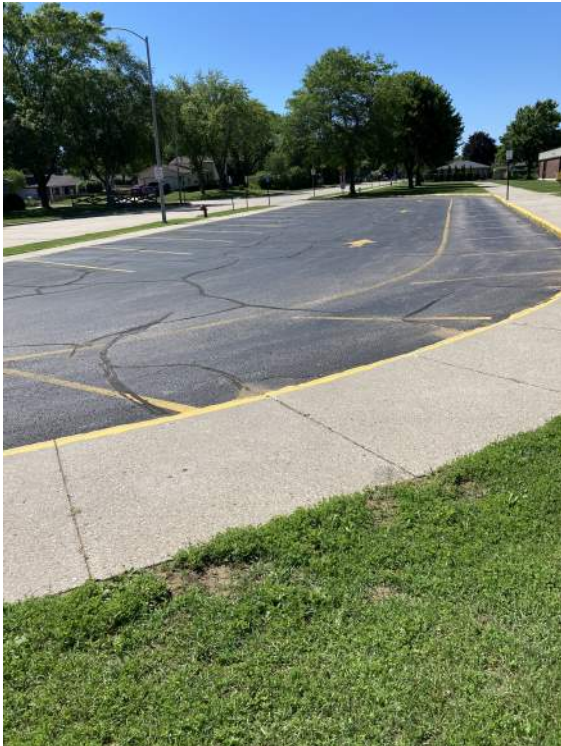
S6: Site Work

Description: Crack at the front parking lot, 2-5 years left

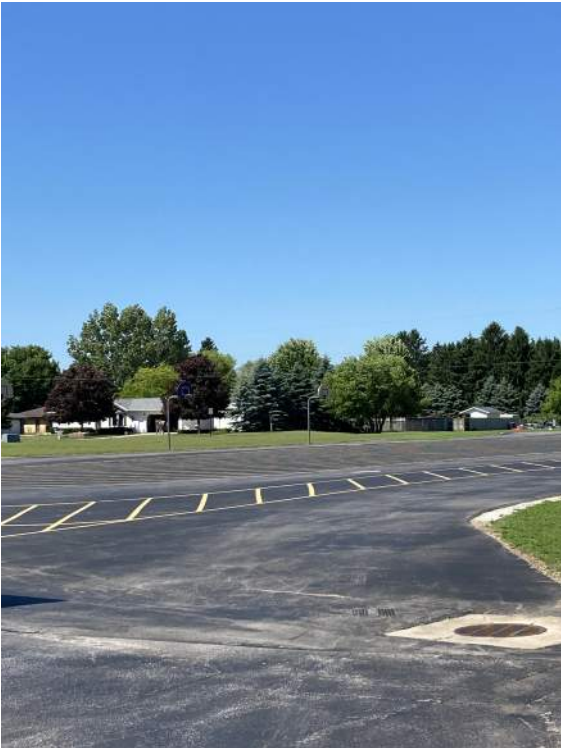
Description: Cracks at the back parking lot, 2-5 years left

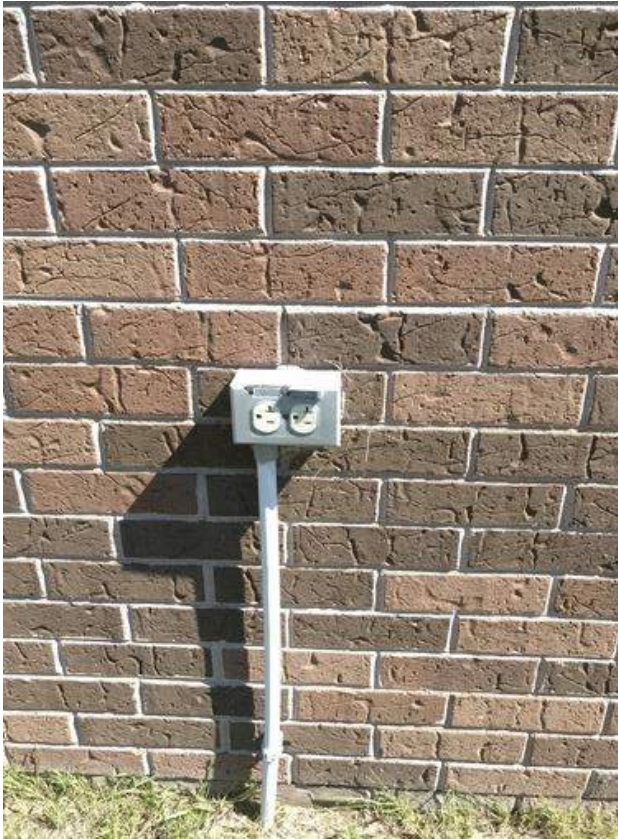
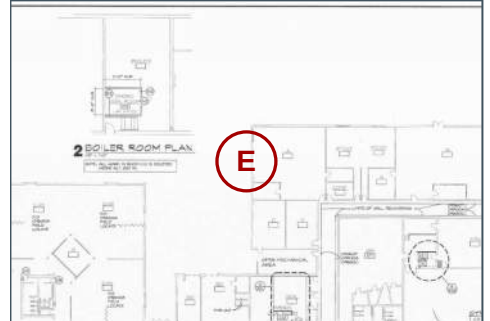
Description: Missing cover on outdoor receptacle

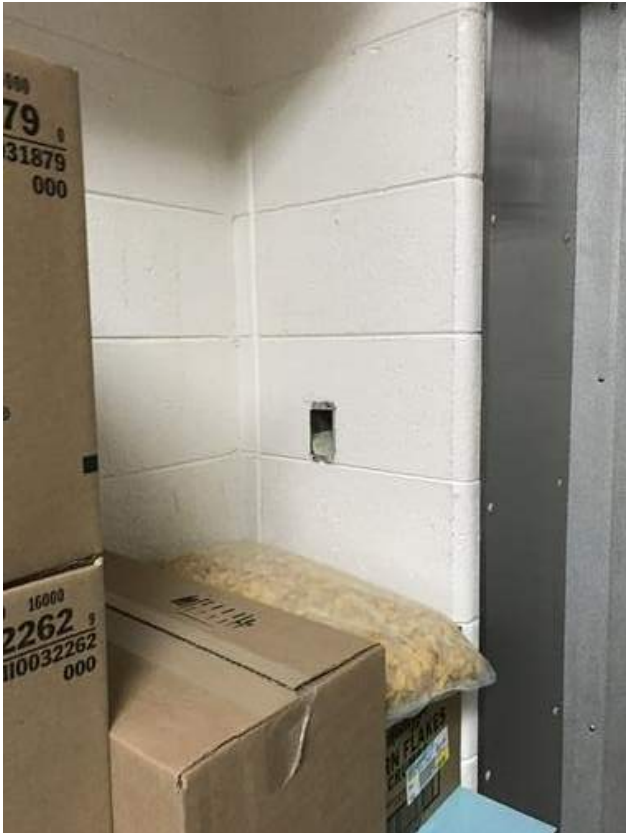
E2: Electrical

Description: Missing electrical box cover

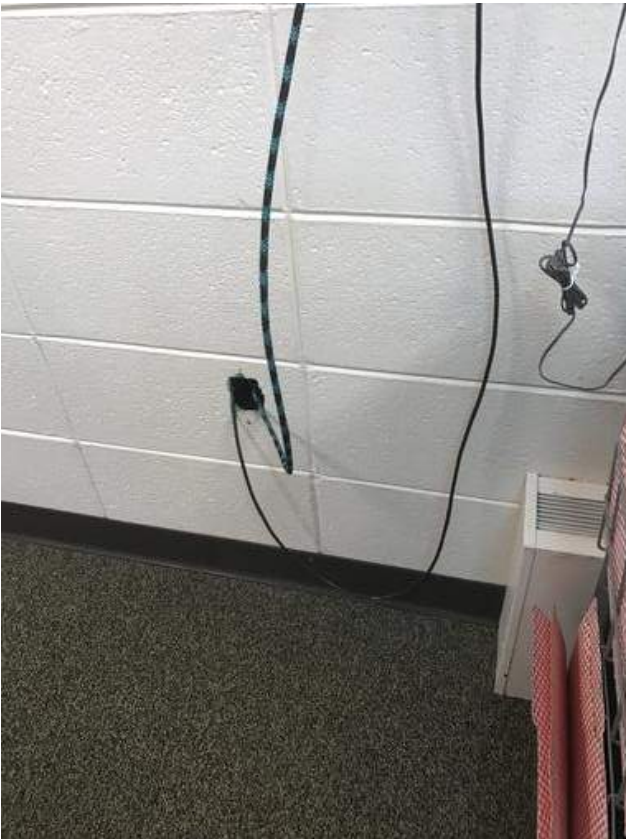
E4: Electrical

Description: Cables running through unfinished wall hole

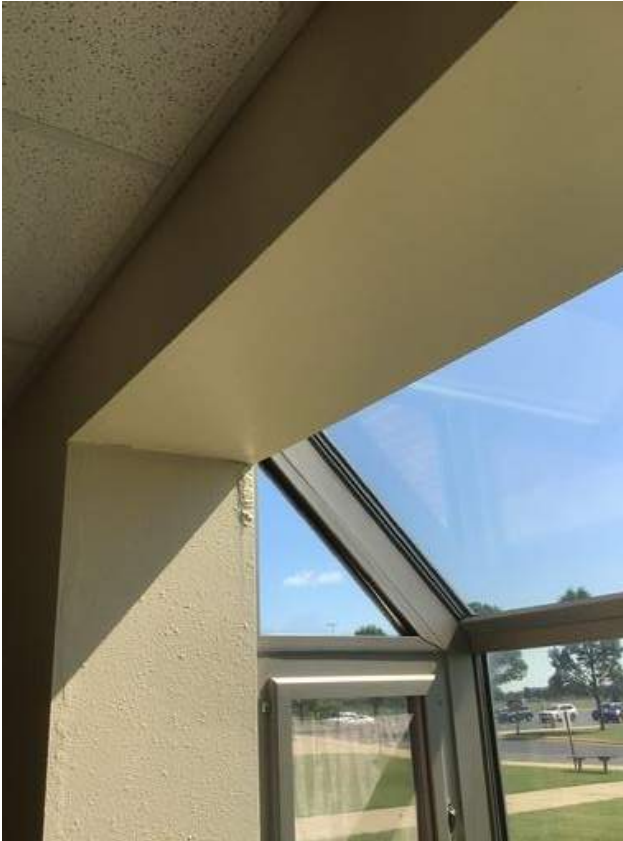
Description: Signs of moisture damage

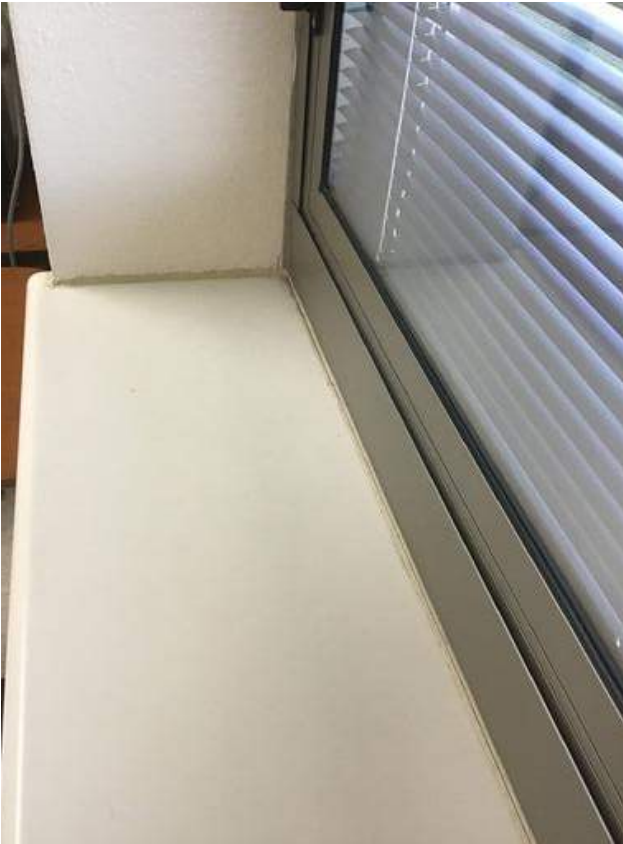
G2: General

Description: Caulking needed at window

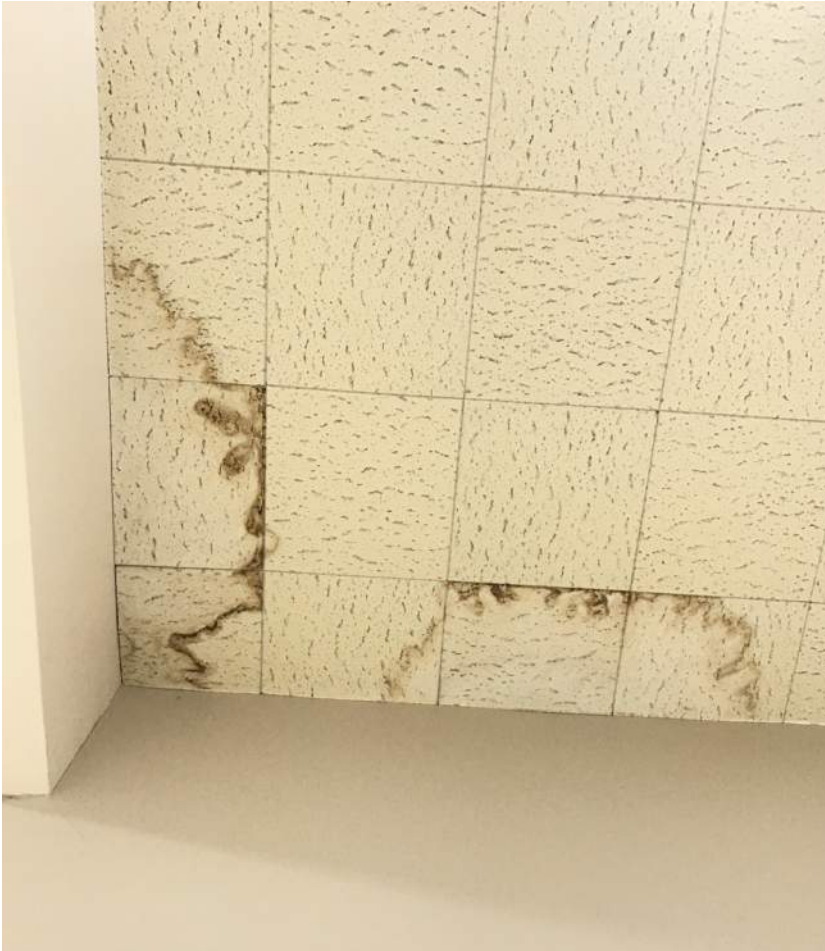
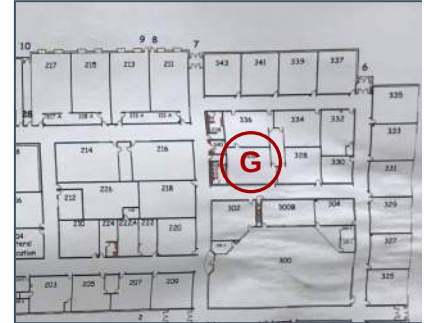
Description: Stained ceiling

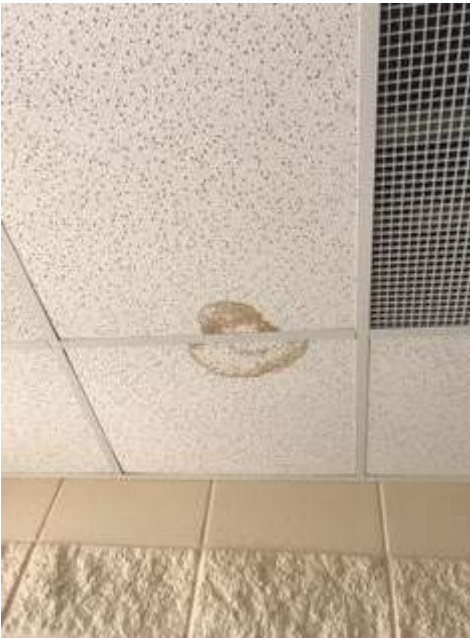
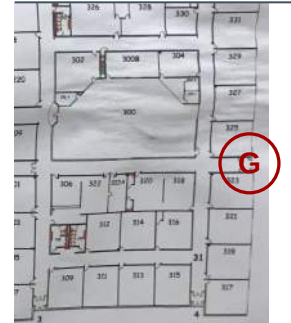
G6: General

Description: Stained ACT

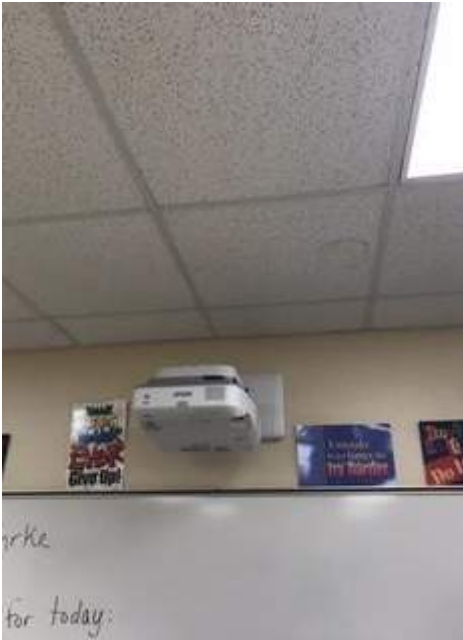
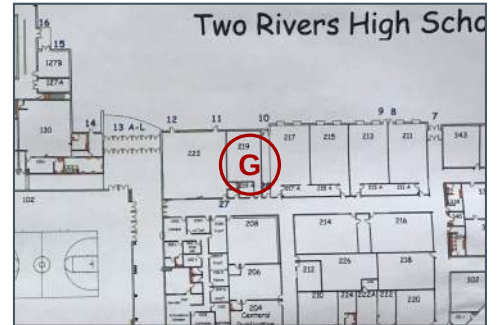
G7: General

Description: Stained ceiling tile

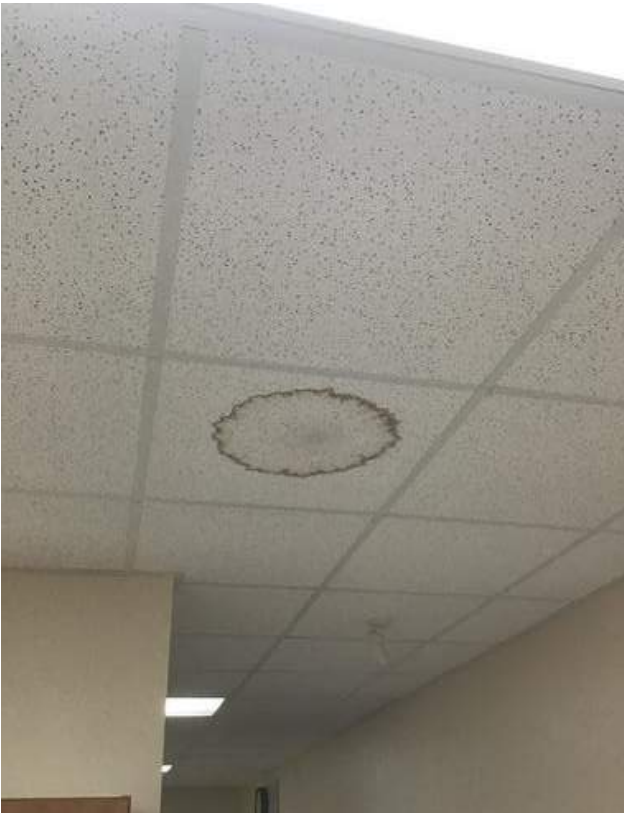
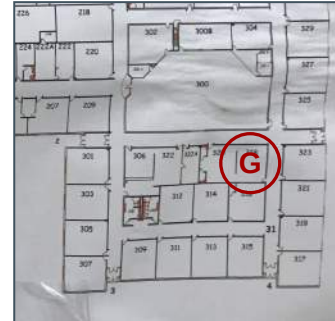
G8: General

Description: Stained ceiling tile grid

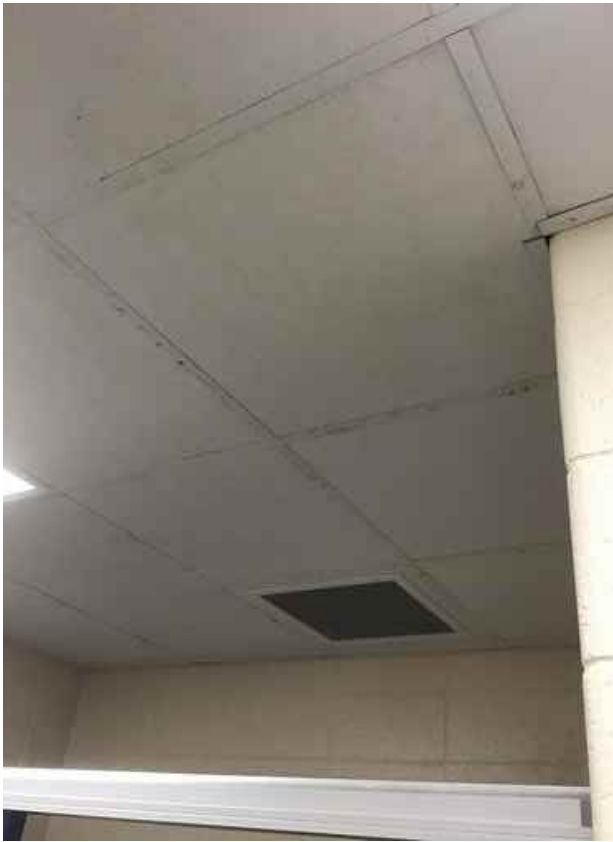
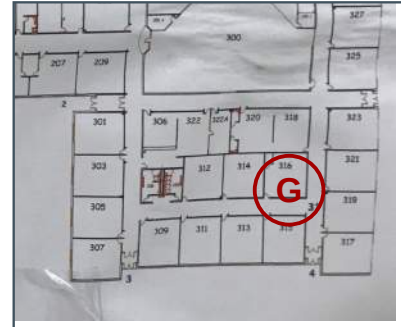
G9: General

Description: Stained ceiling tile

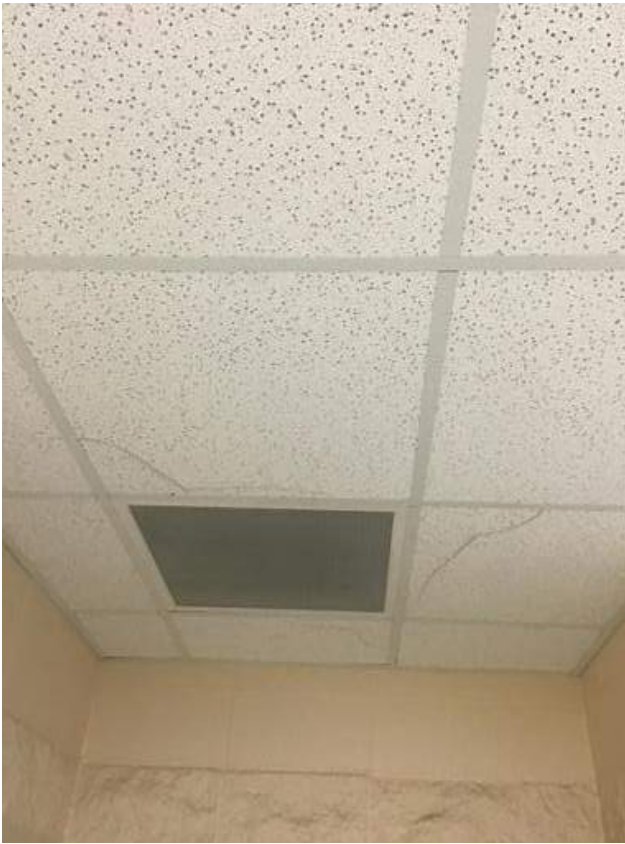
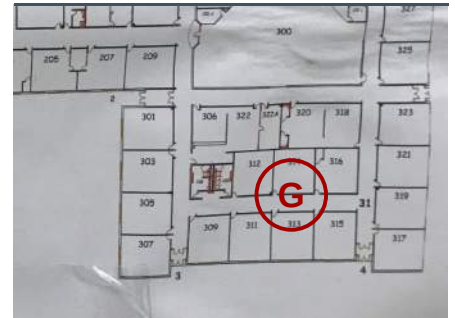
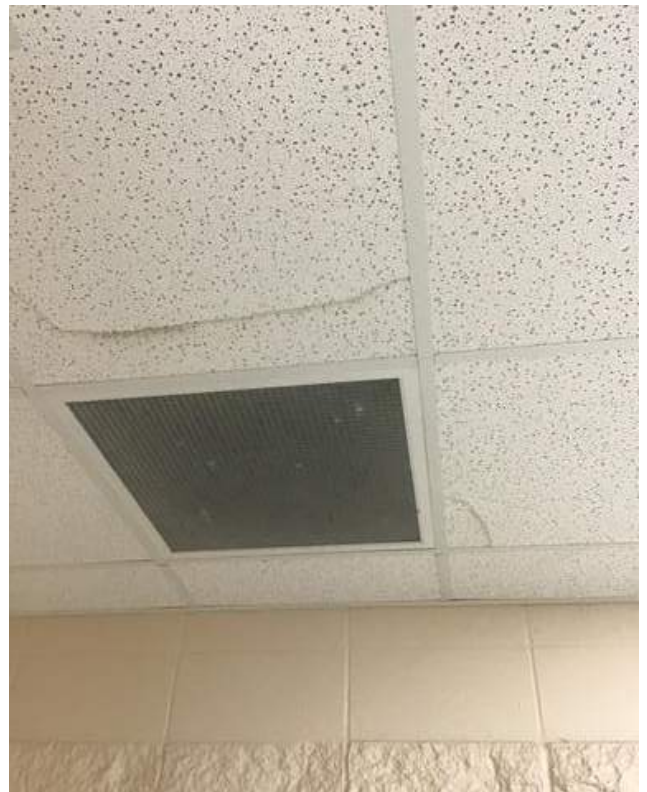
G10: General

Description: Stained ceiling tile

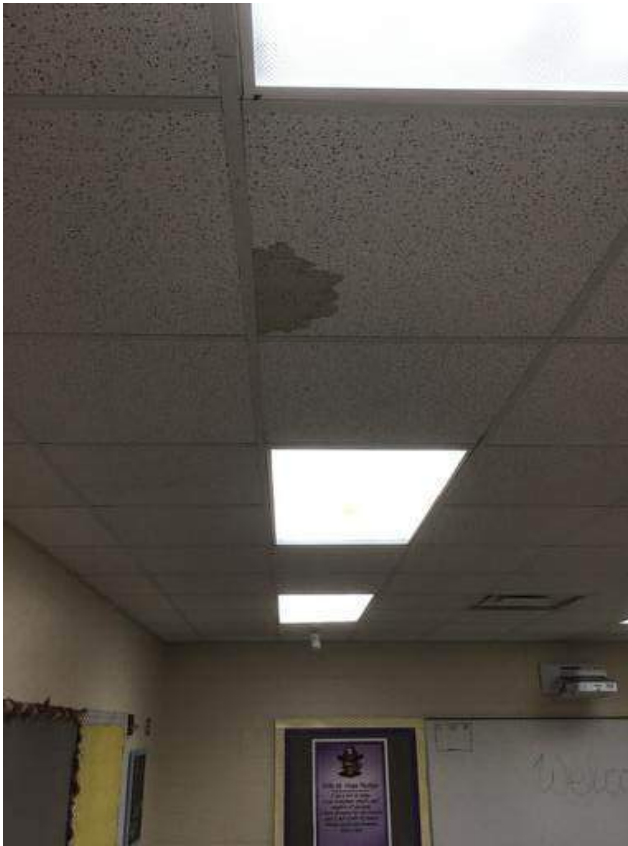
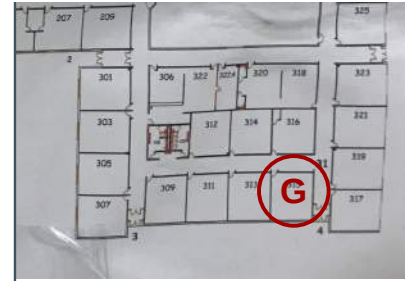
G11: General

Description: Stained ceiling tile

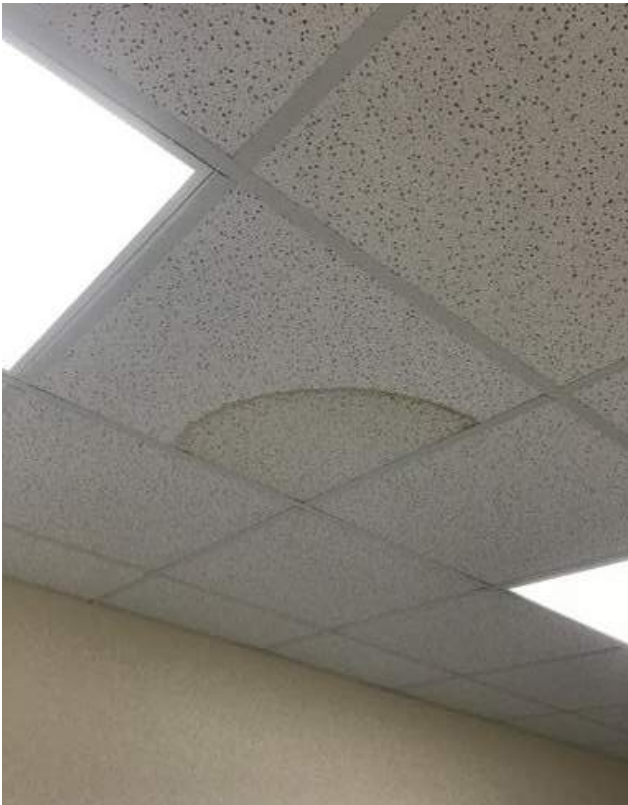
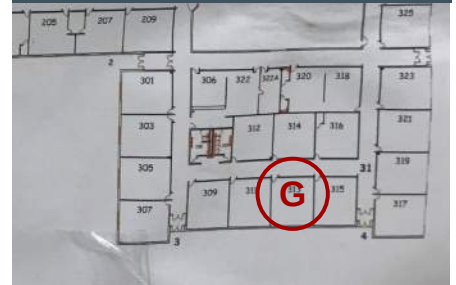
G12: General

Description: Rusted conduit

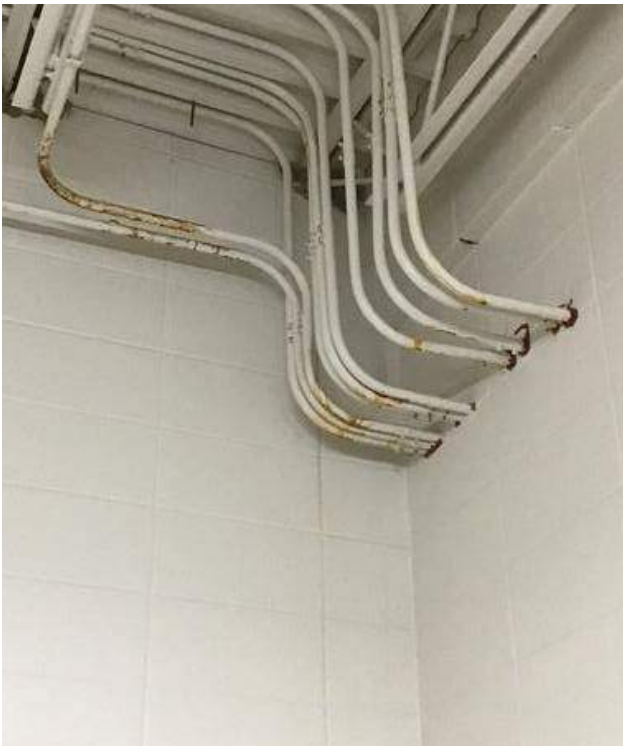
G13: General

Description: Damaged ceiling

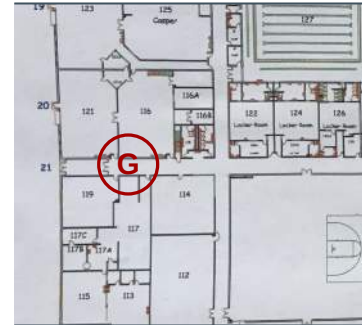
G14: General

Description: Damaged ACT

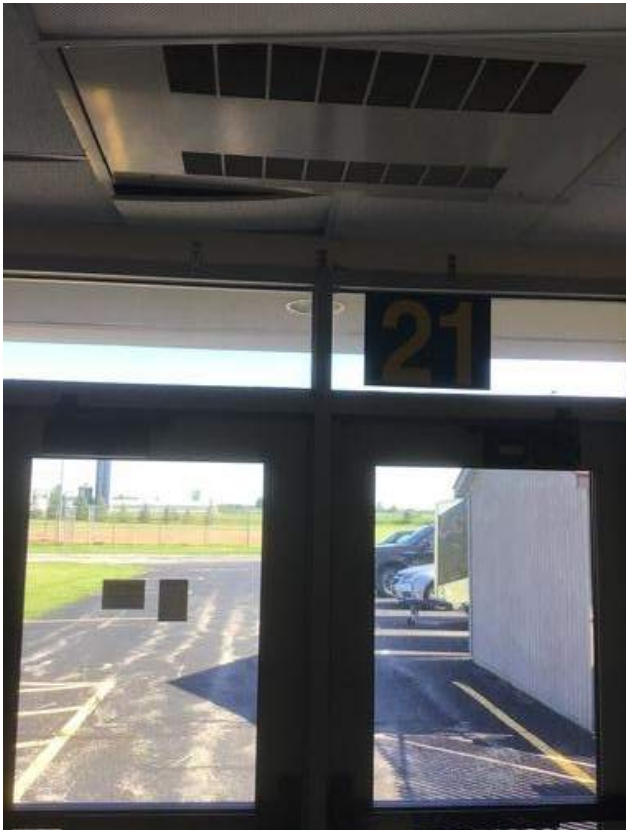
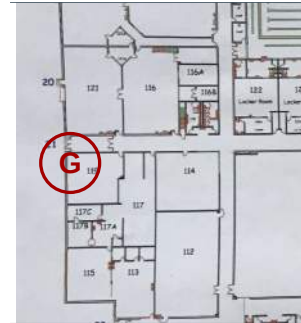
G15: General

Description: Stained ACT

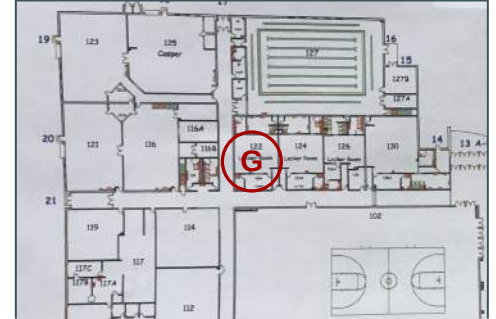
G17: General

Description: Stained ceiling grid

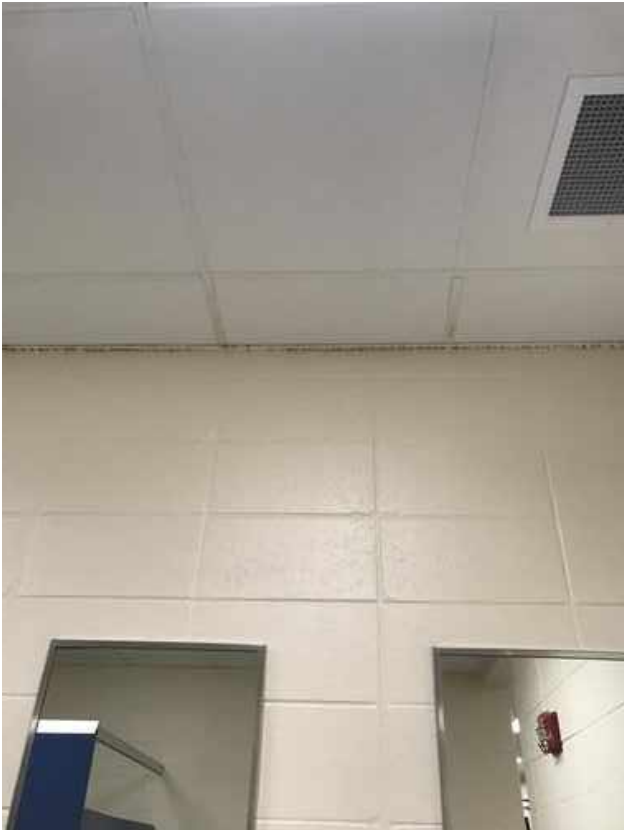
G18: General

Description: Cracked tile

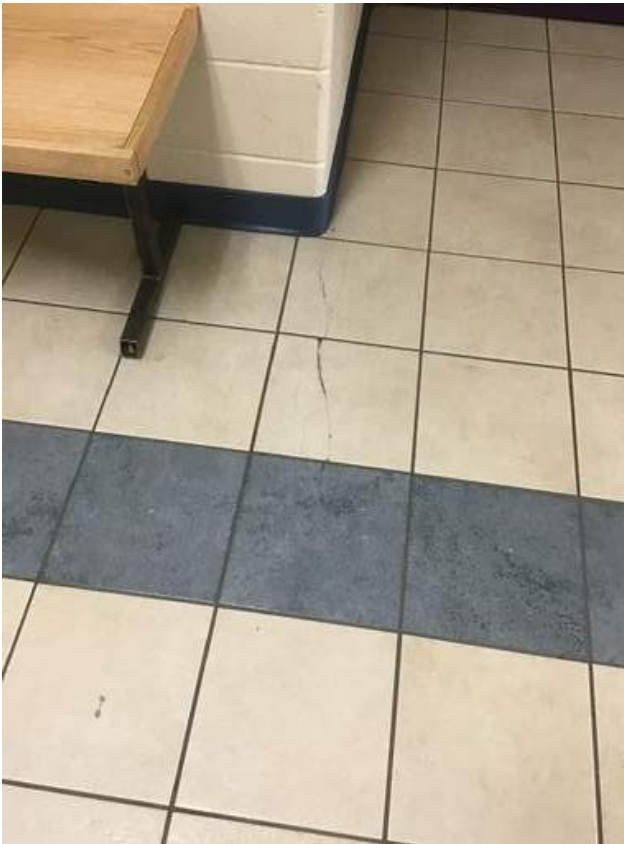
Description: Cracked floor tile

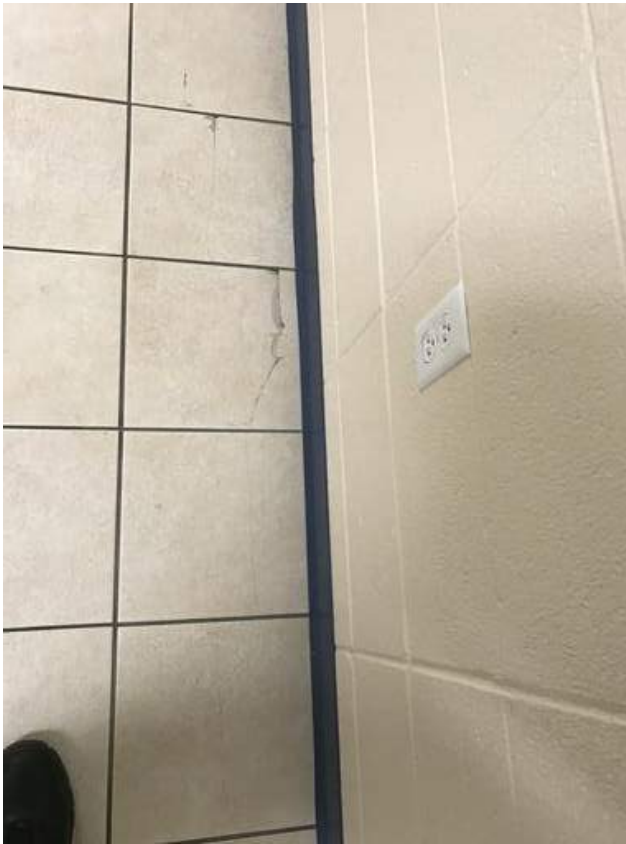
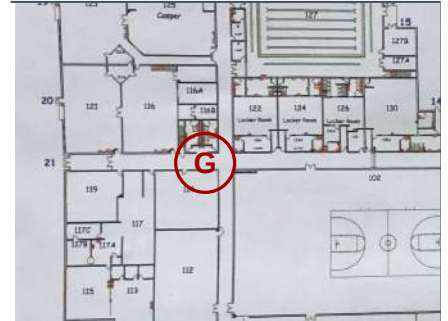
G20: General

Description: Cracked floor

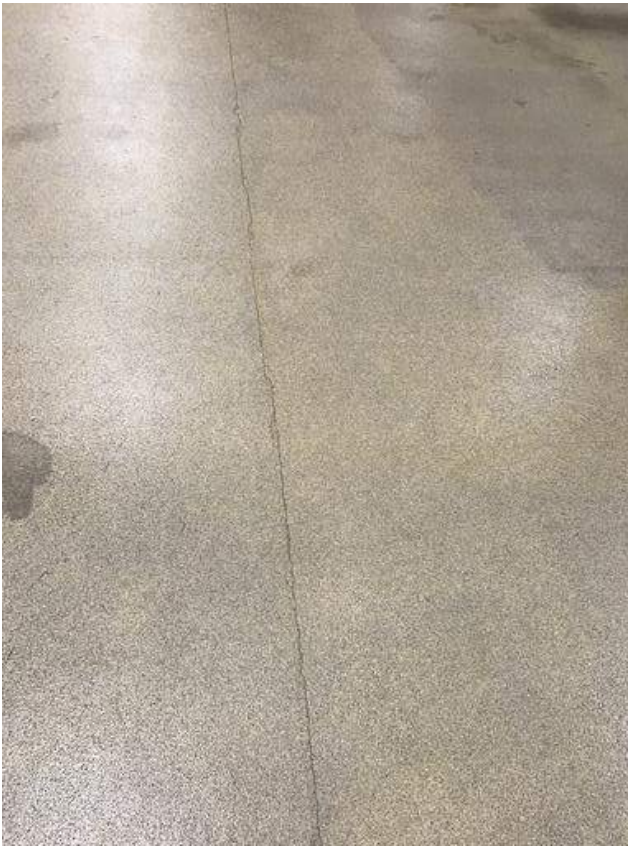
G21: General

Description: Stained ceiling

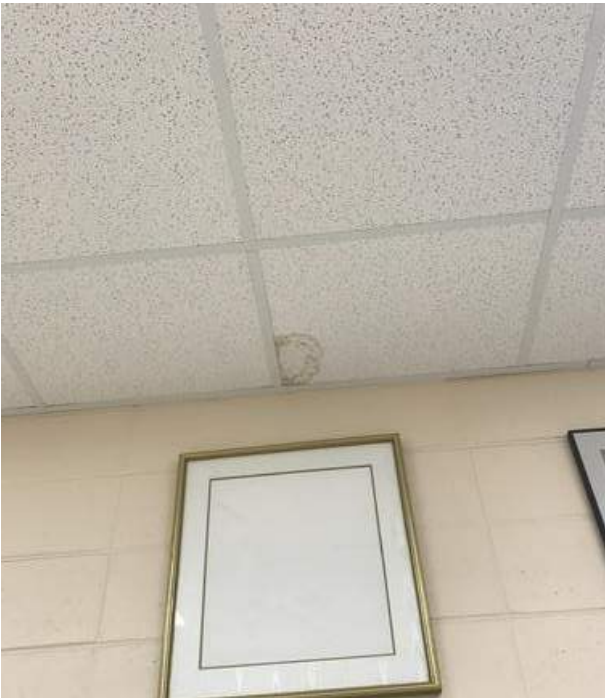
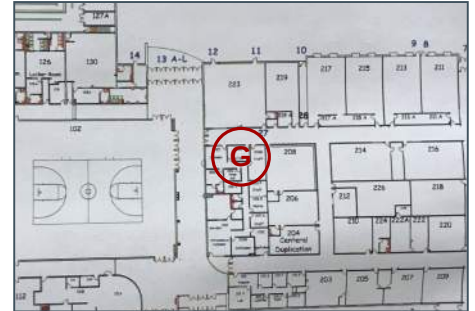
G22: General

Description: Hole in wall and chipped corner
