TWO RIVERS PUBLIC SCHOOLS

FACILITIES ASSESSMENT REPORT

08.19.21

Two Rivers School District Facilities Assessment July 2021

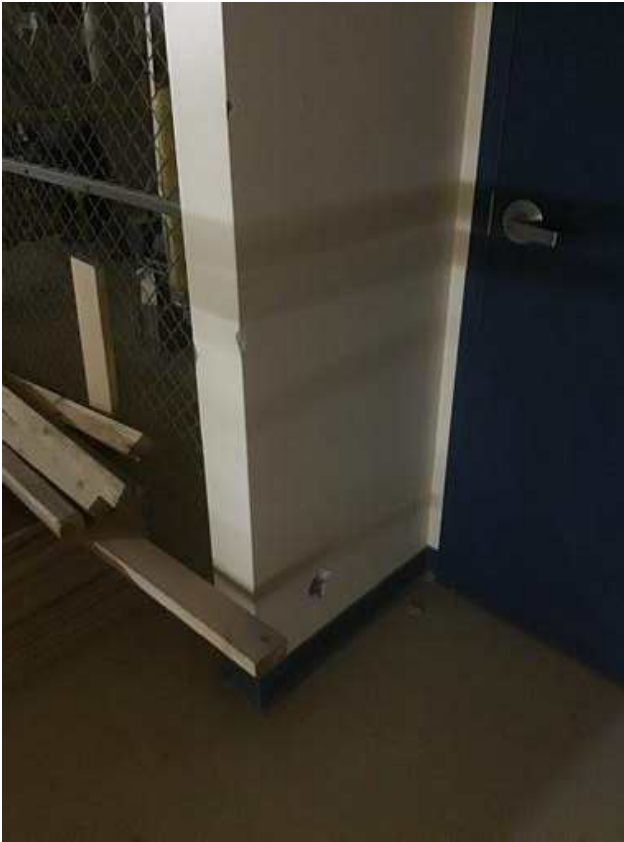
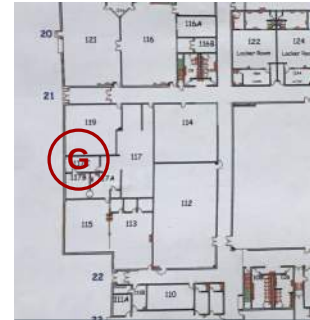
G23: General

Description: Cracked and stained floor

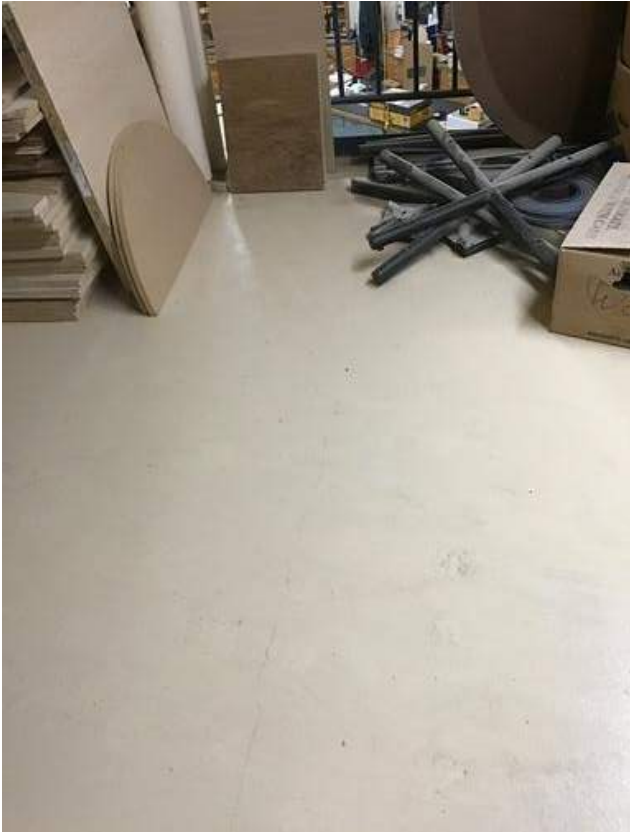
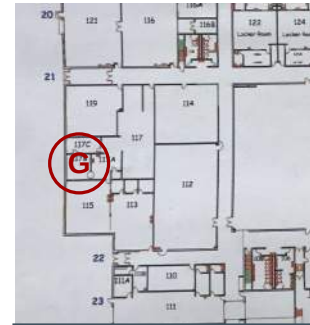
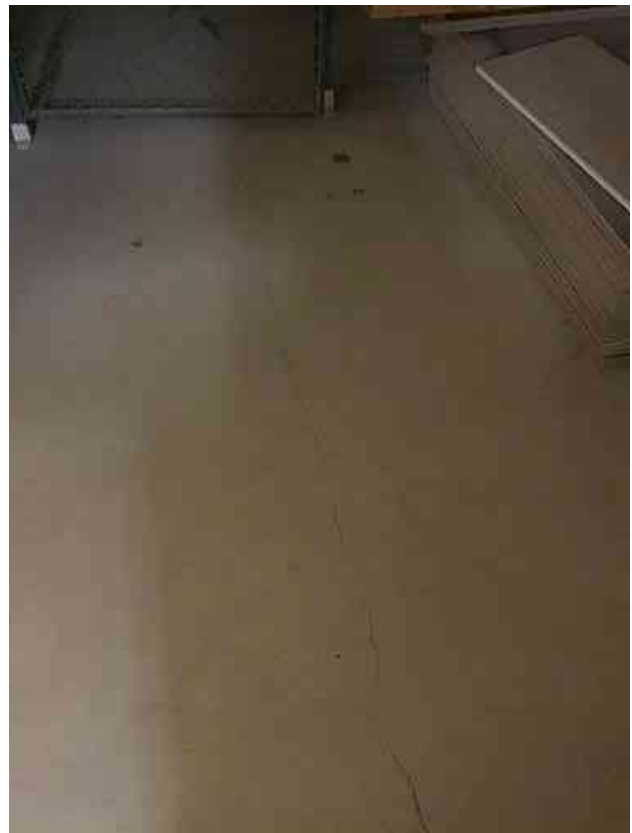
G24: General

Description: Wall cracks

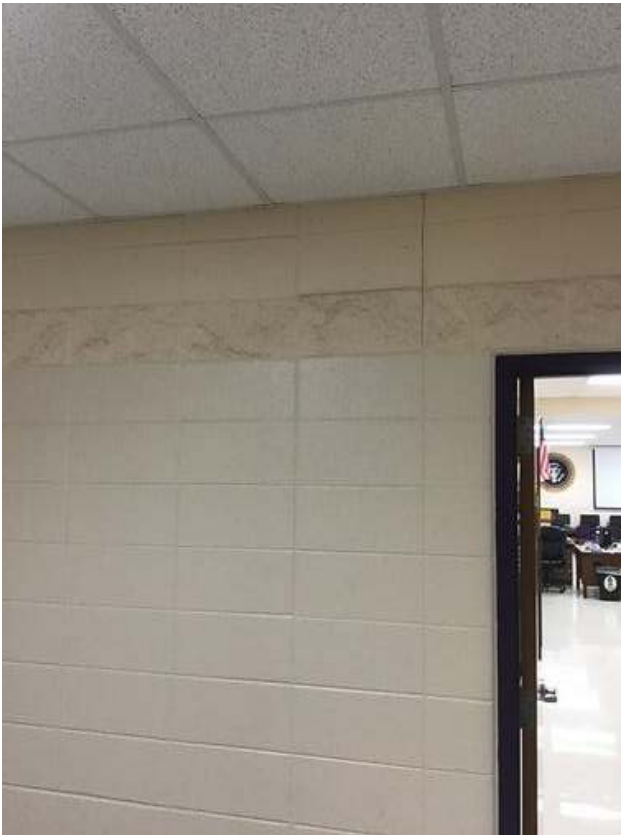
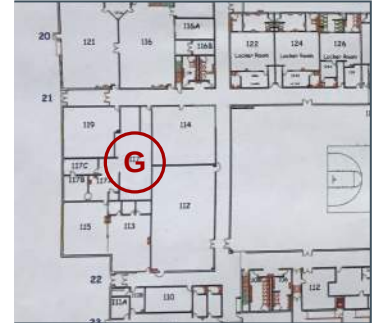
G25: General

Description: Stained ceiling grid

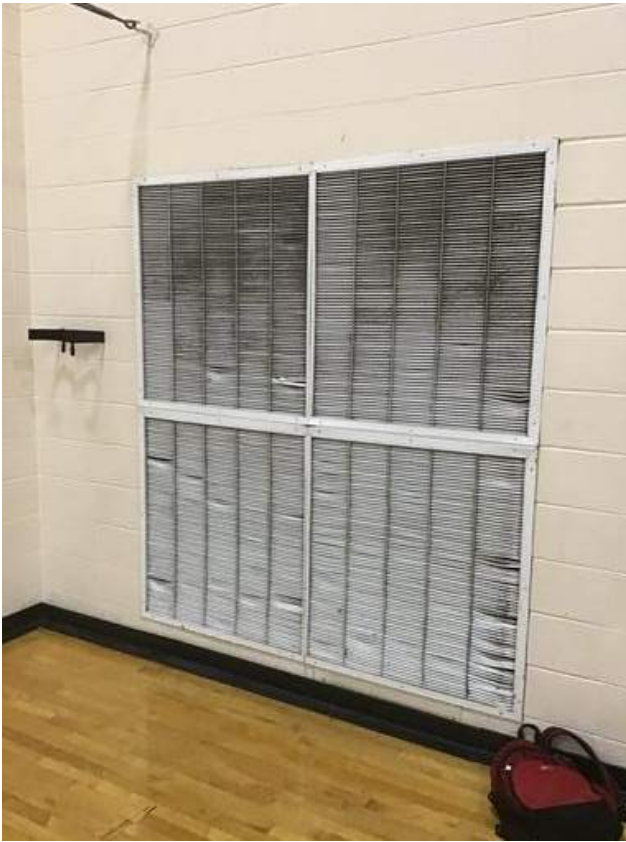
G26: General

Description: Bent vent

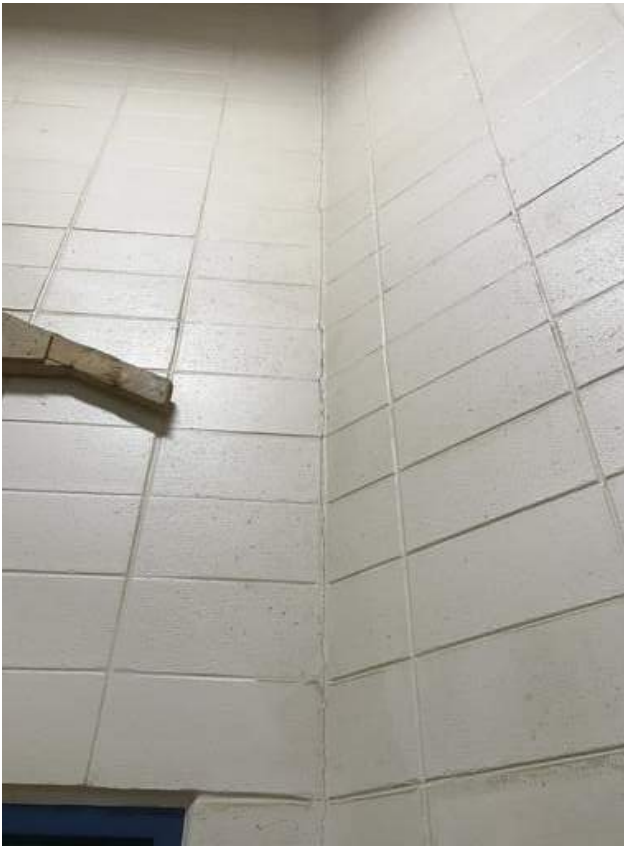
G27: General

Description: Cracks in wall

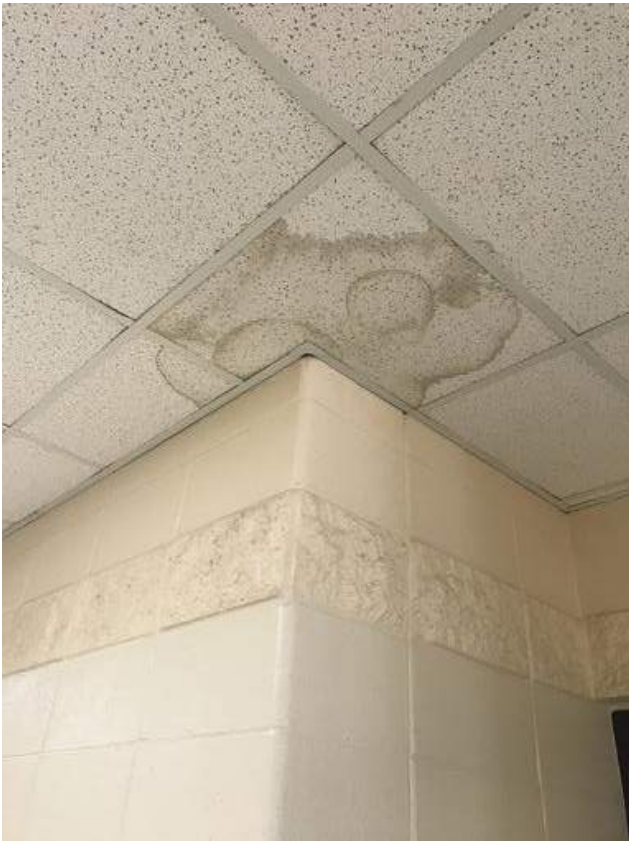
G28: General

Description: Stained ACT due to potential leaks

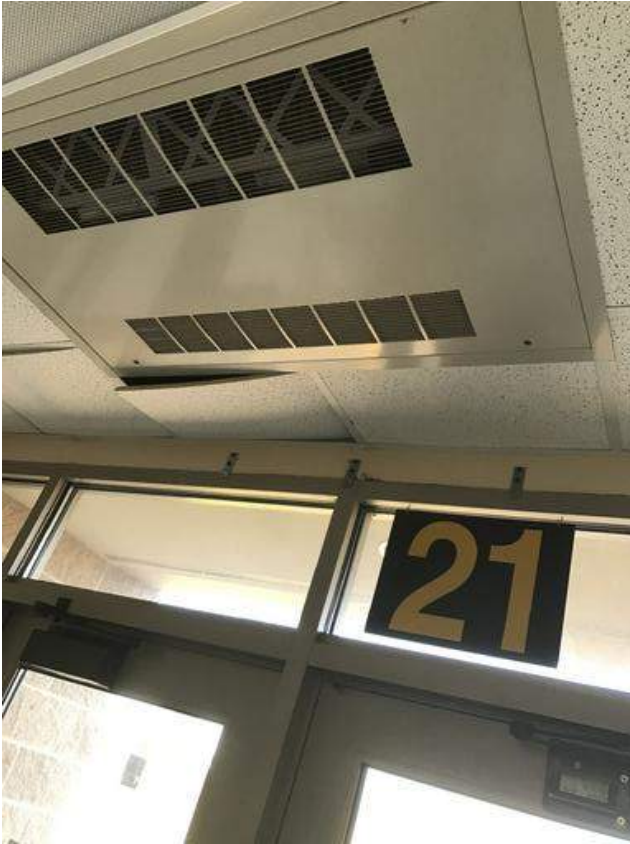
G30: General

Description: Hanging/loose ACT

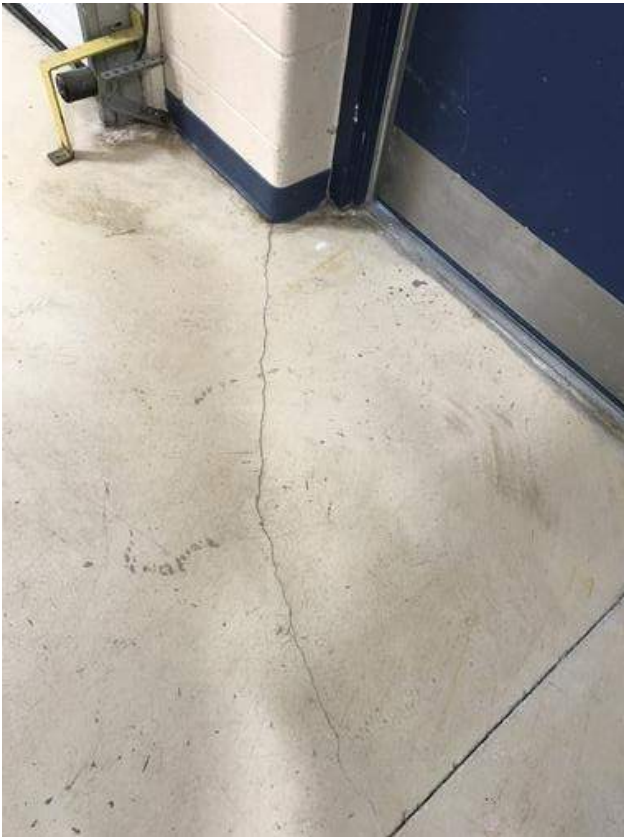
G32: General

Description: Crack in concrete floor

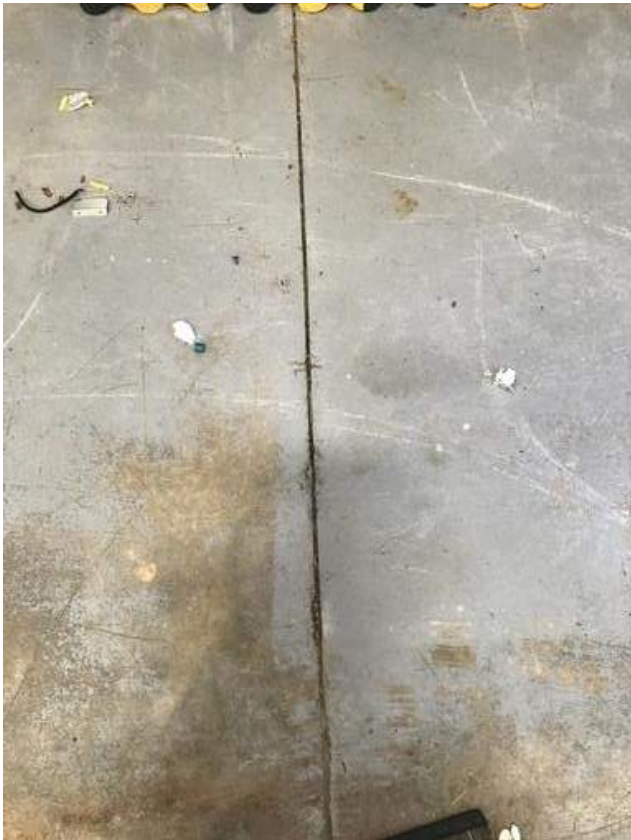
G34: General

Description: Scratched and worn floor

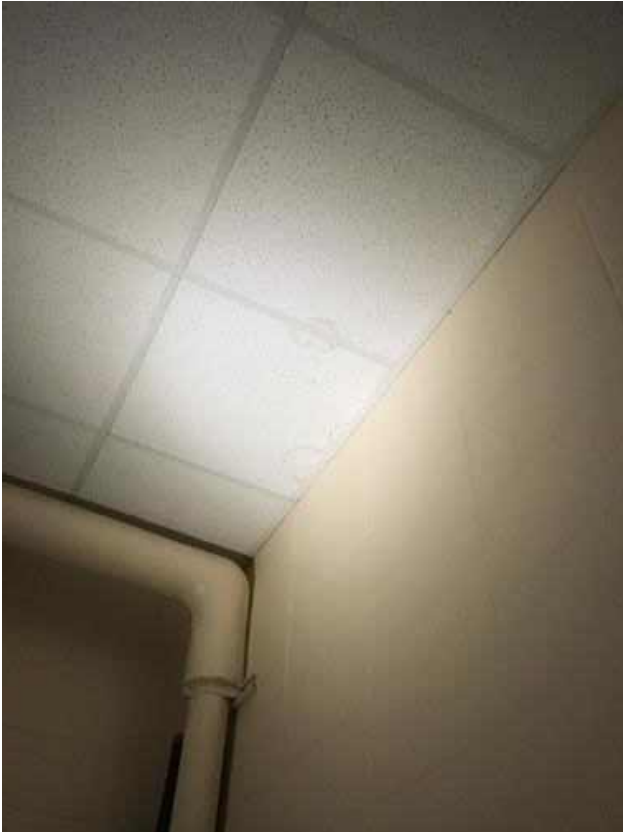
G35: General

Description: Stained ACT

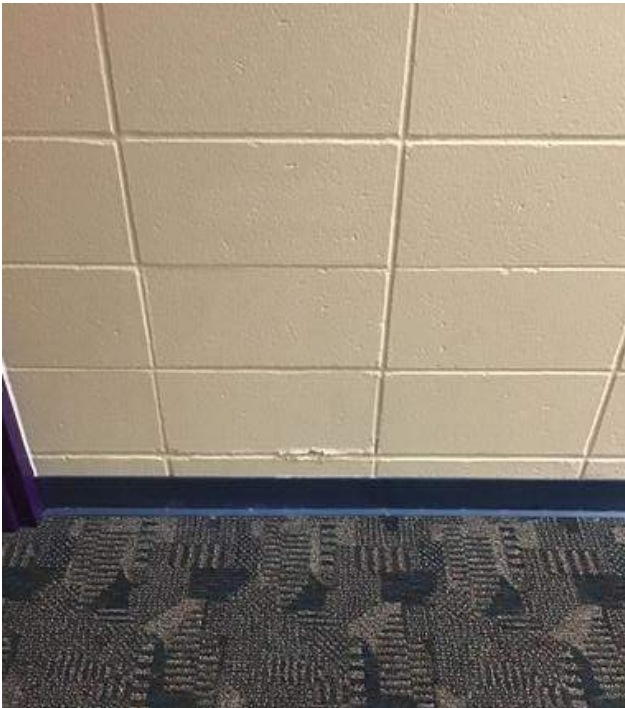
G37: General

Description: Peeling wall paint

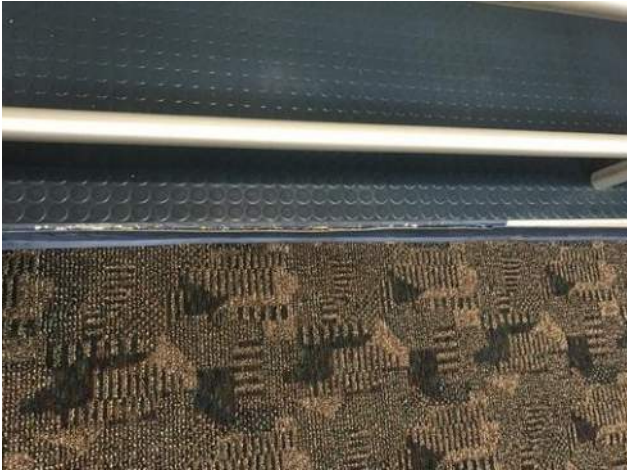
G38: General

Description: Damaged trim at flooring

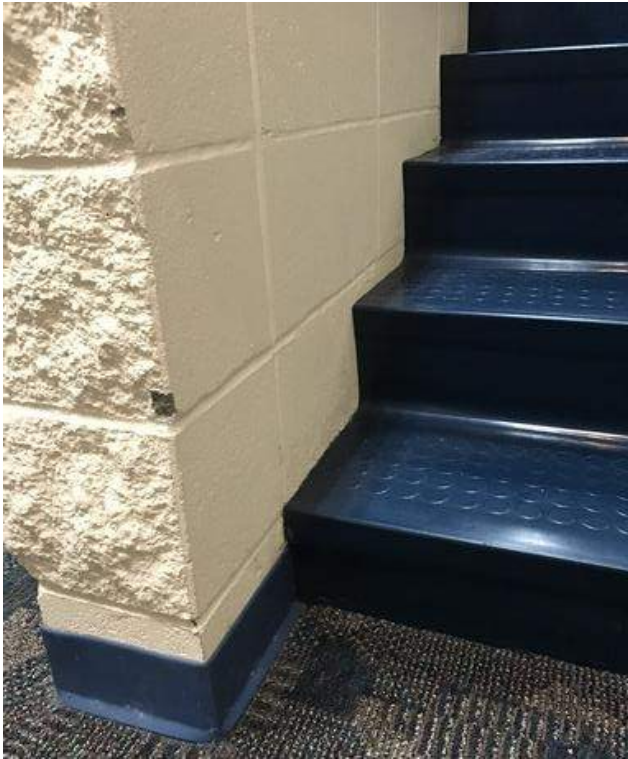
G39: General

Description: Chipped paint at corner of wall

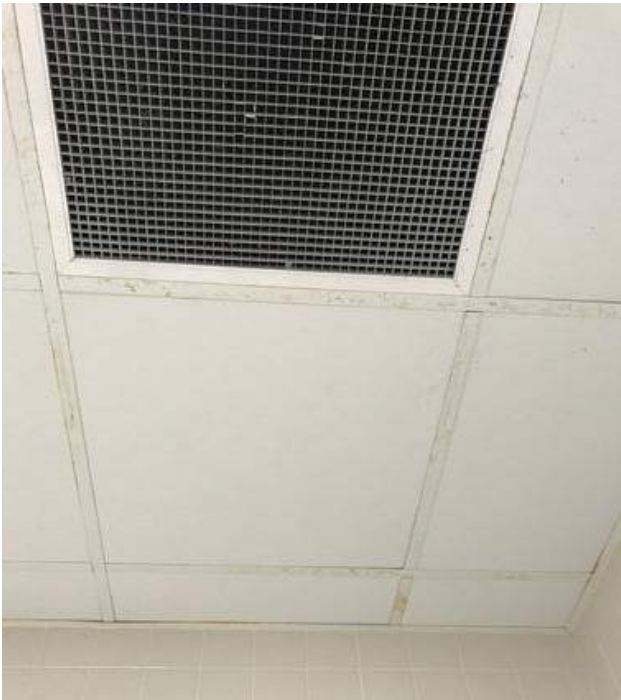
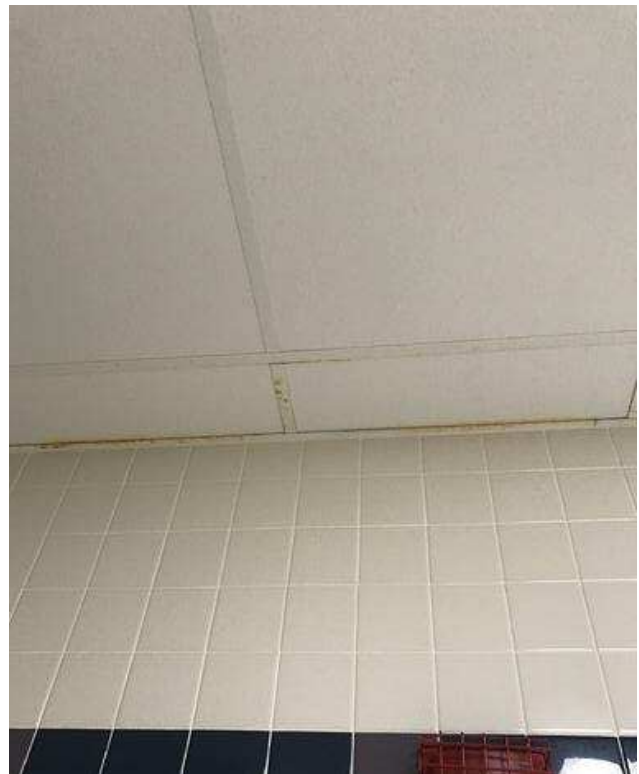
G40: General

Description: Stained ceiling grid

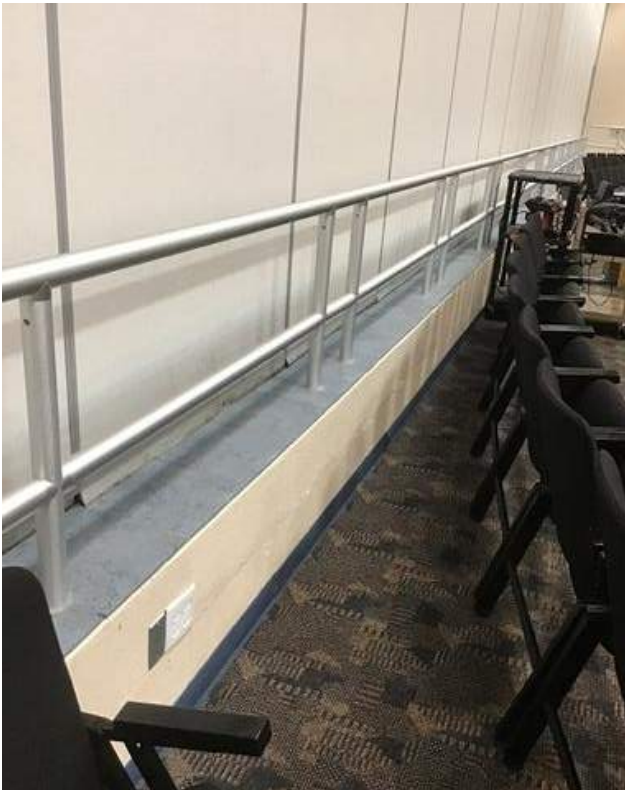
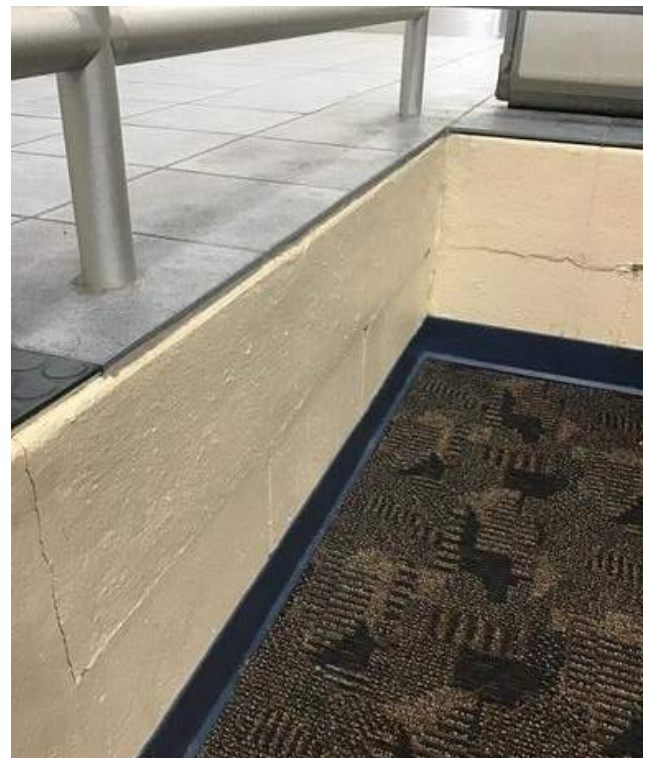
G41: General

Description: Cracked concrete

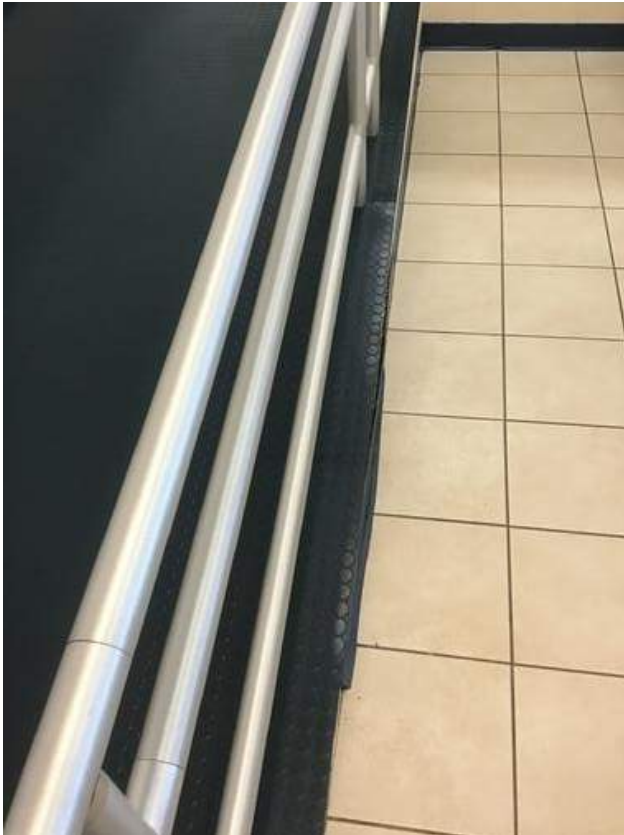
G42: General

Description: Damaged flooring

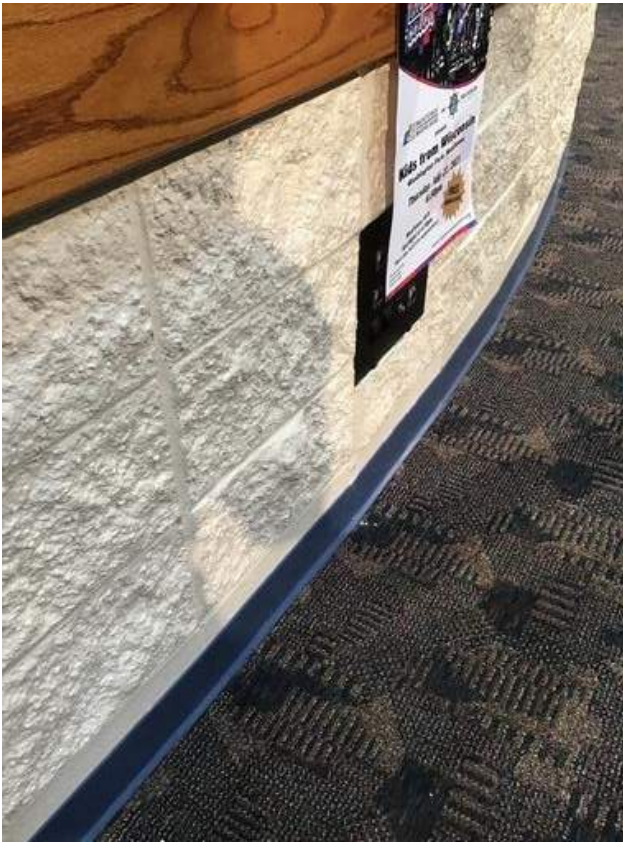
G43: General

Description: Moisture in carpet

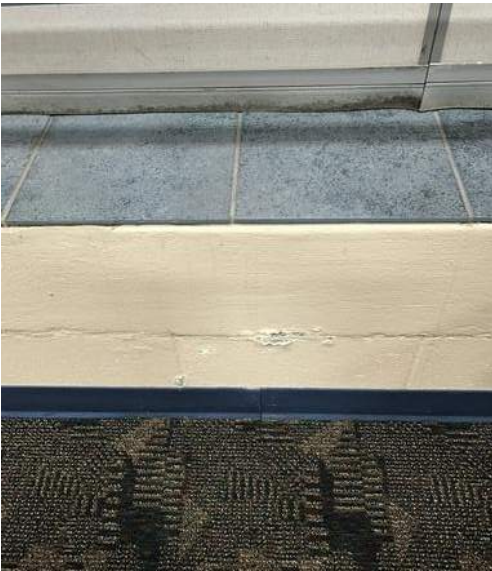
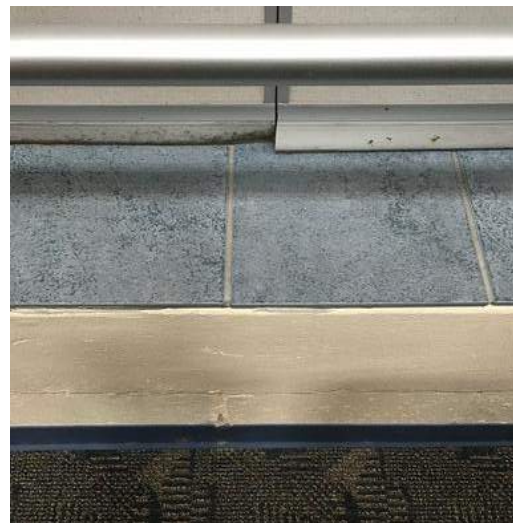
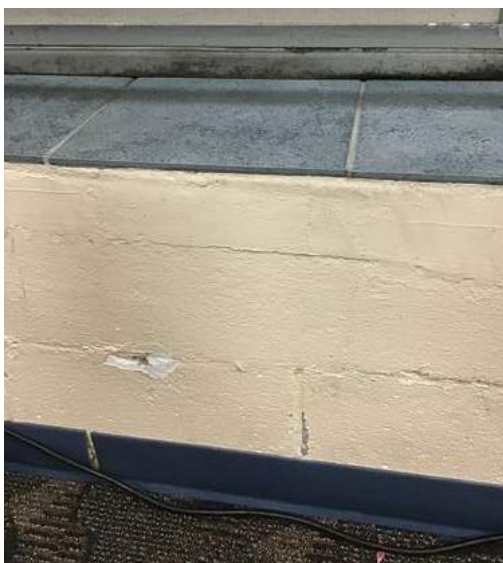
Description: Wall base damage and chipped paint

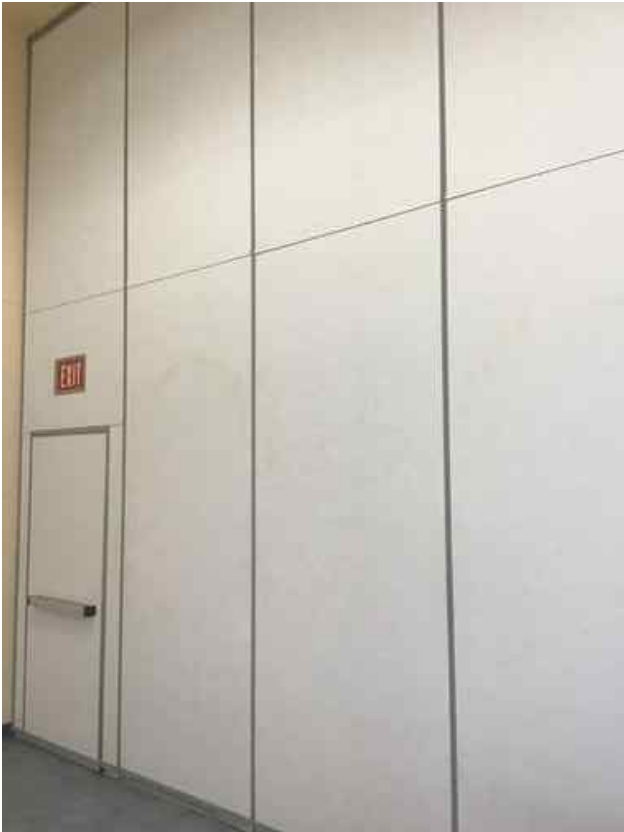
G45: General

Description: Stained wall

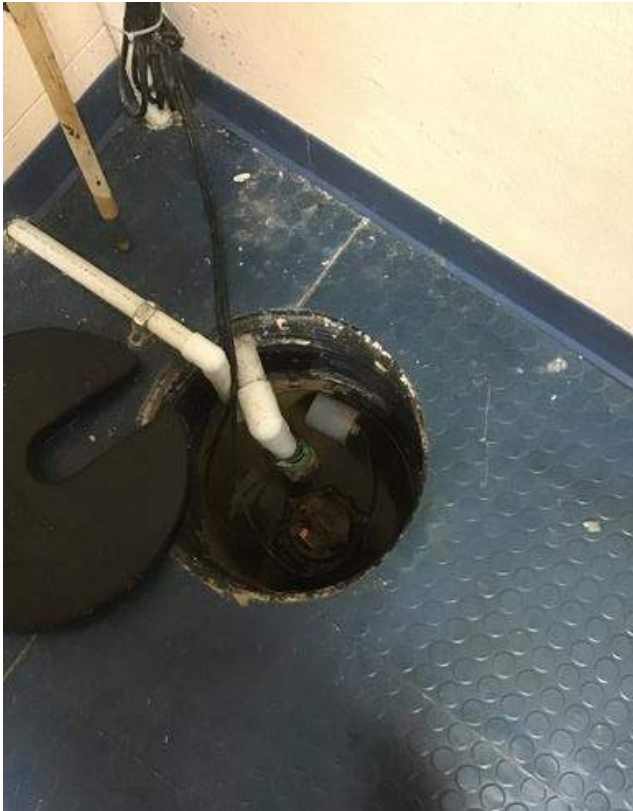
G46: General

Description: Current pump to keep water level below building

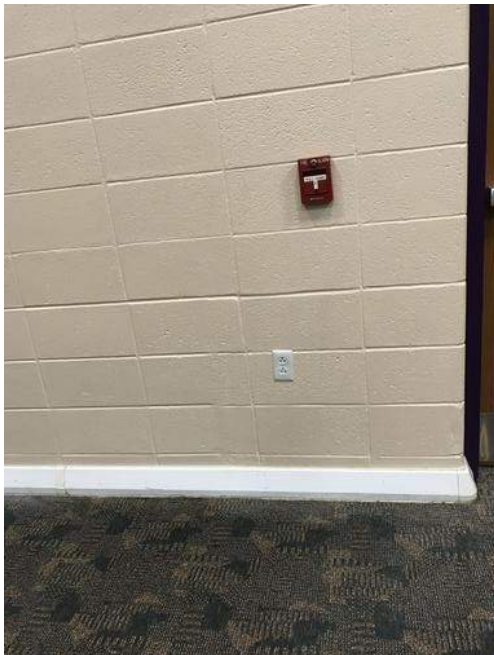
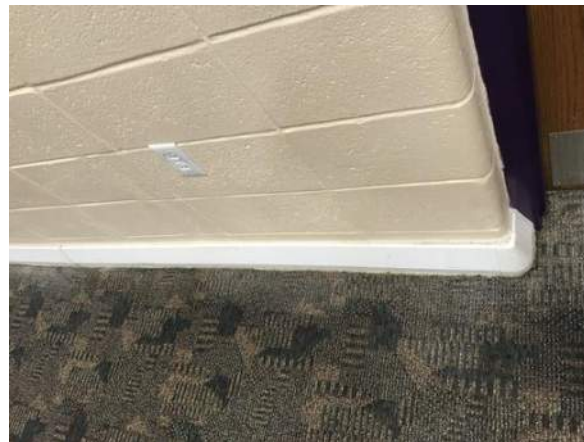
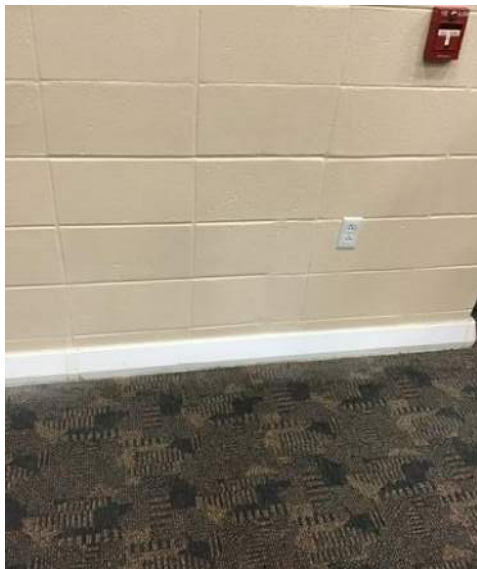
G47: General

Description: Stains and moisture in carpet

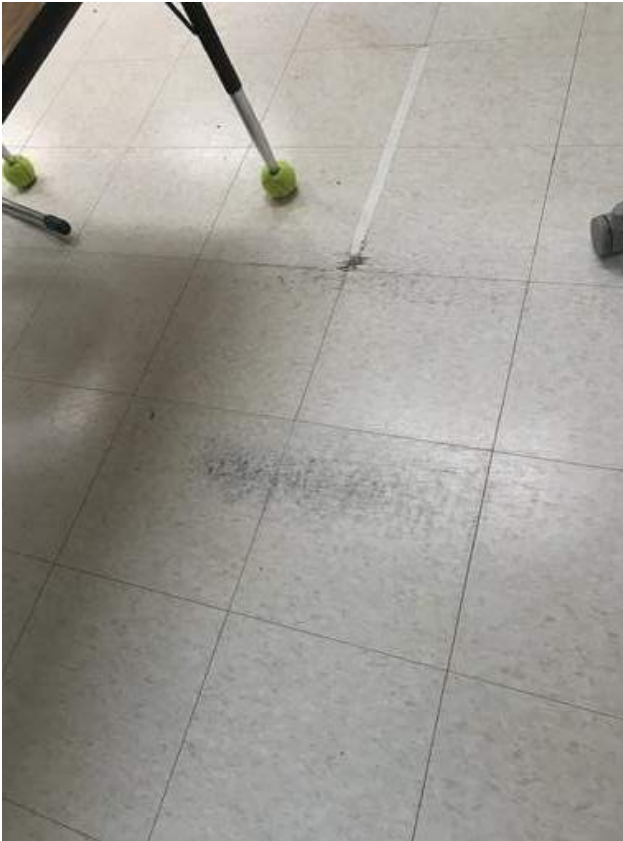
G48: General

Description: Scratches on floor

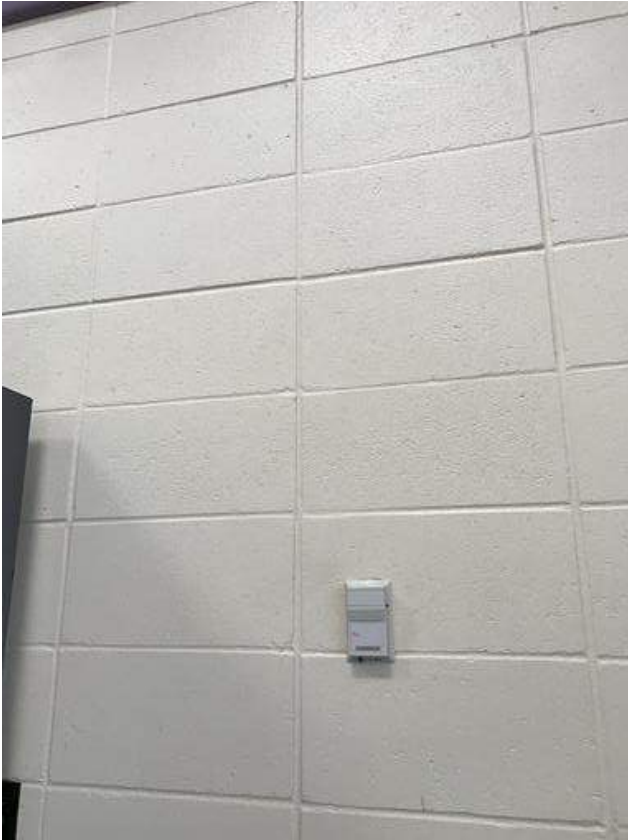
G48: General

Description: Crack on the wall

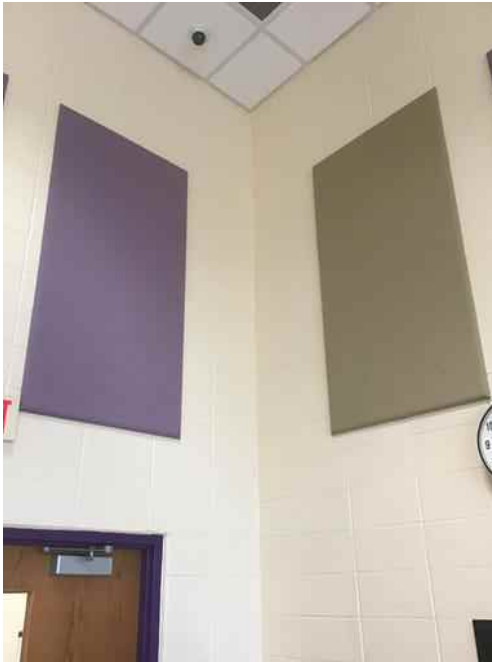
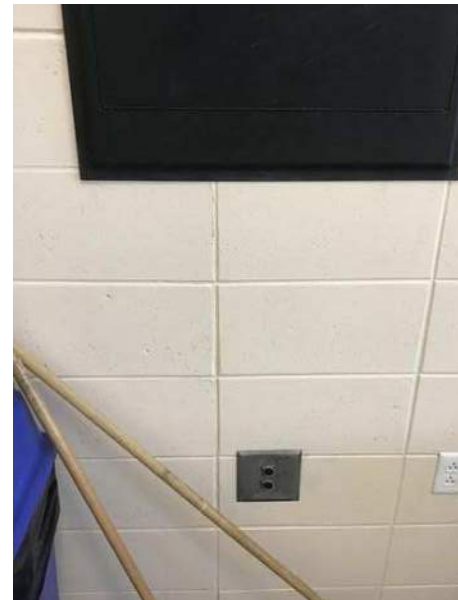
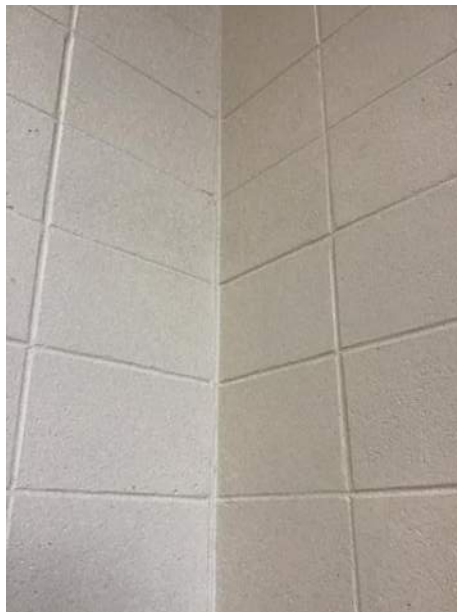
G50: General

Description: Wall cracks

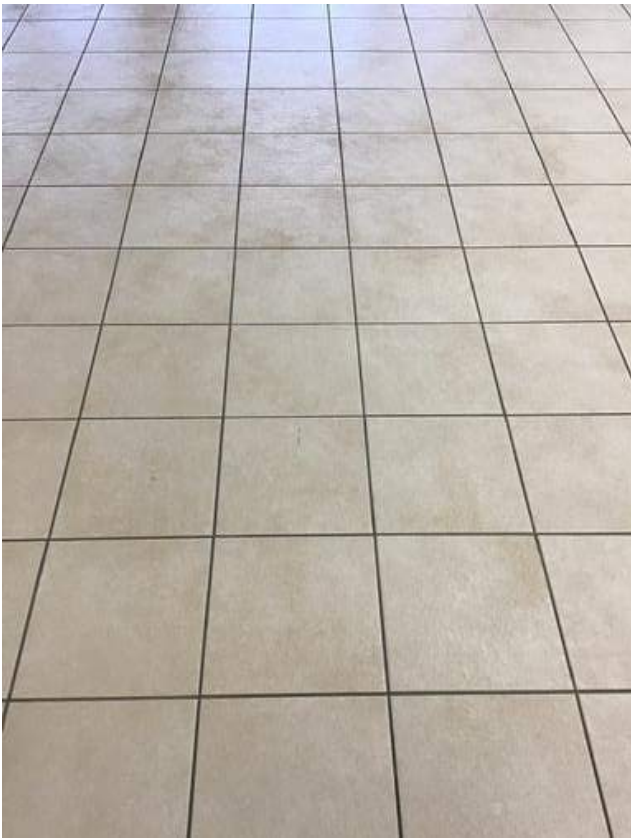
G51: General

Description: Cracked floor tile in the hallway area

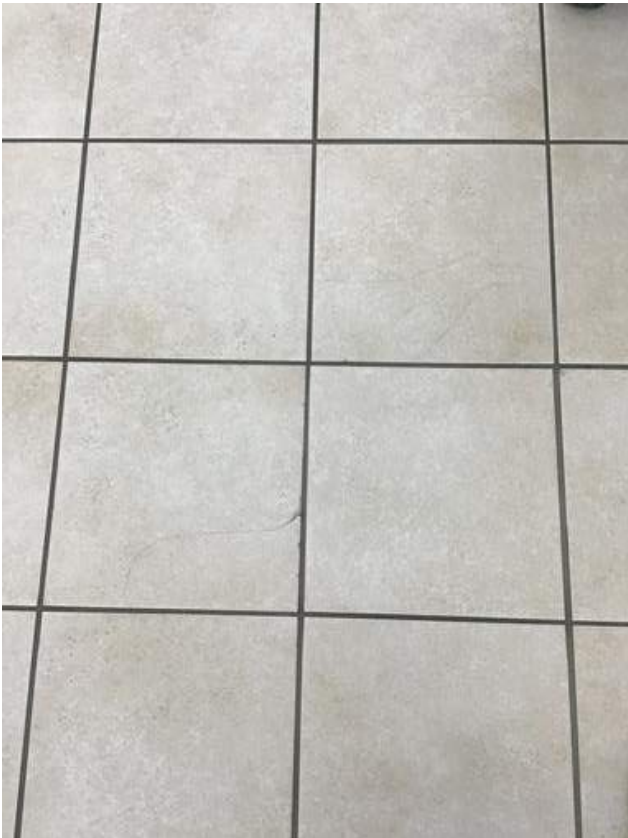
G52: General

Description: Cracked floor tile

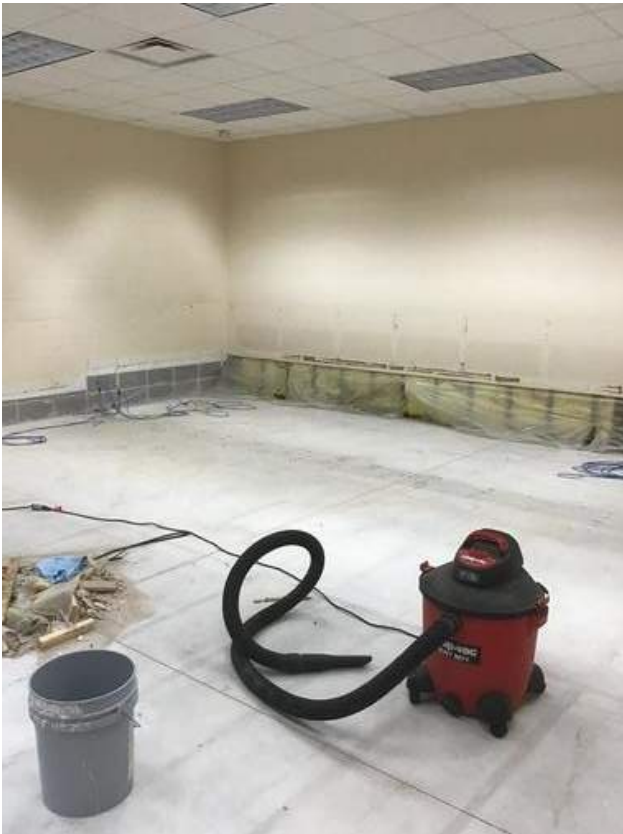
G53: General

Description: Drywall work

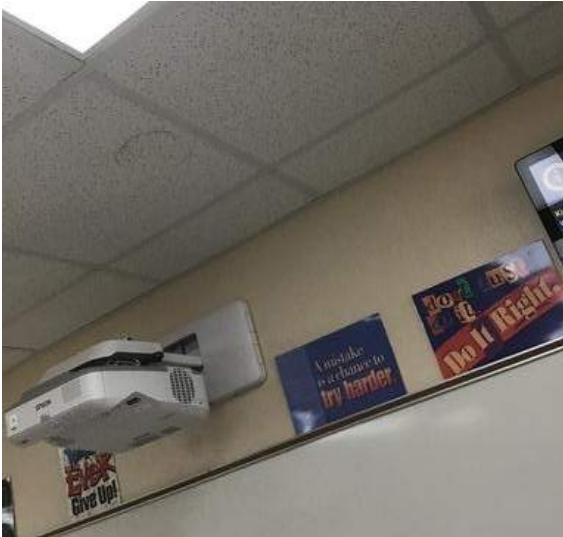
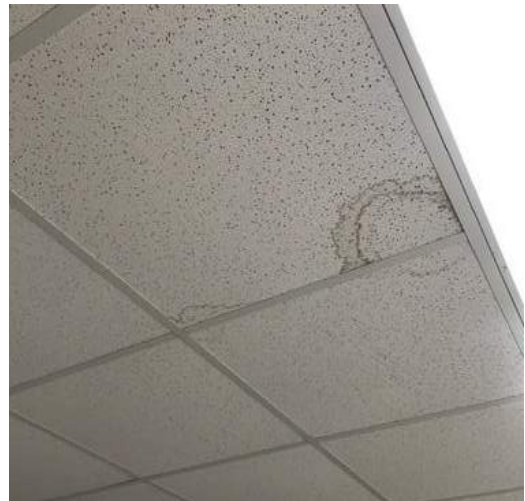
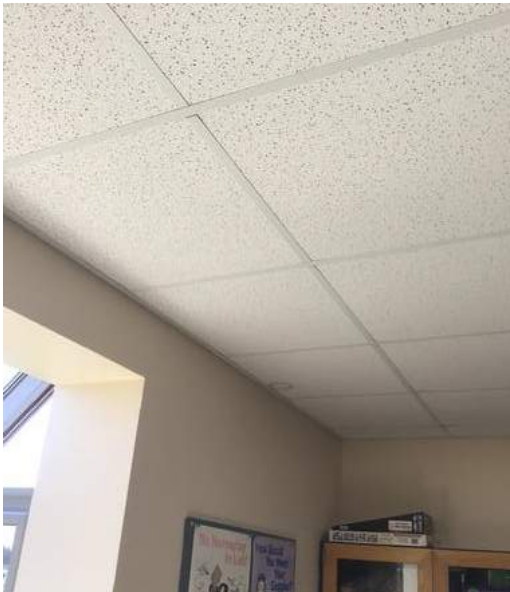
G54: General

Description: Stained ACT

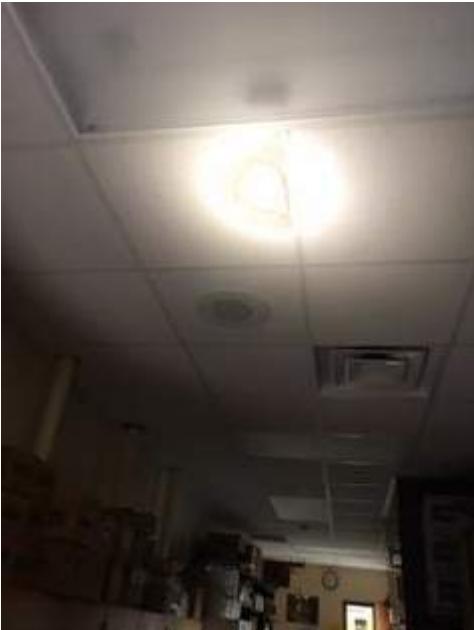
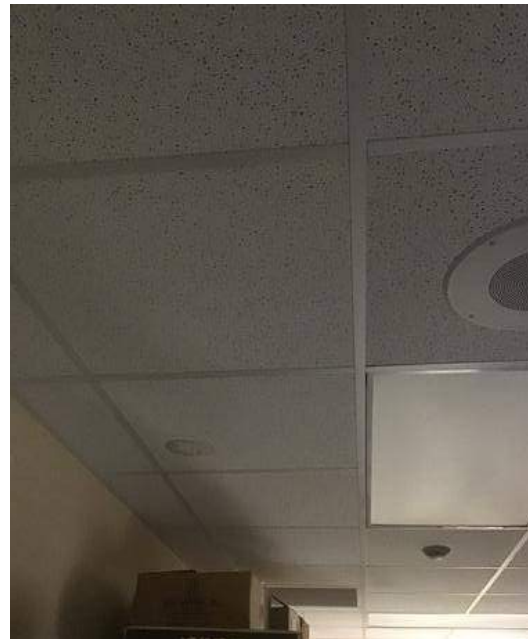
G55: General

Description: Stained ceiling

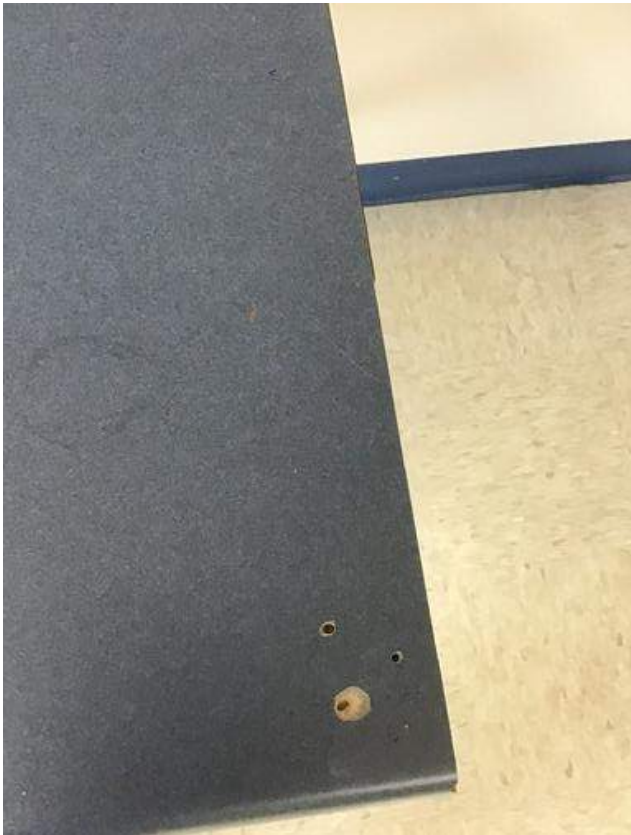
G56: General

Description: Holes in counter top

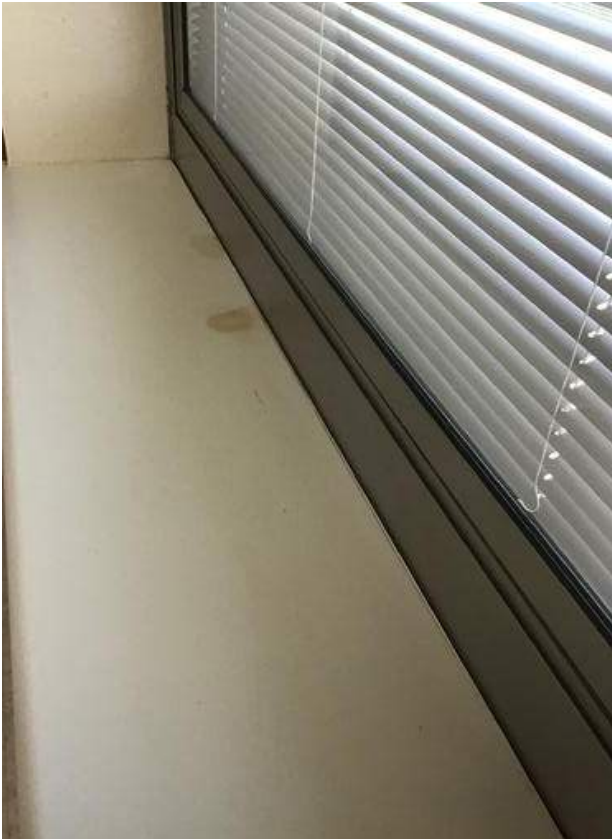
G57: General

Description: Caulking needed at window

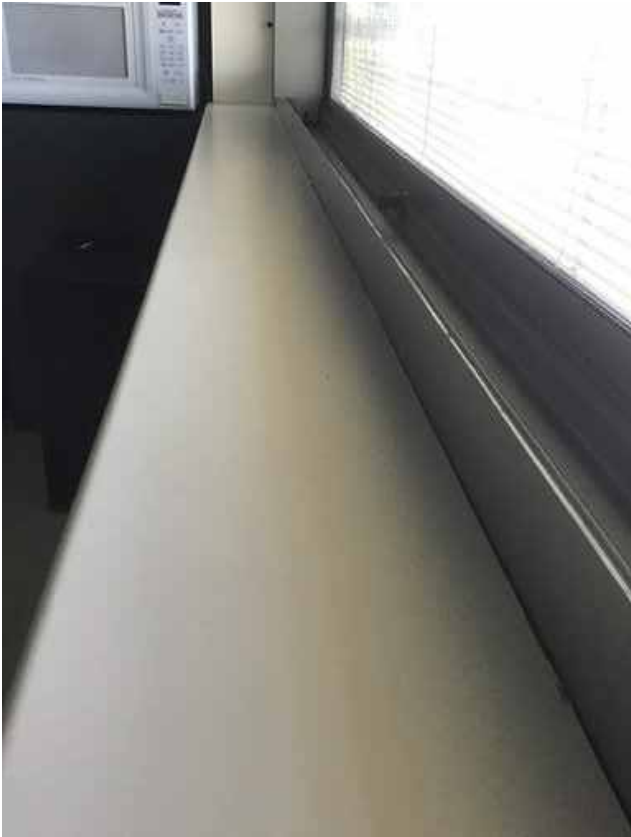
G58: General

Description: Caulking needed at window

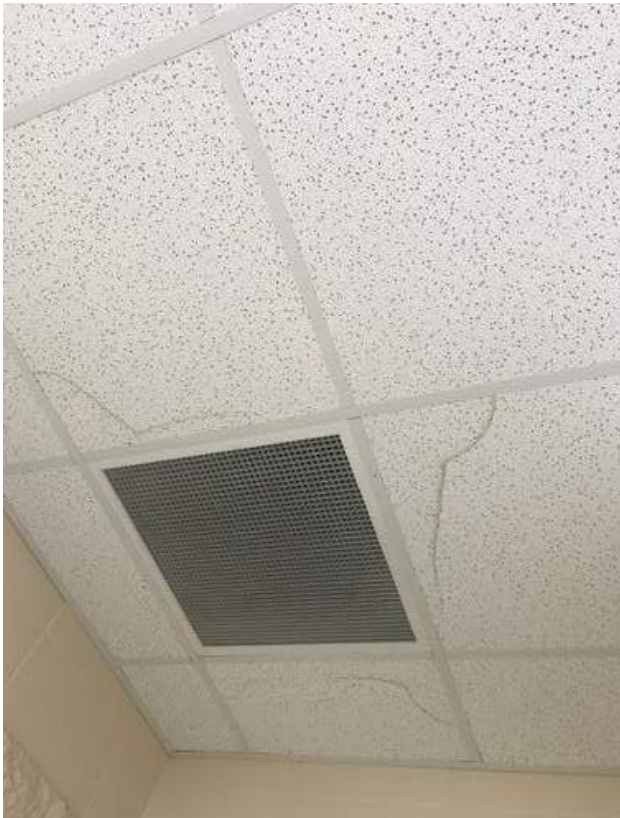
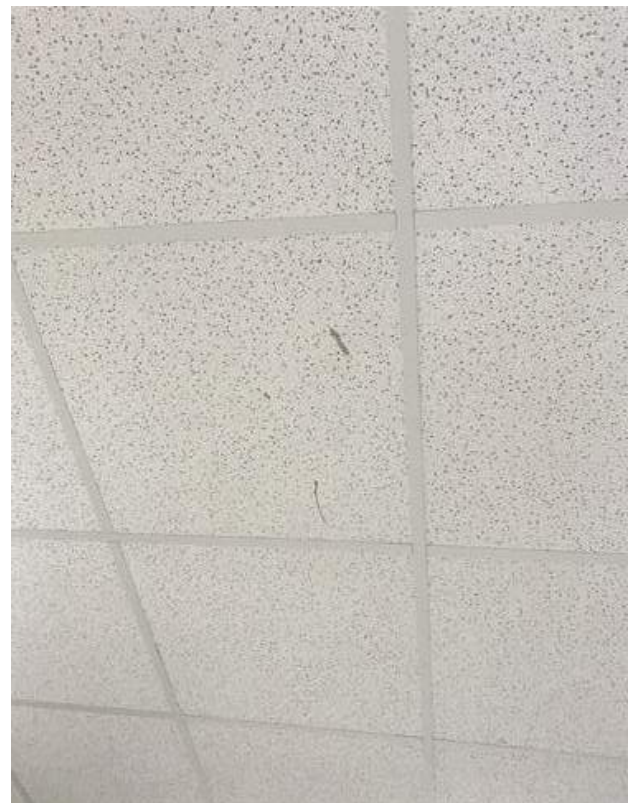
Description: Stained ceiling

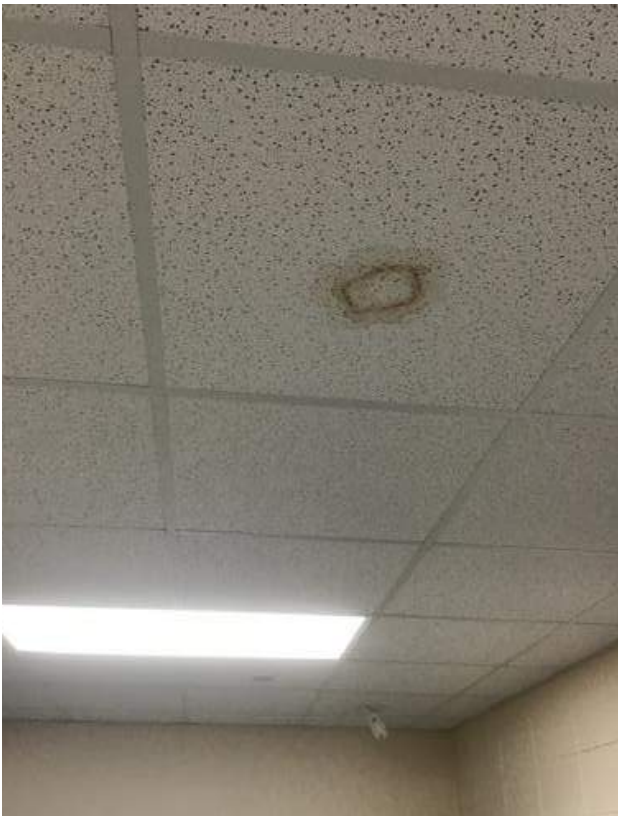
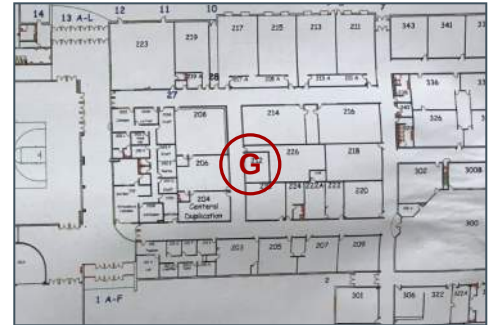
G60: General

Description: Stained ACT

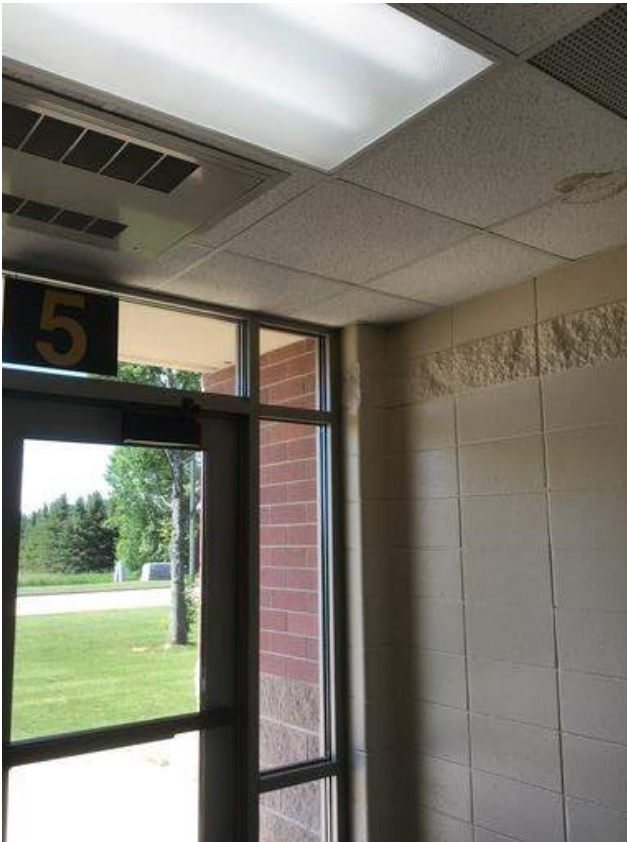
G61: General

Description: Stained ACT

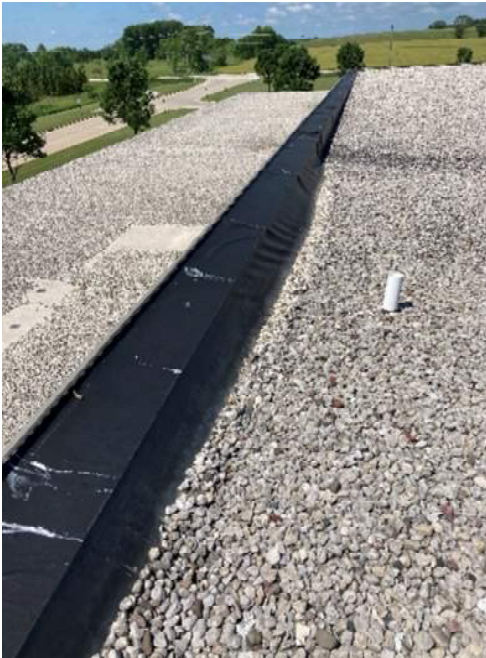
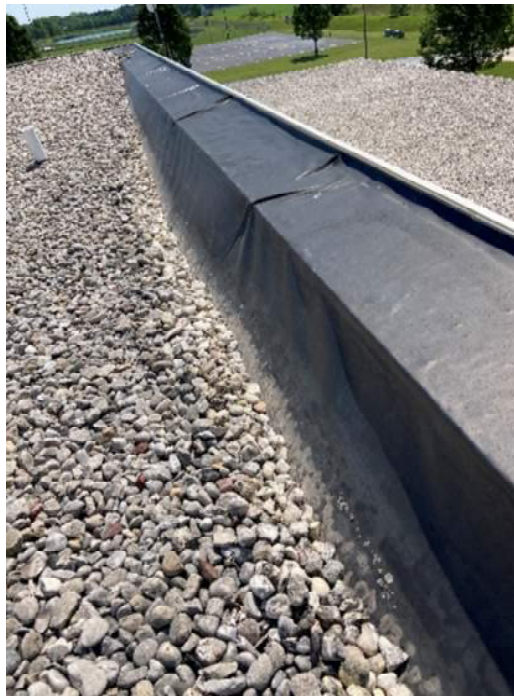
R1: Roof

Description: Pillowing at parapet
