TWO RIVERS PUBLIC SCHOOLS

FACILITIES ASSESSMENT REPORT

08.19.21

Two Rivers School District Facilities Assessment July 2021

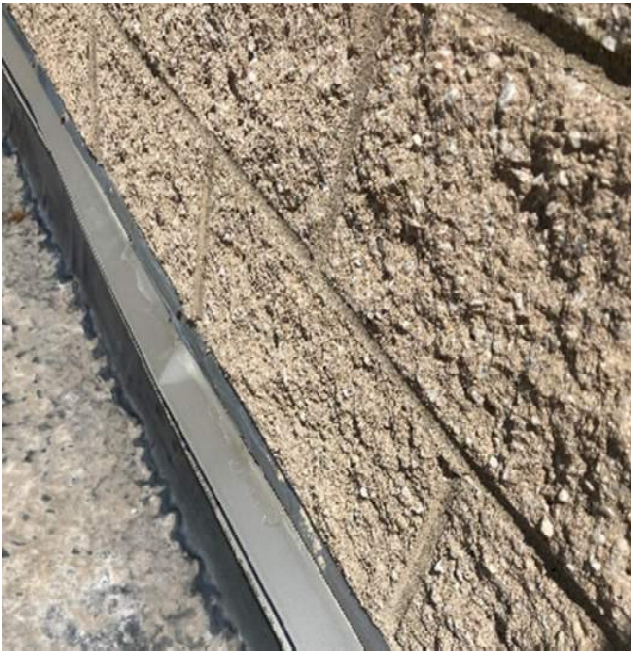
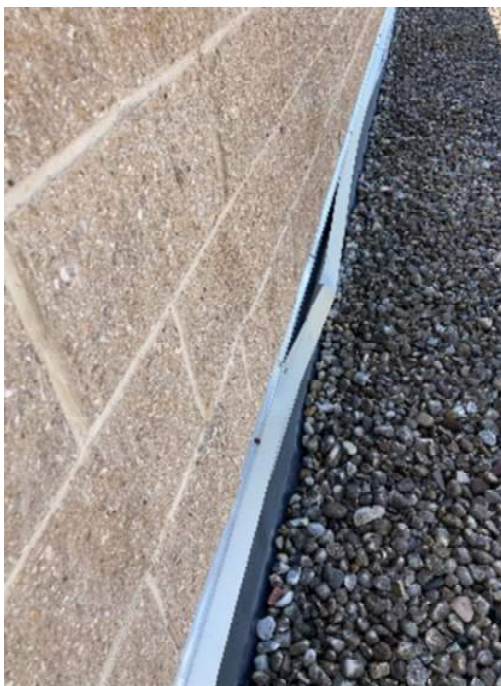
R2: Roof

Description: Bent and damaged flashing

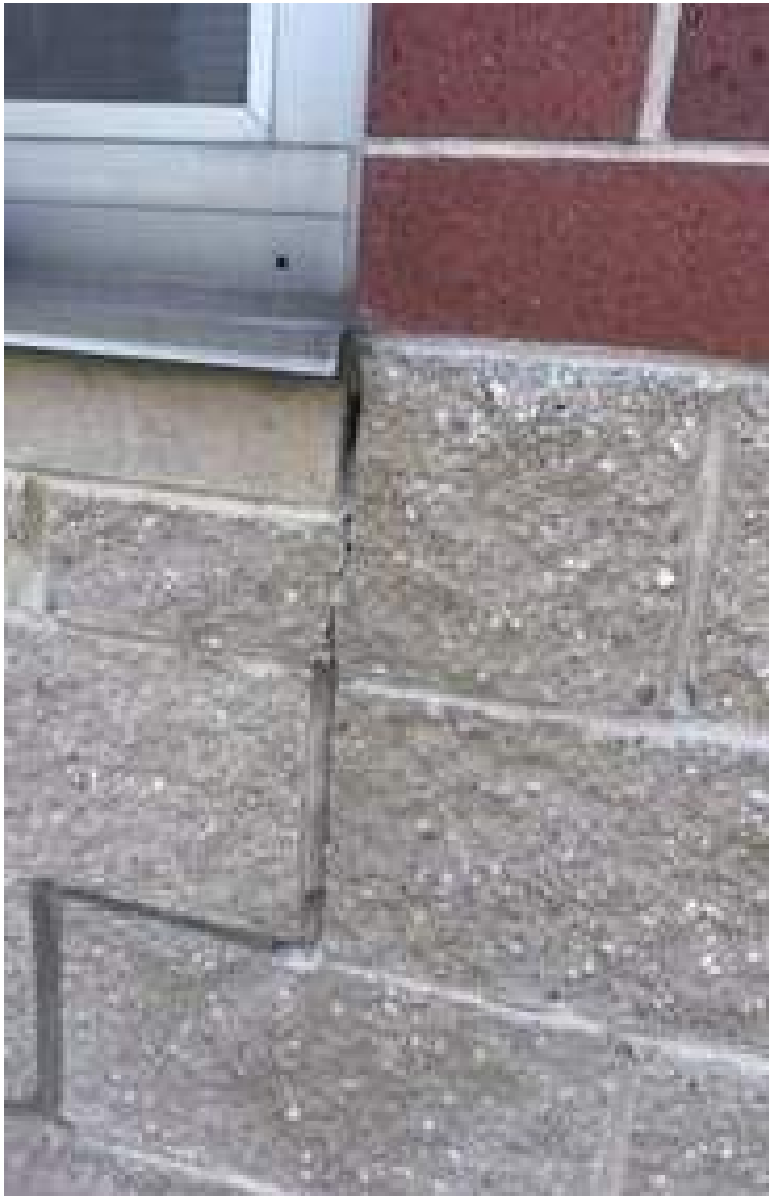
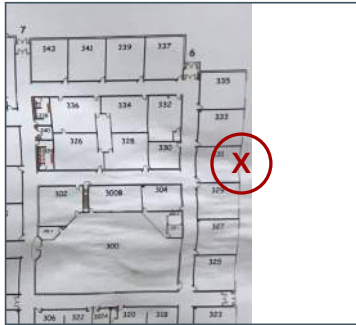
Description: Mortar cracked and missing at CMU

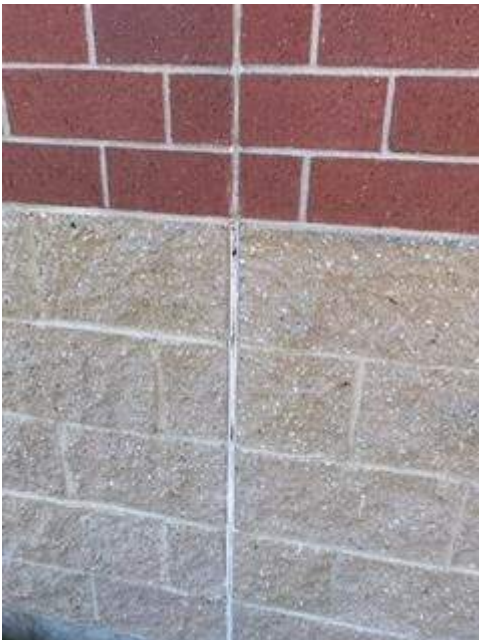
X2: Exterior

Description: Joints need caulking at exterior wall

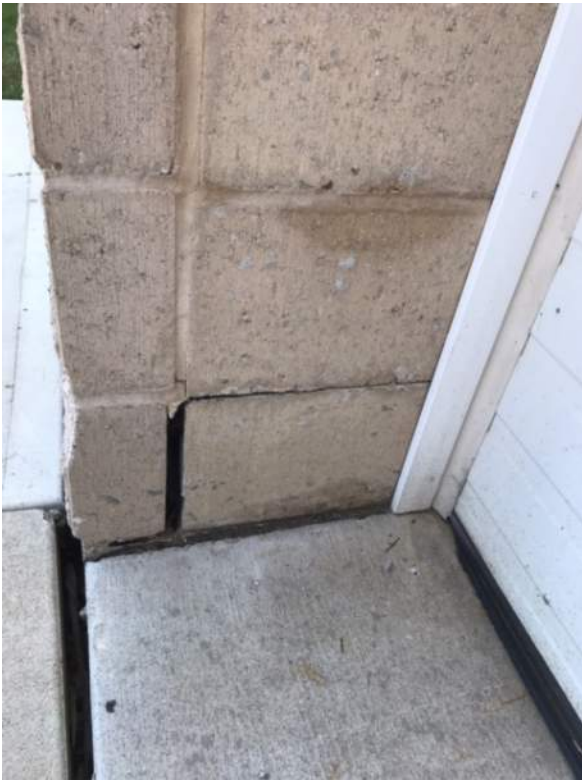
X3: Exterior

Description: Large joint between concrete slabs. Missing mortar at CMU

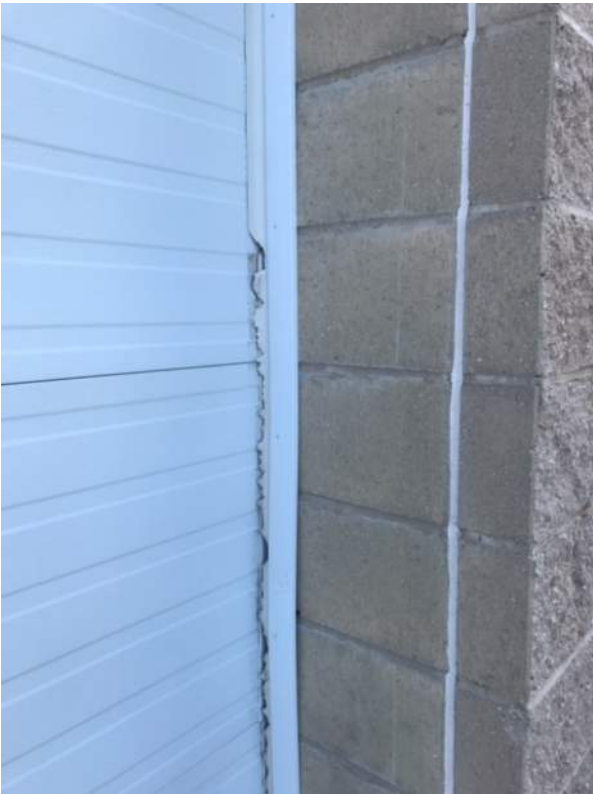
Description: Caulking needed at CMU, garage door seal is broken

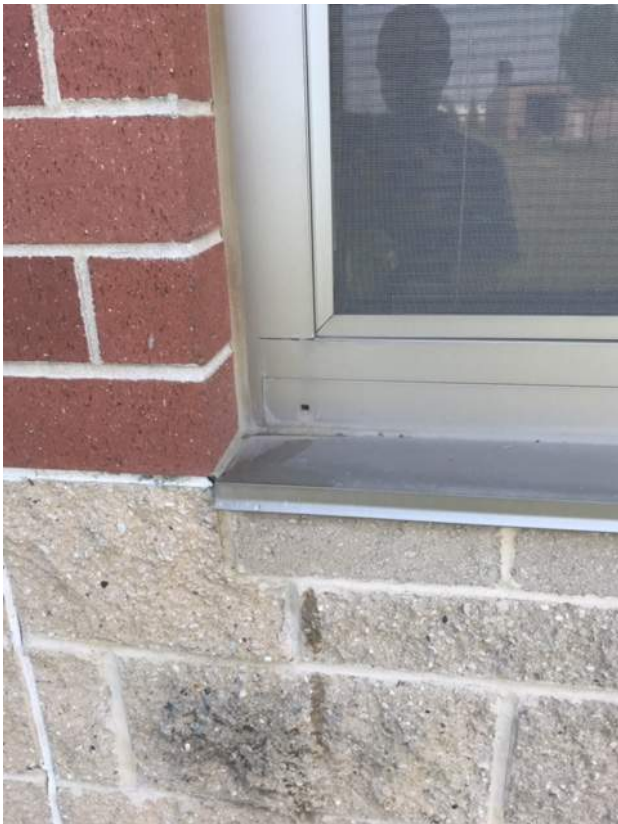
Description: Stain on CMU

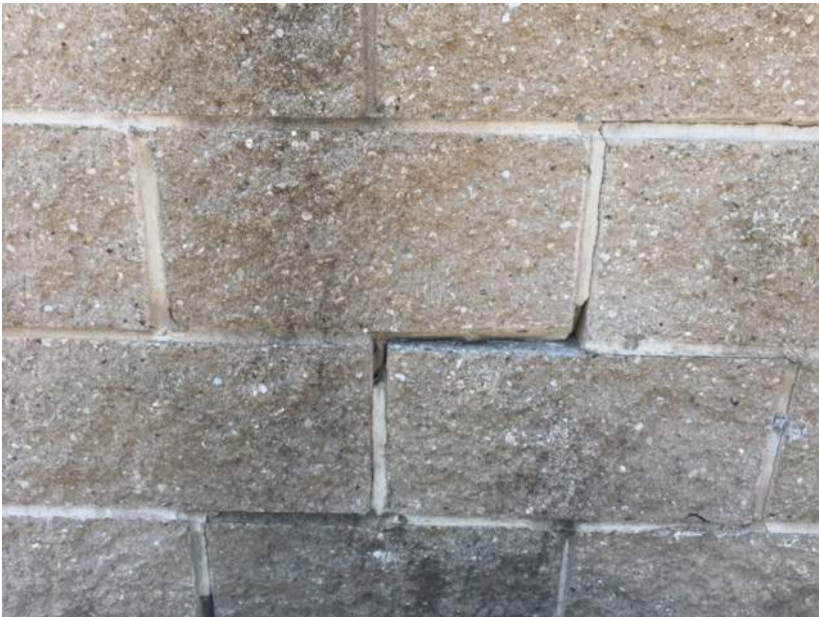
Description: Mortar cracked and missing at CMU

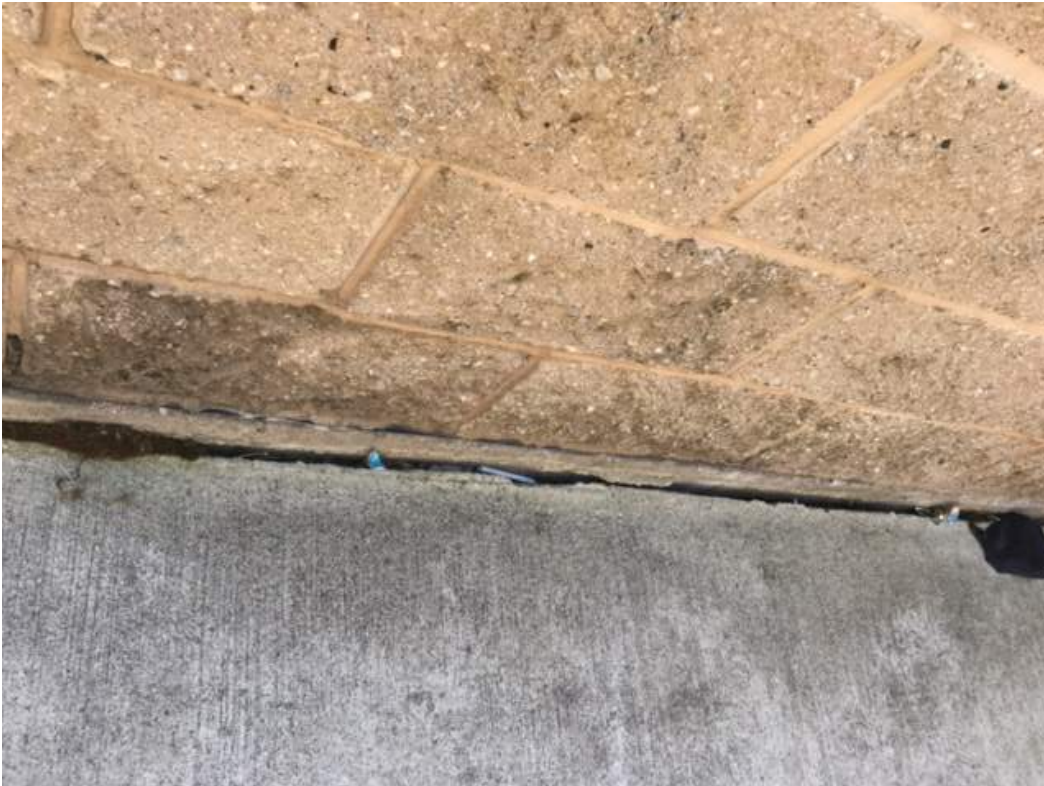
X10: Exterior

Description: Large joint between concrete sidewalk and CMU wall

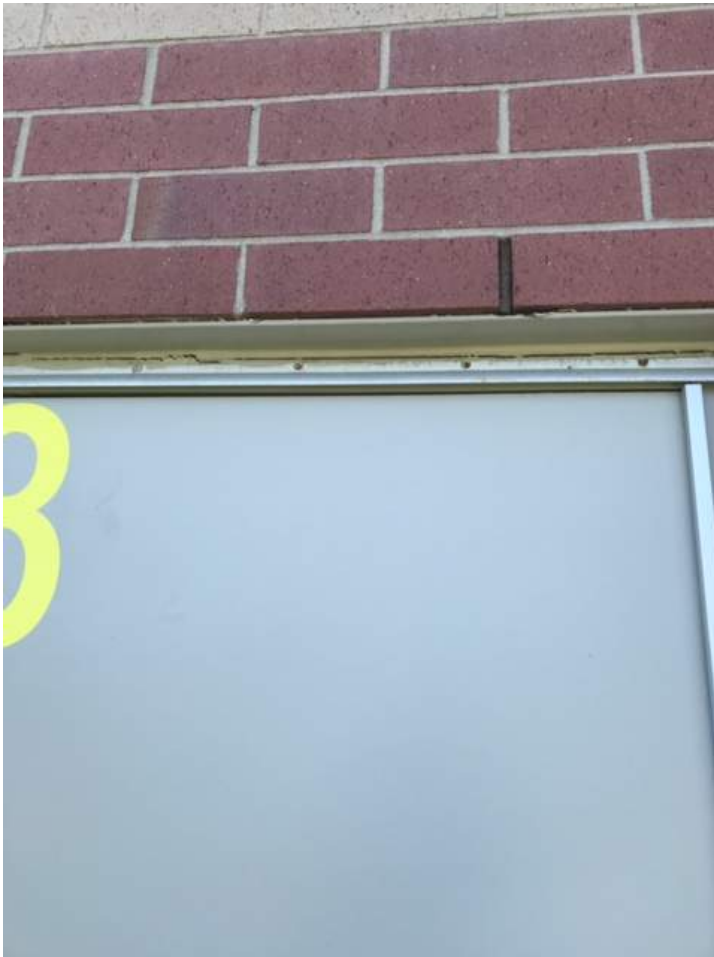
X11: Exterior

Description: Caulking needed above door

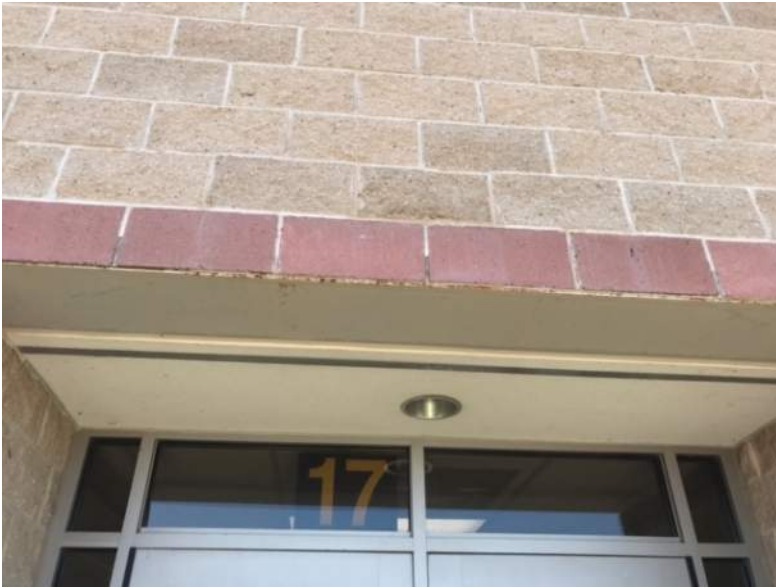
X12: Exterior

Description: Lintels above all windows and doorways require painting

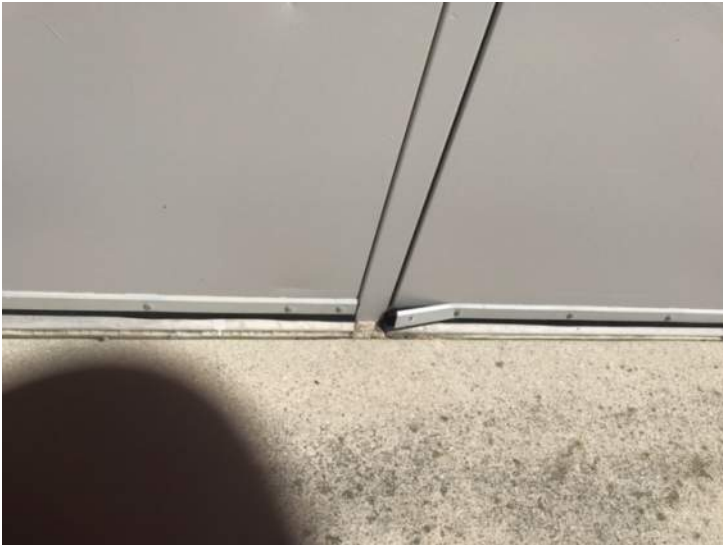
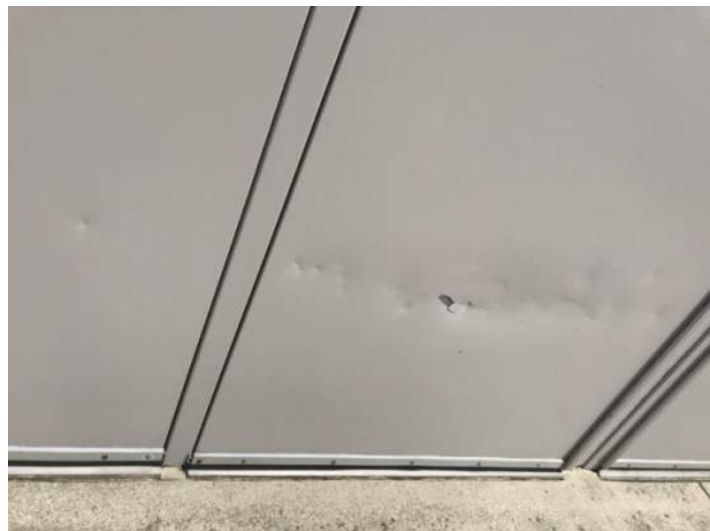
X13: Exterior

Description: Damaged door

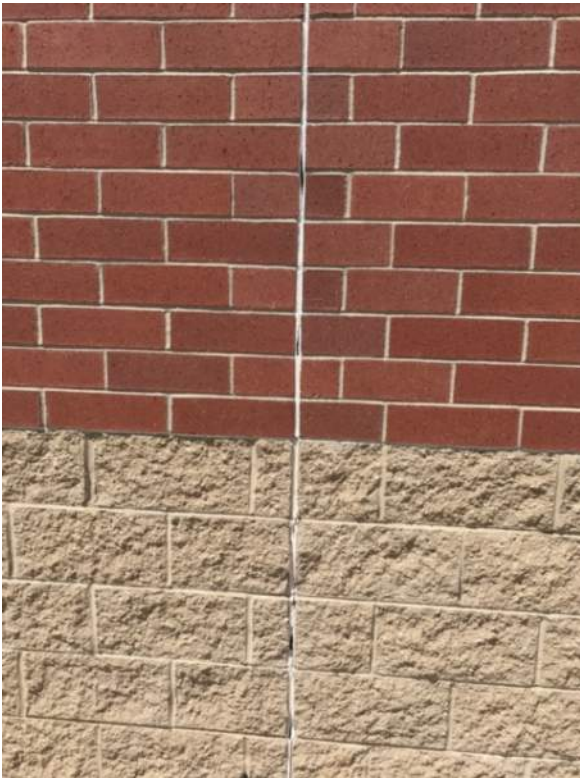
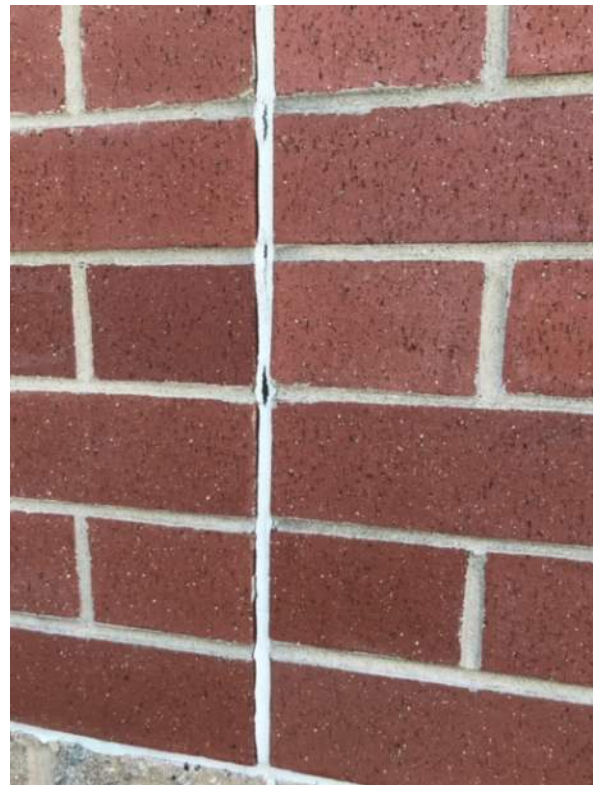
X14: Exterior

Description: Caulking needed at joint

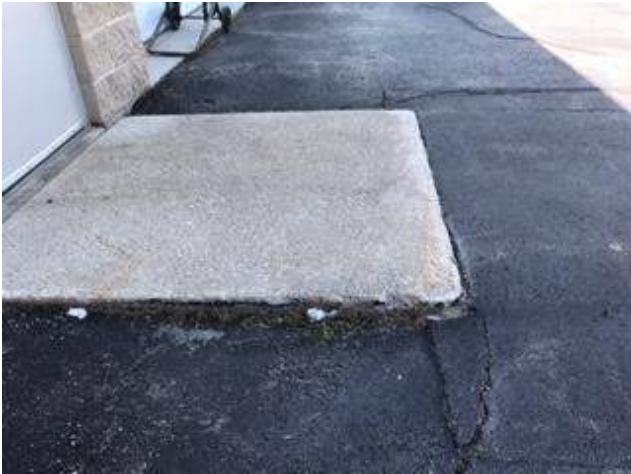
Description: Asphalt is cracking and settling below concrete stoop

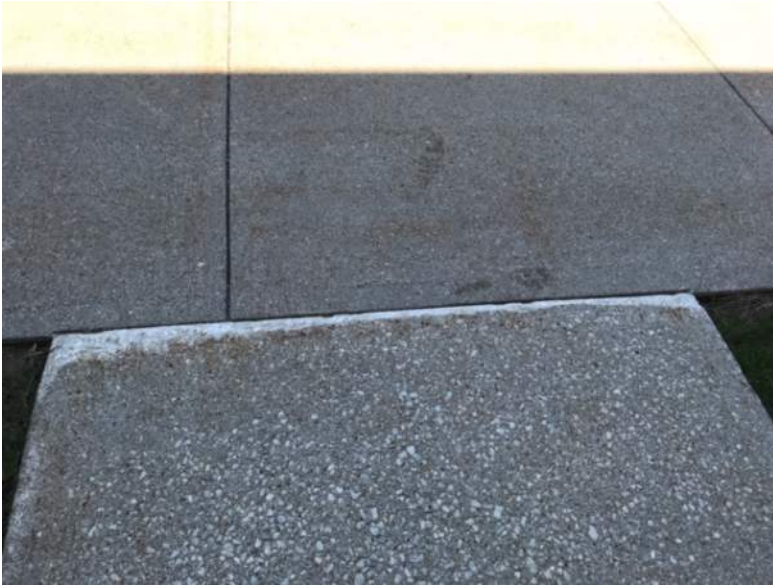
Description: Concrete cracking and settling

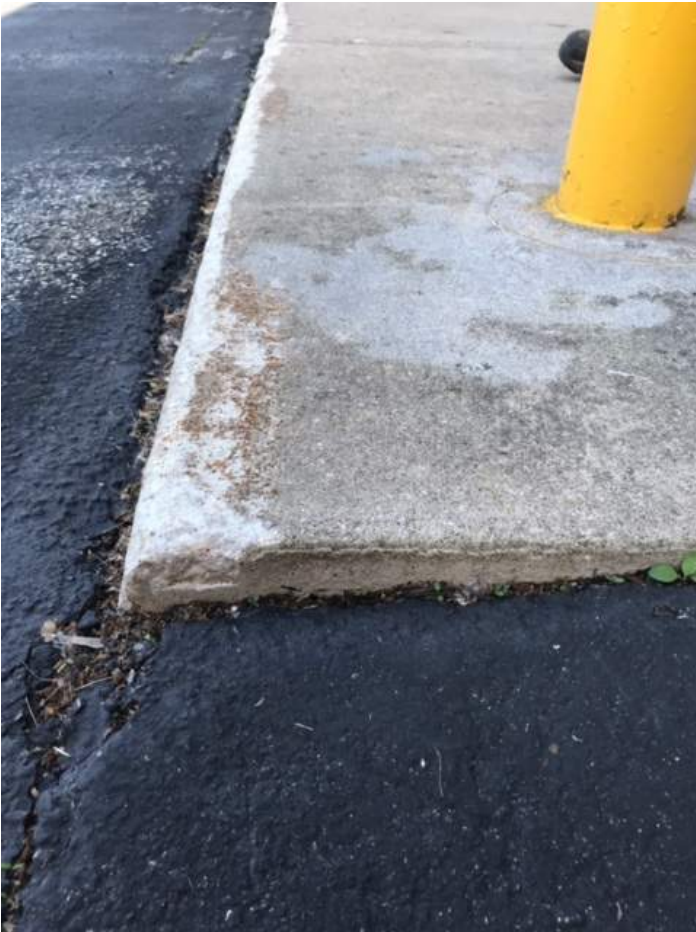
S3: Site Work

Description: Asphalt settled below concrete stoop

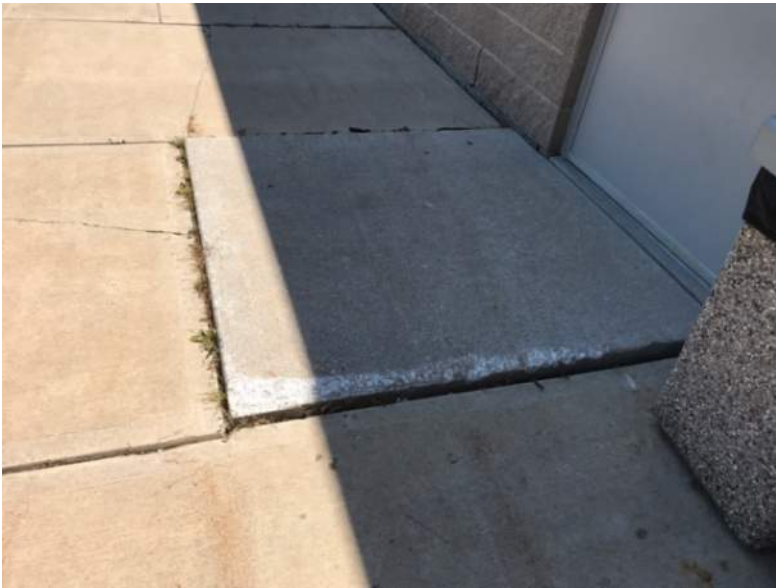
S4: Site Work

Description: Concrete settled below stoop

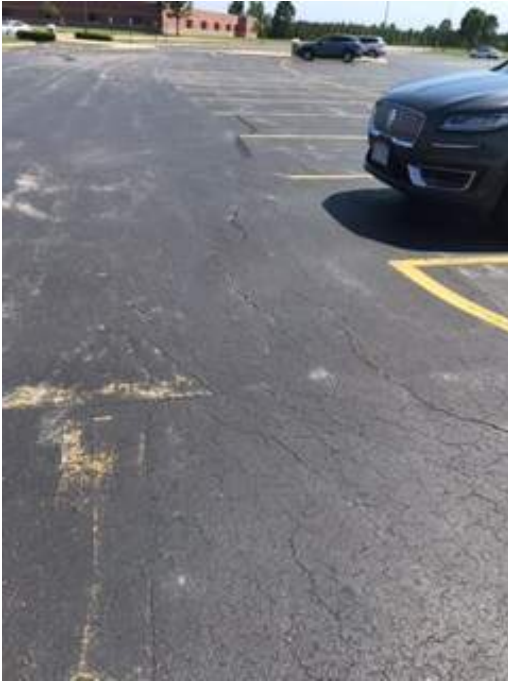
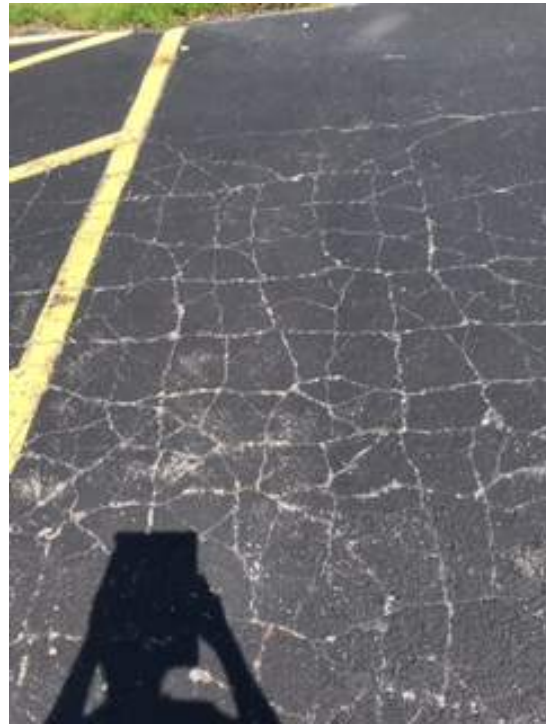
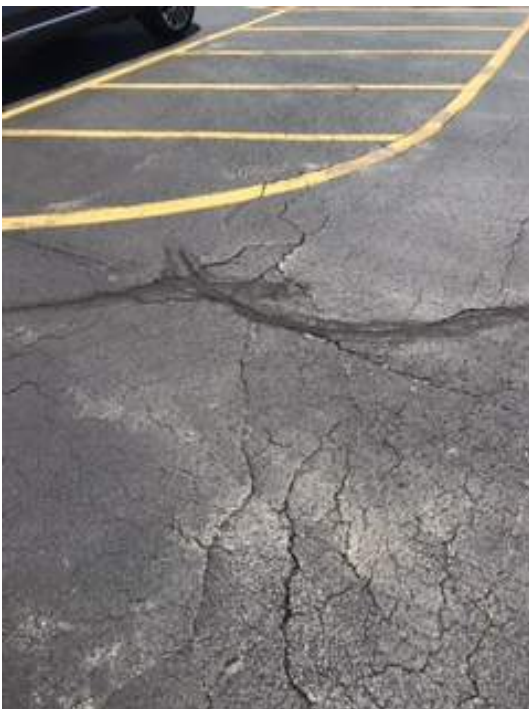
S5: Site Work

Description: Asphalt cracks in the front parking lot

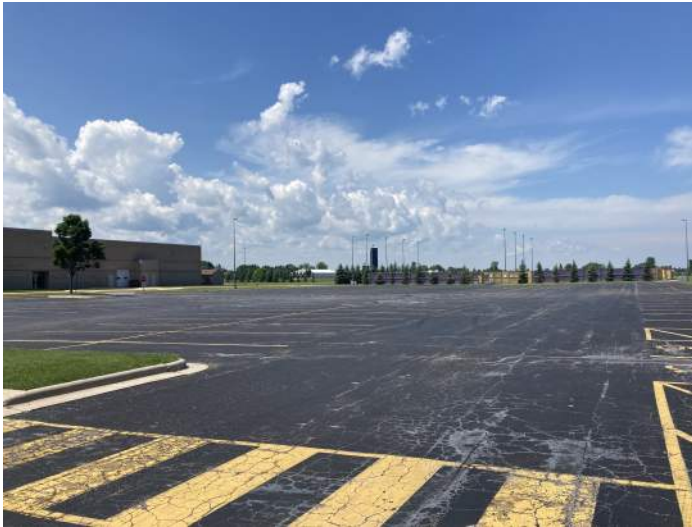
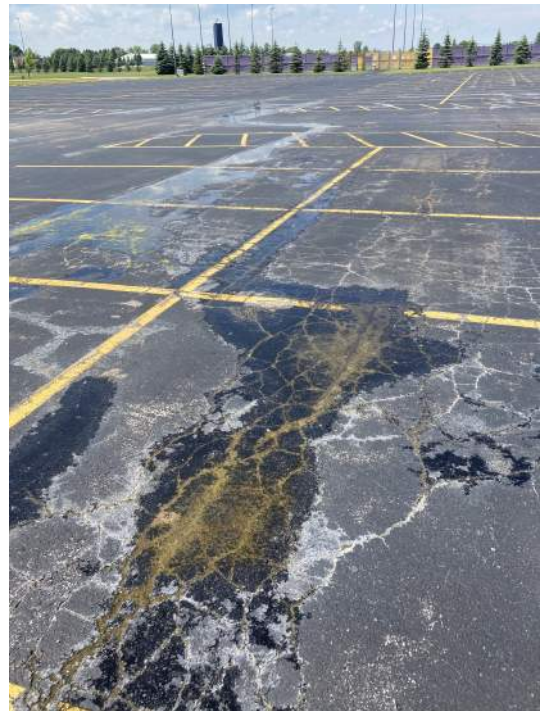
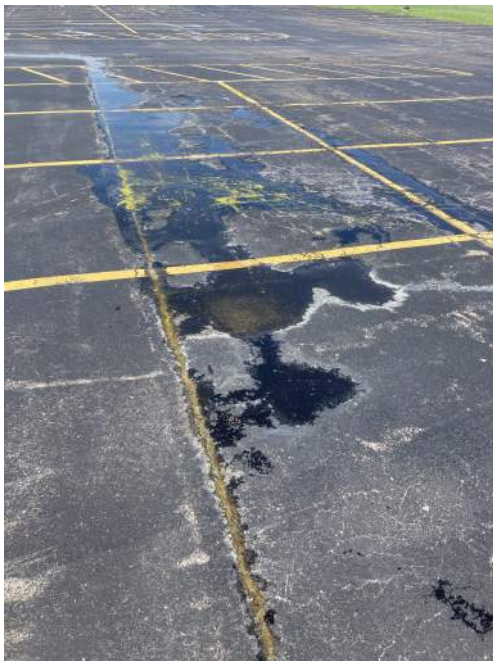
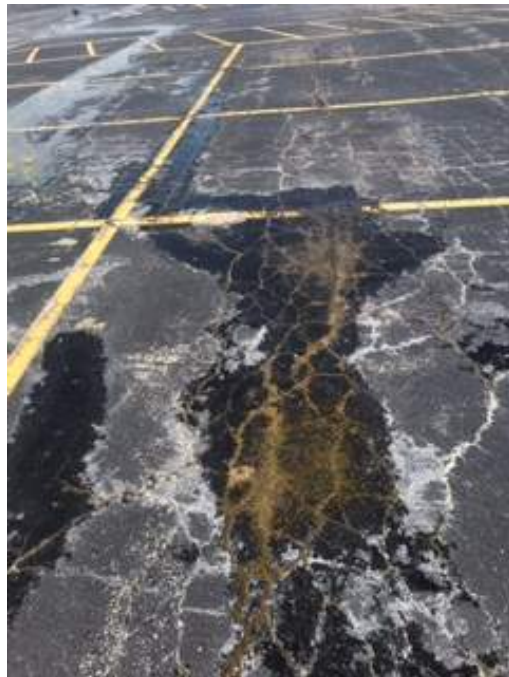
S6: Site Work

Description: Water coming up through cracks in asphalt, back parking lot

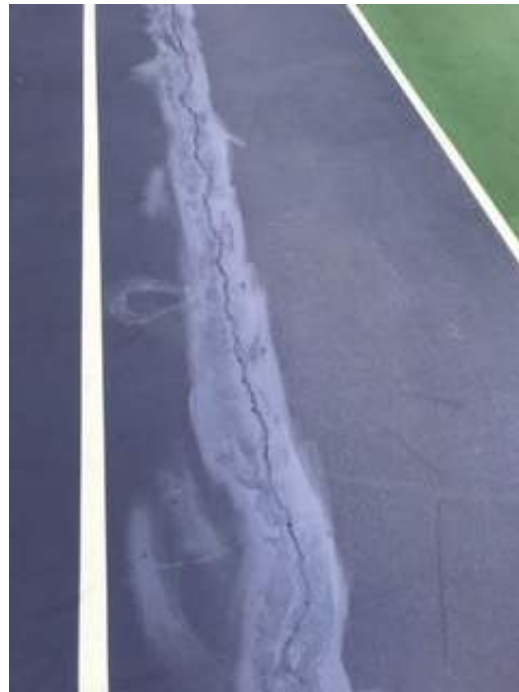
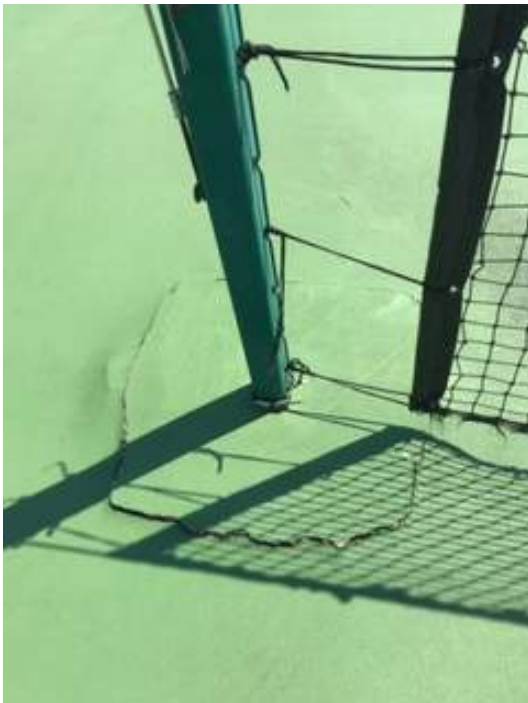
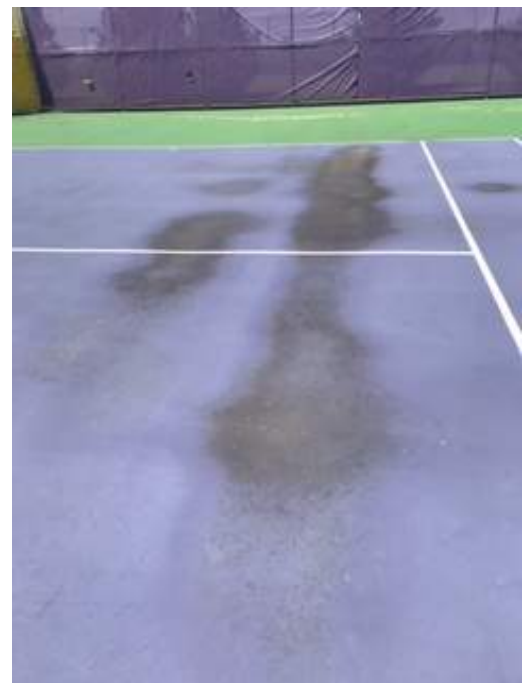
Description: Tennis court floor cracks with floor stains

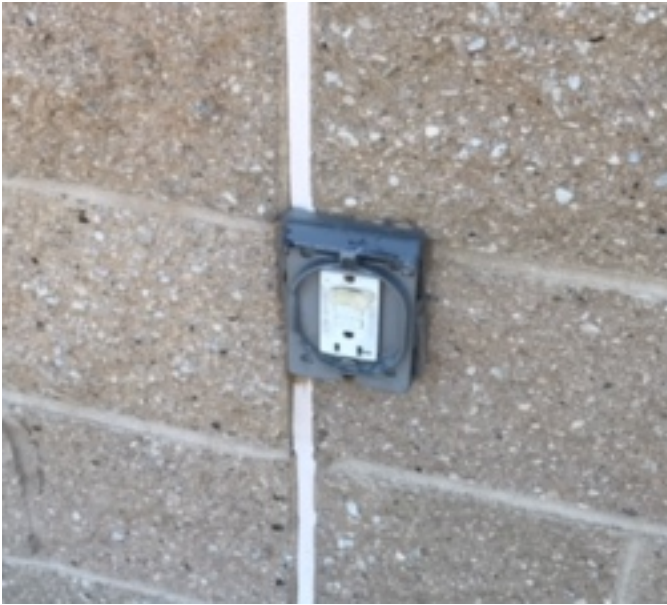
Description: Missing receptacle cover

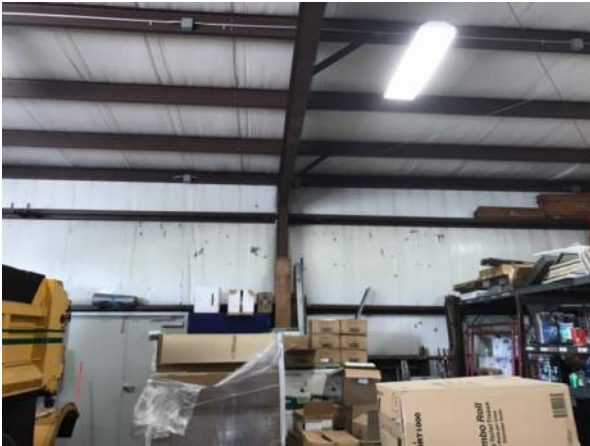
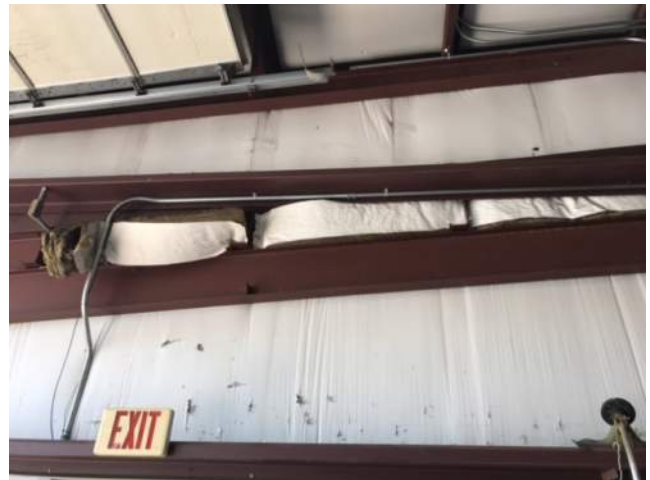
Description: Damaged walls and ceiling

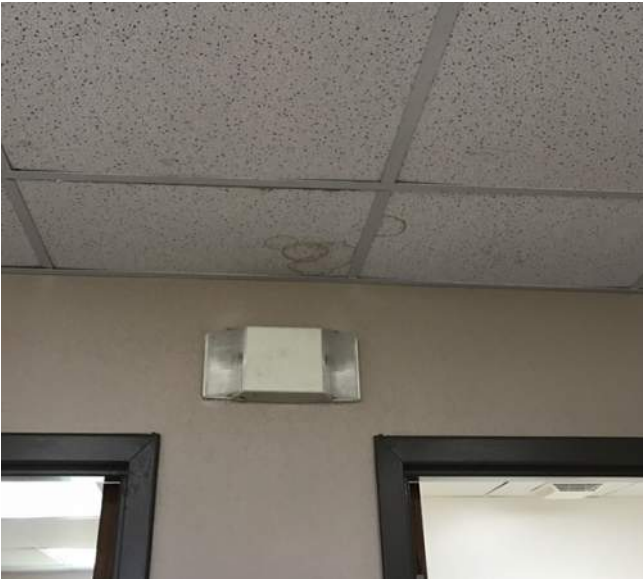
G2: General

Description: Stained ceiling in the office room of the maintenance building

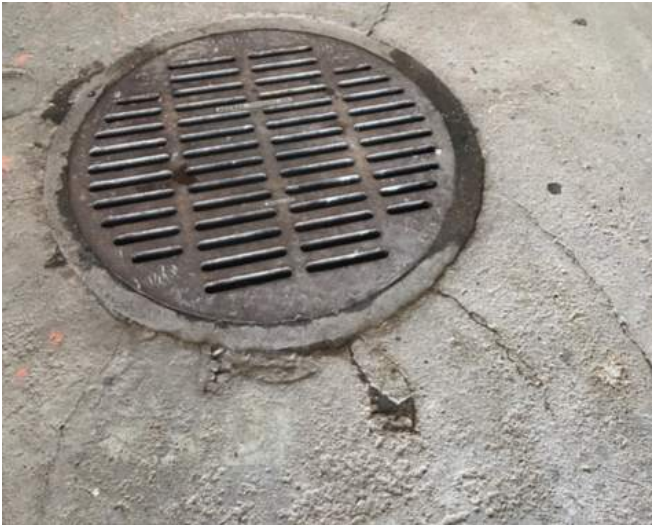
G3: General

Description: Cracks around drain

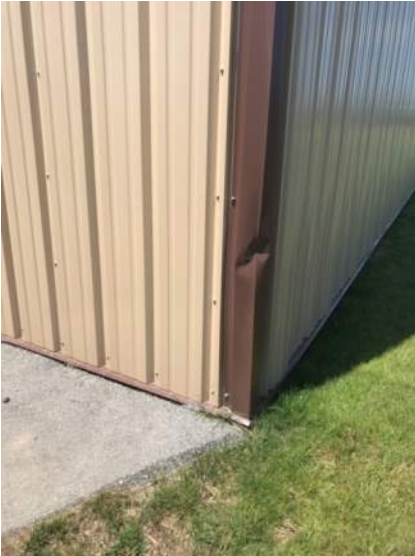
X1: Exterior

Description: Corner of metal dented

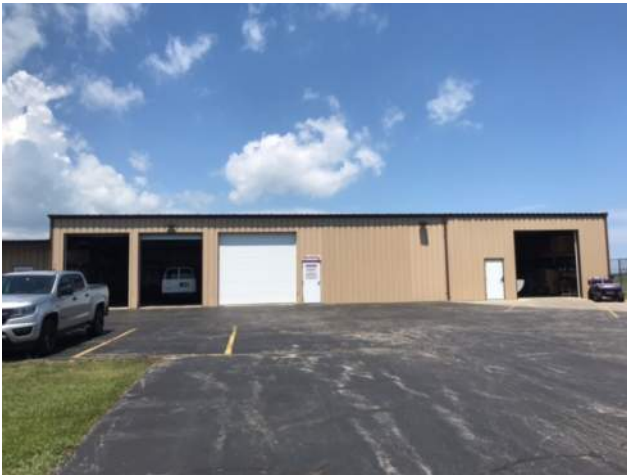
S1: Site Work

Description: Cracked asphalt

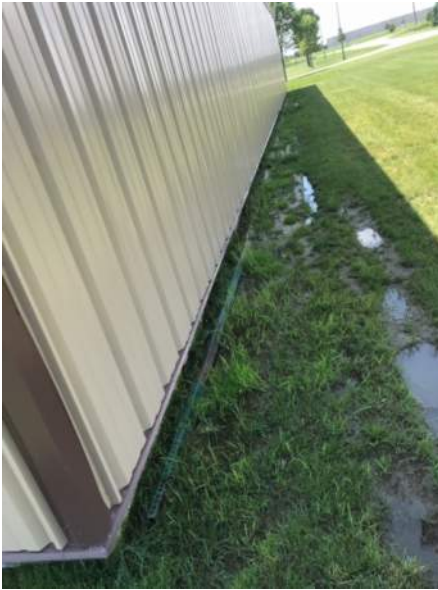
S2: Site Work

Description: Standing water behind maintenance shed
